Subject: **FIR RIDGE LIFT STATION RENEWAL &
REPLACEMENT**
204 Fir Ridge
WBS NO. R-000267-0117-3

Asbestos Survey Report

*Lift Station Renewal and Replacement
Lift Station FN070
204 Fir Ridge Dr.
Huffman, TX*

*WBS No. R-000267-0117-3
Task Number 14-07
ECMS Project Number: 3806 - D*

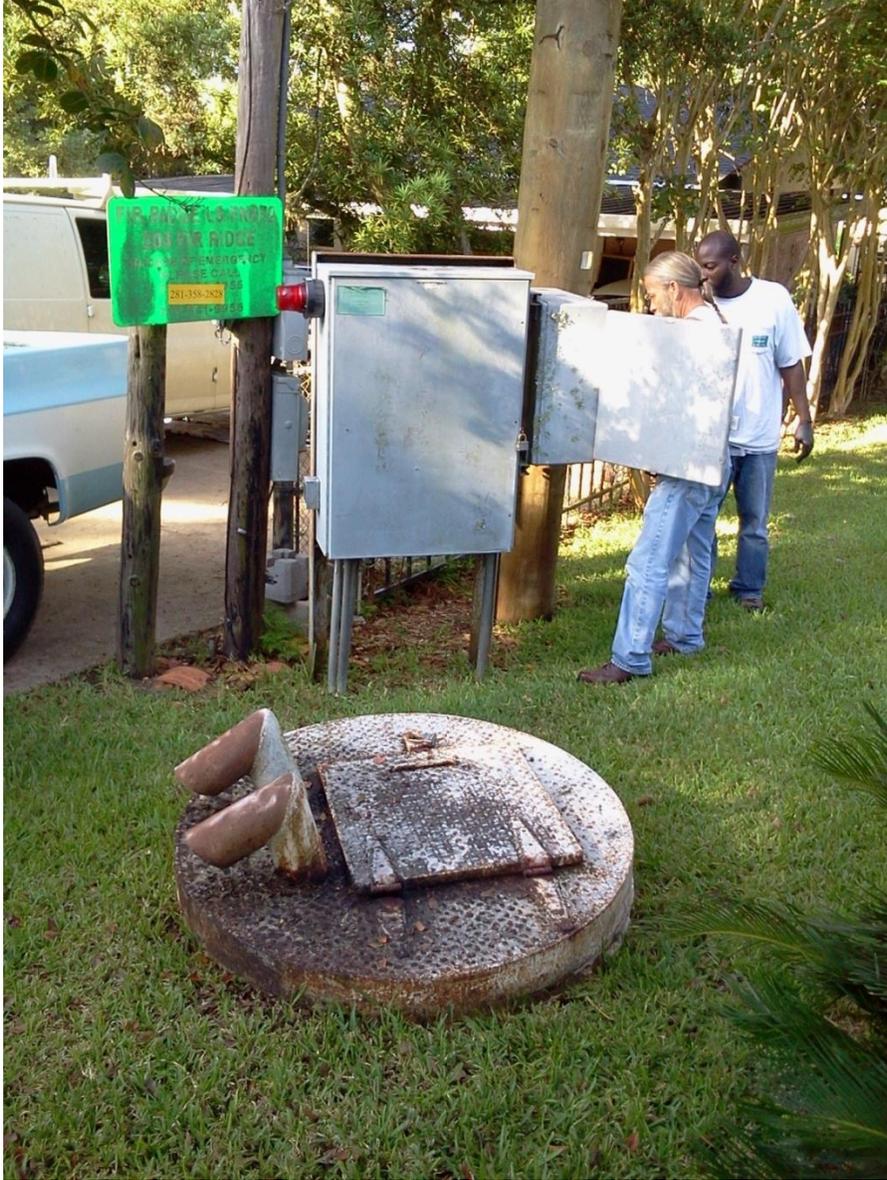
Manway access

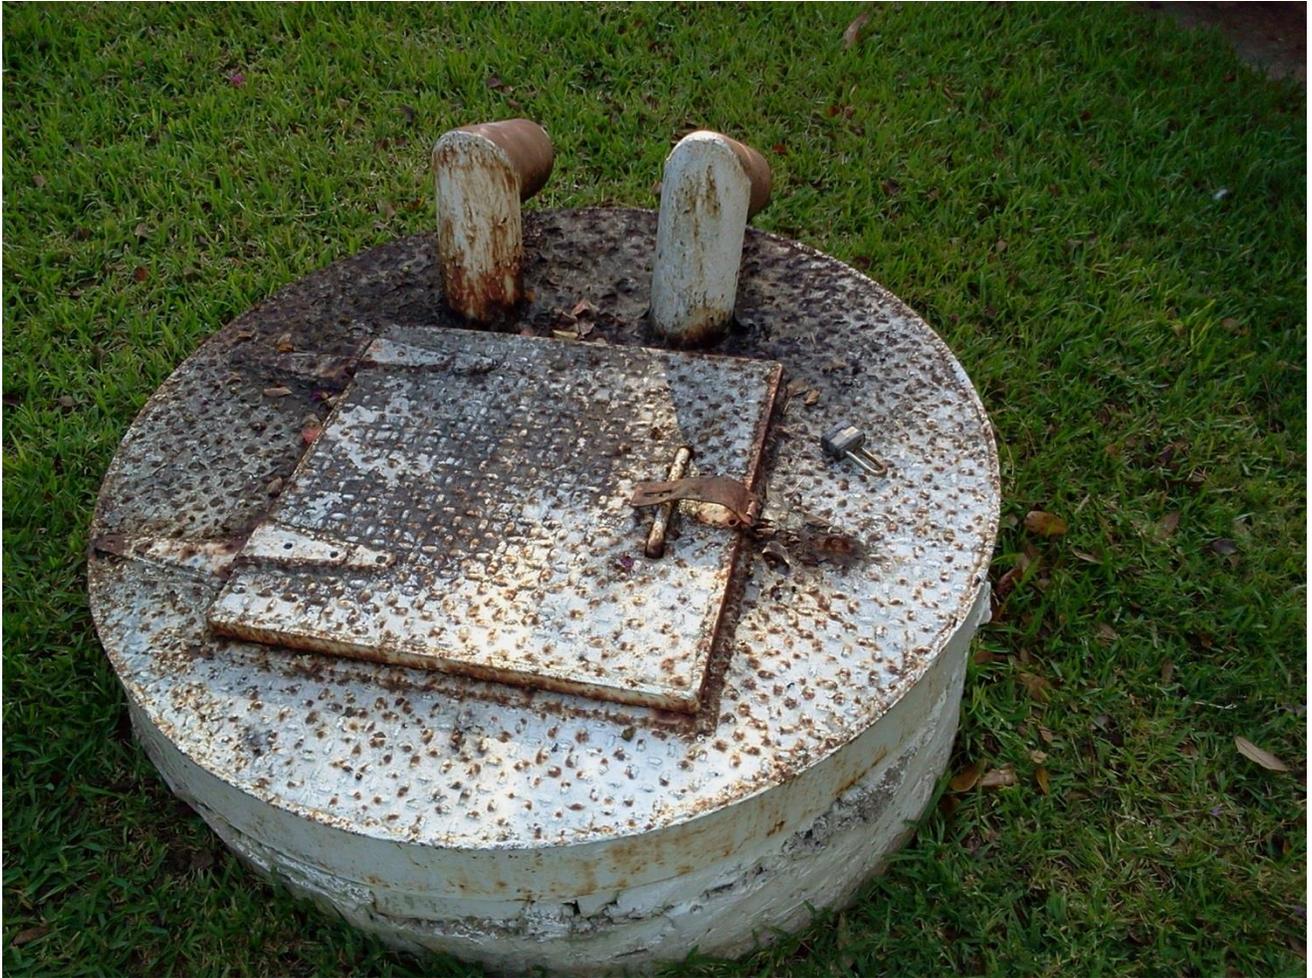
Manway access

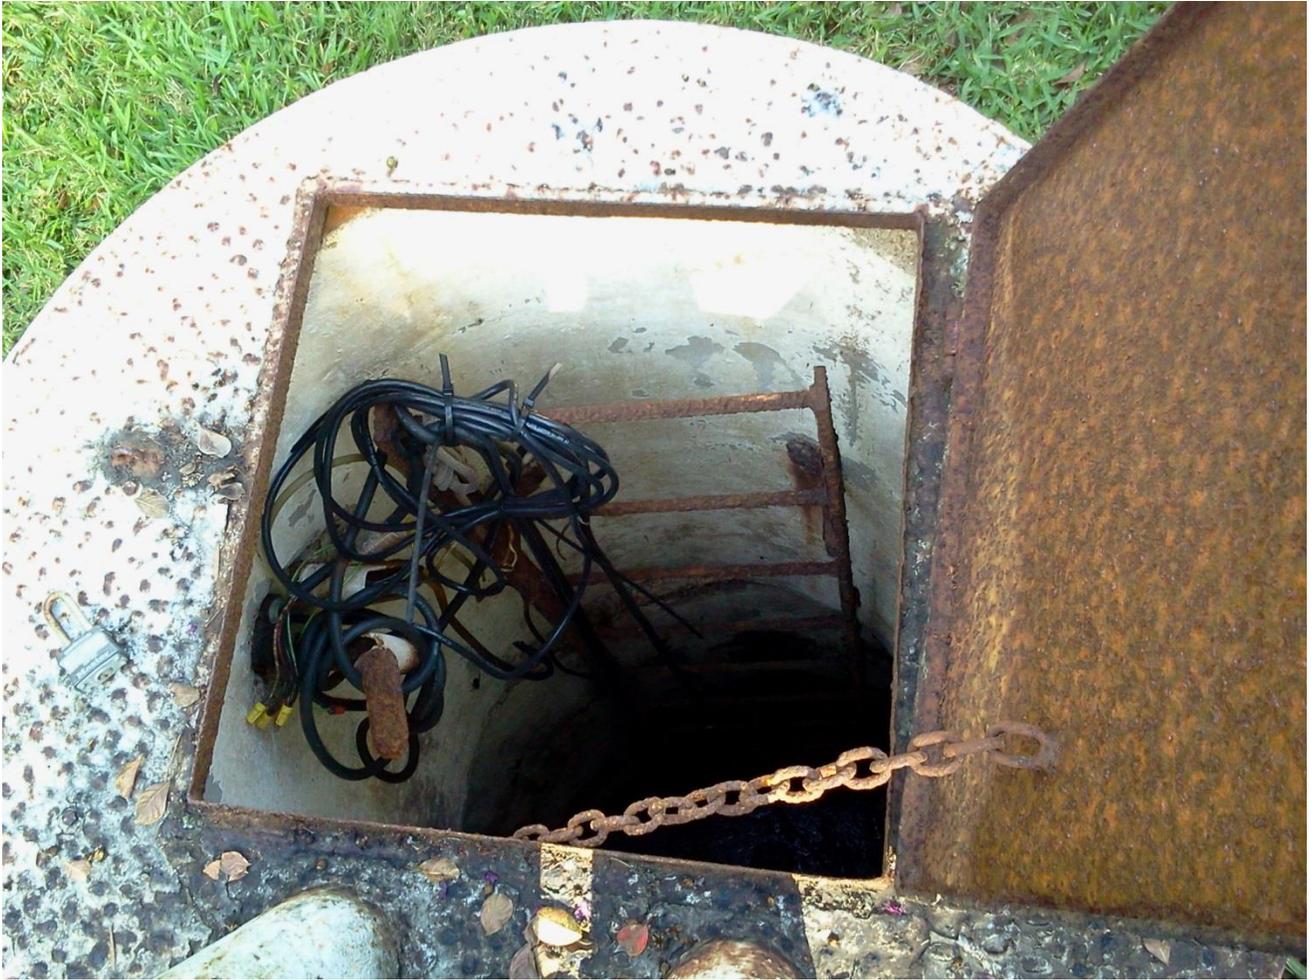
Open manway to below grade pump area

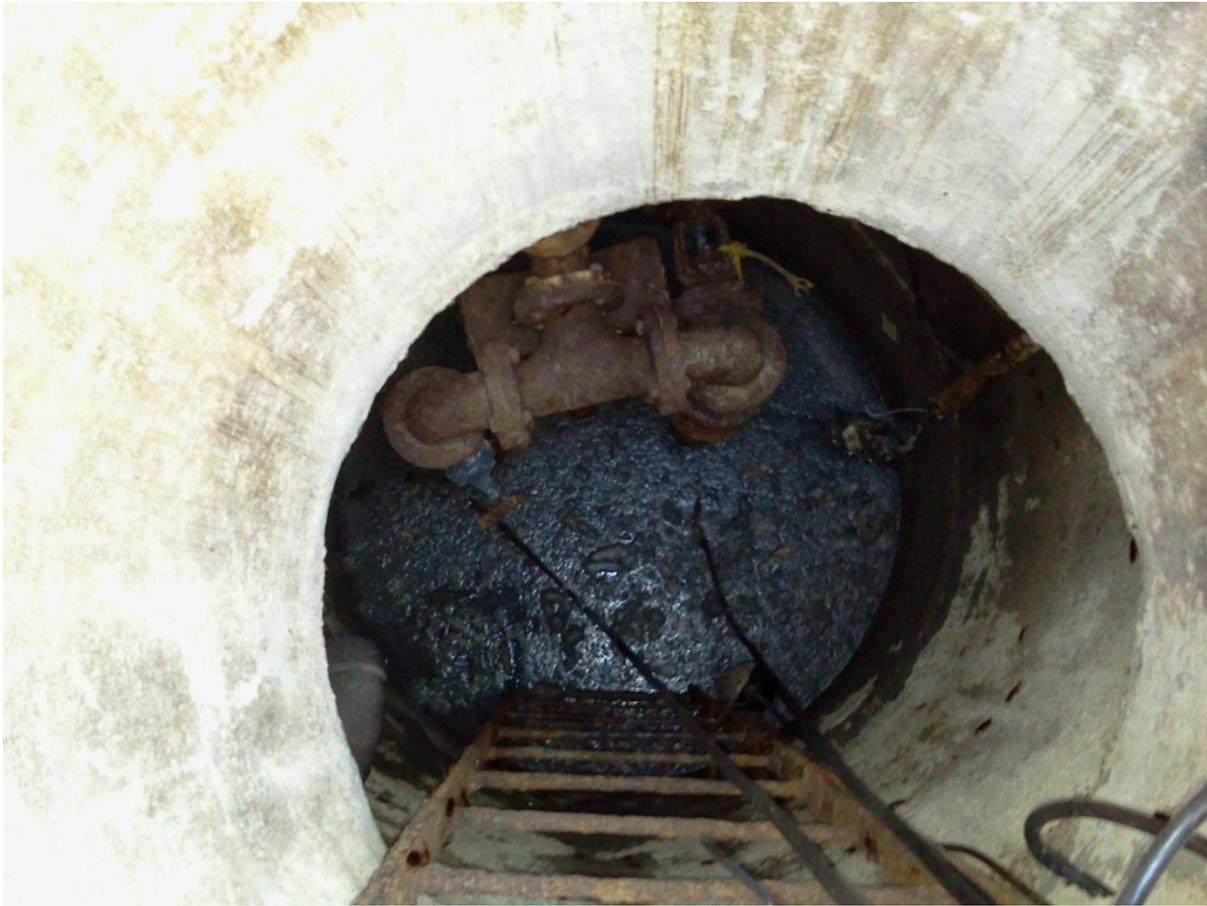
Pump system below grade

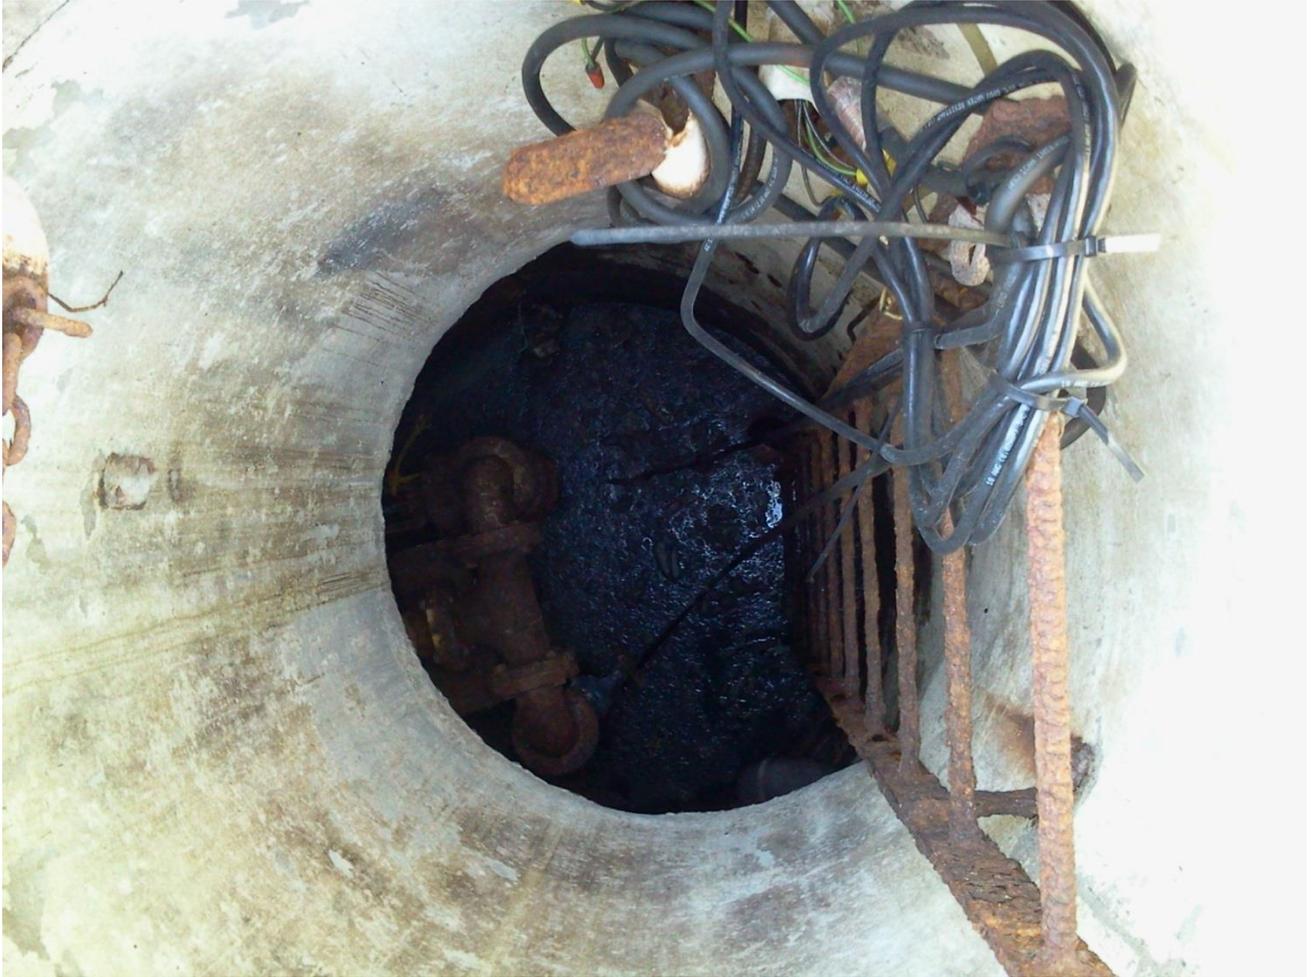
Pump system below grade- different view

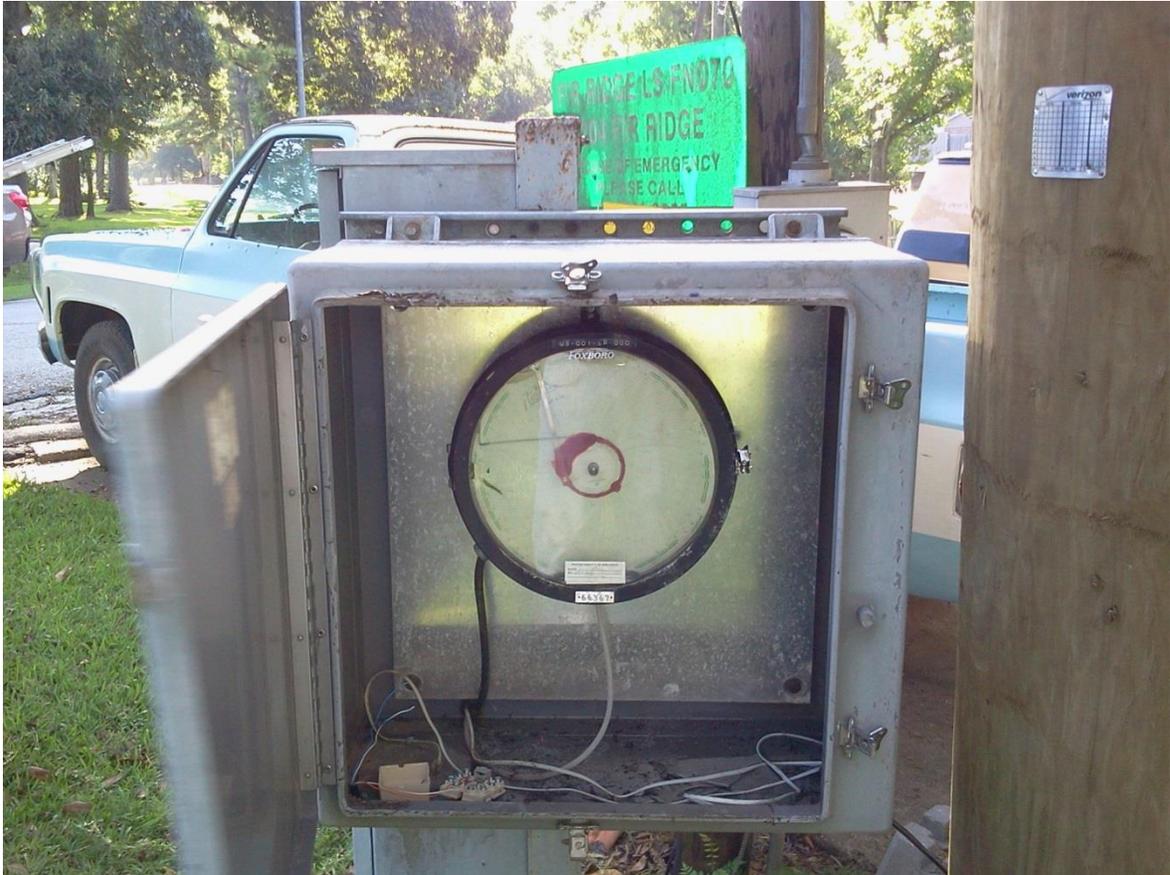
Metering instrument device
