Subject: **STABLEWOOD LIFT STATION DEMOLITION**
8855 Harness Creek Drive
WBS NO. R-000267-0109-3

**Asbestos and Lead Survey
Stablewood Lift Station FN 127
8855 Harness Creek Drive
Houston, Texas**

**WBS No. R-000267-0109-3
Task No. 12-21**

**Inspected
January 22, 2013**

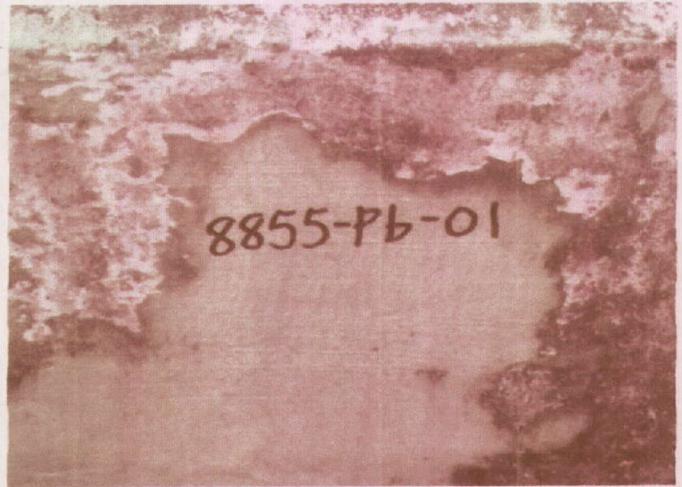
Green concrete pad paint (8855-Pb-01) had no lead detected in it. OSHA requirements do not apply.

Green Concrete Paint (8855-Pb-01) BRL

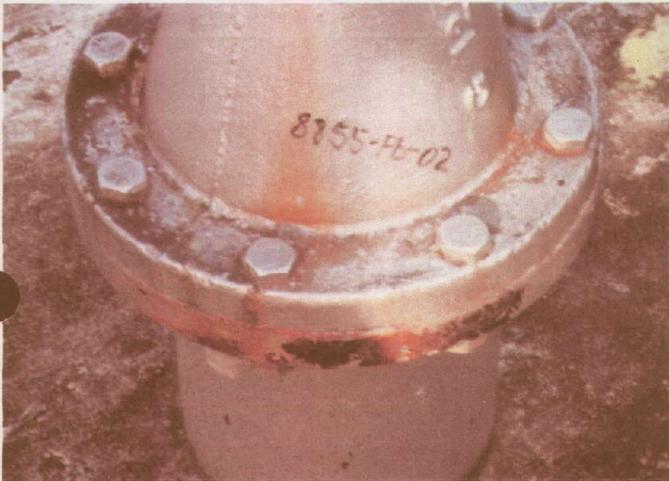
Silver vent pipe paint (8855-Pb-02) had no lead detected in it. OSHA requirements do not apply.

Silver Vent Paint (8855-Pb-02) BRL

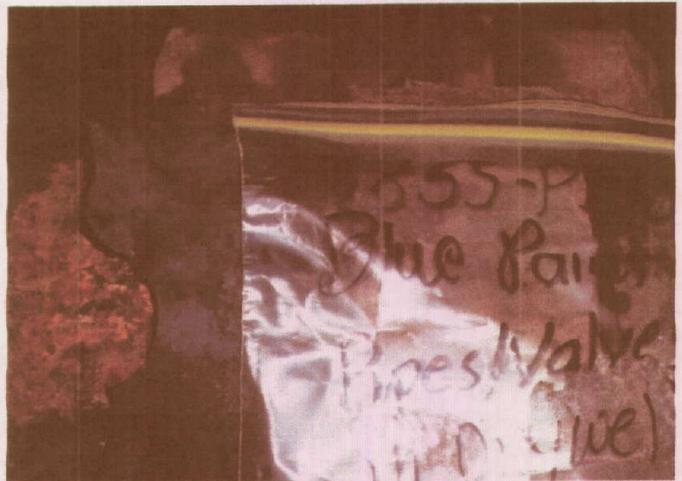
Blue pipe/valve paint sample from the dry well had a detectable lead content of 292 mg/Kg and is not a lead based paint. The paint is in fair condition. OSHA regulations apply during renovation activities.

Blue Valve/Pipe Paint (8855-Pb-03) 292 mg/Kg

The lift station is scheduled for replacement or renewal in the future. Recycle all metal components including those with lead containing paint. No lead abatement required.

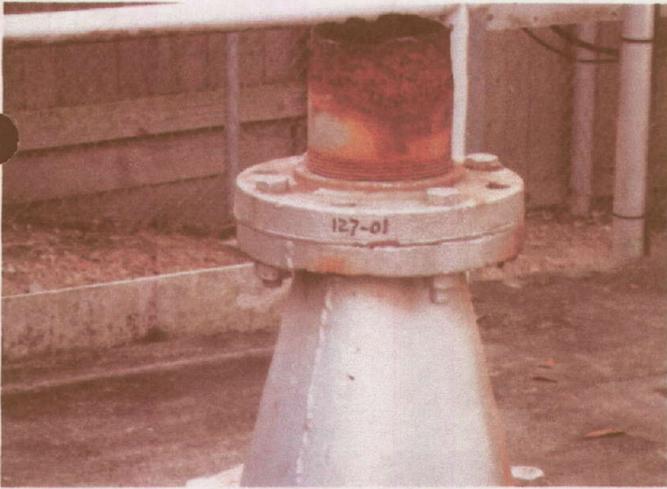
Vent Flange Gasket (127-01) ND

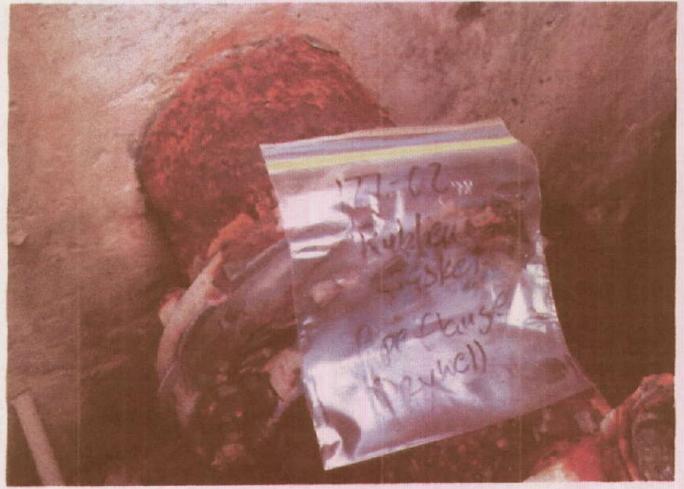
Pipe Flange Gasket (127-02) ND

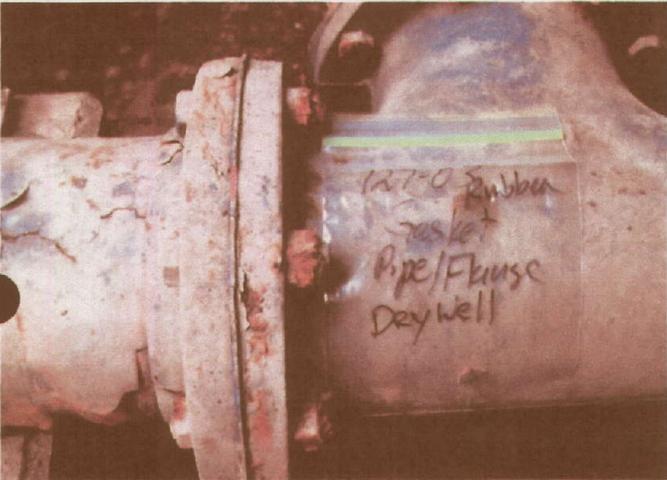
Pipe Flange Gasket (127-03) ND
