Asbestos Survey Report

Water Facility - West Houston #3
14925 South Richmond Avenue
HOUSTON, TX

WBS No. S-001000-0046-4
Task Number 14-13
ECMS Project Number: 3817C

January 15, 2015

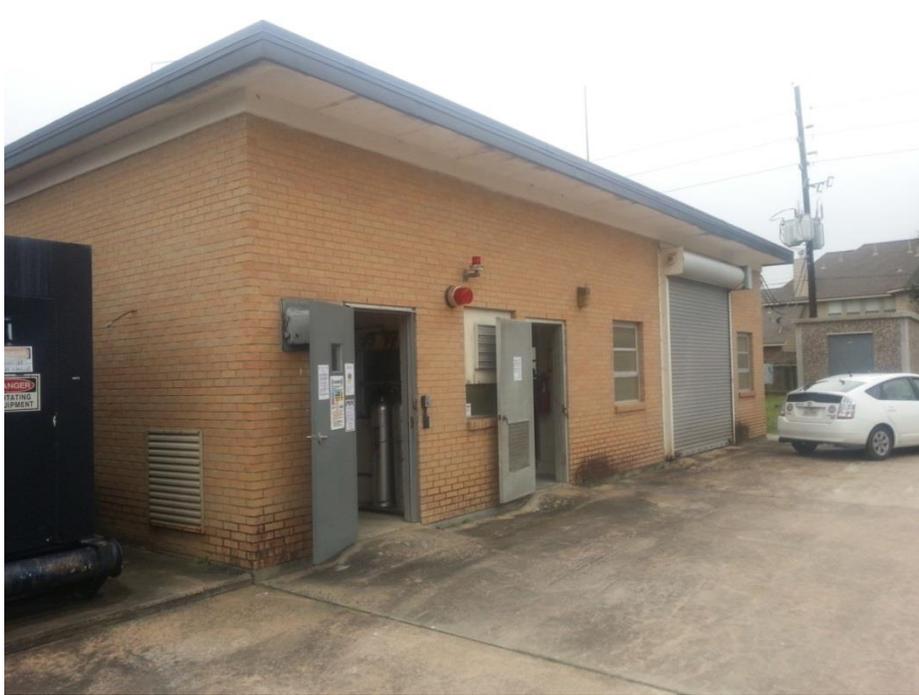
Views of Control Building

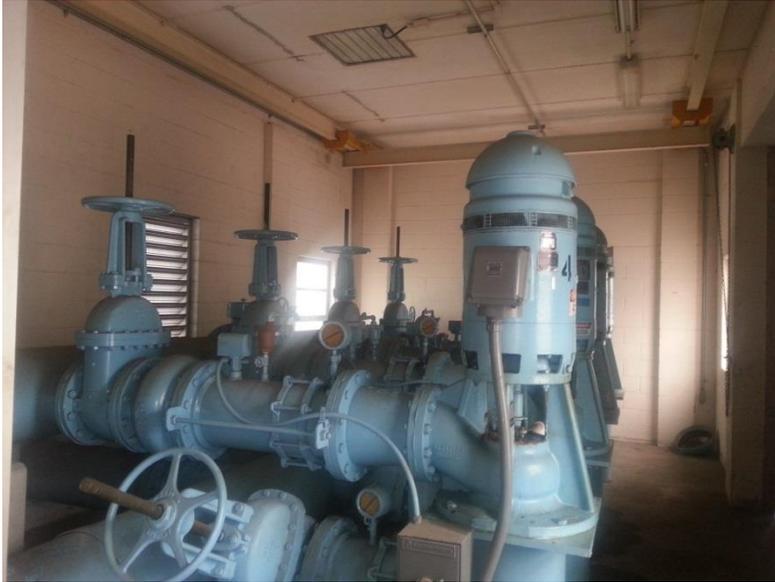
Full view of entire pump system

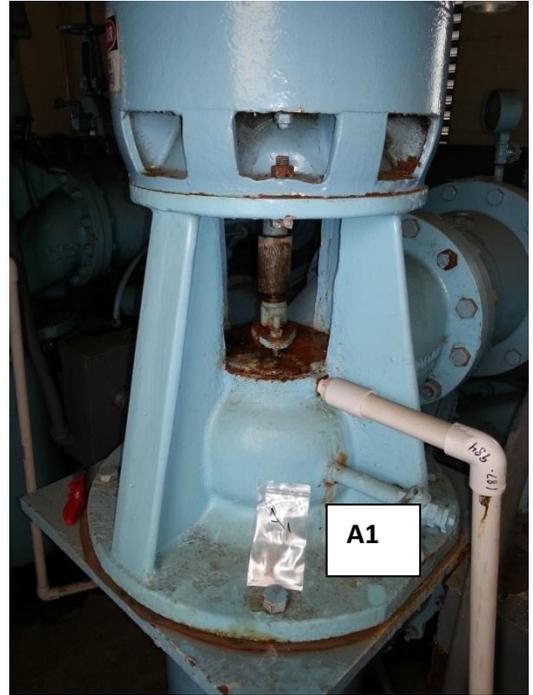
gasket at centrifuge pump #1 base

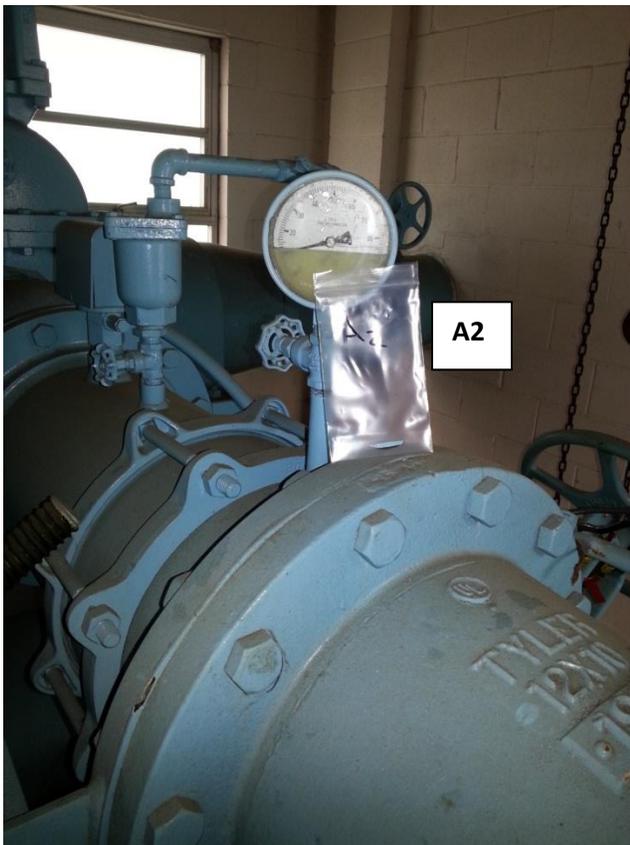
Gasket at horizontal flange pump system #1

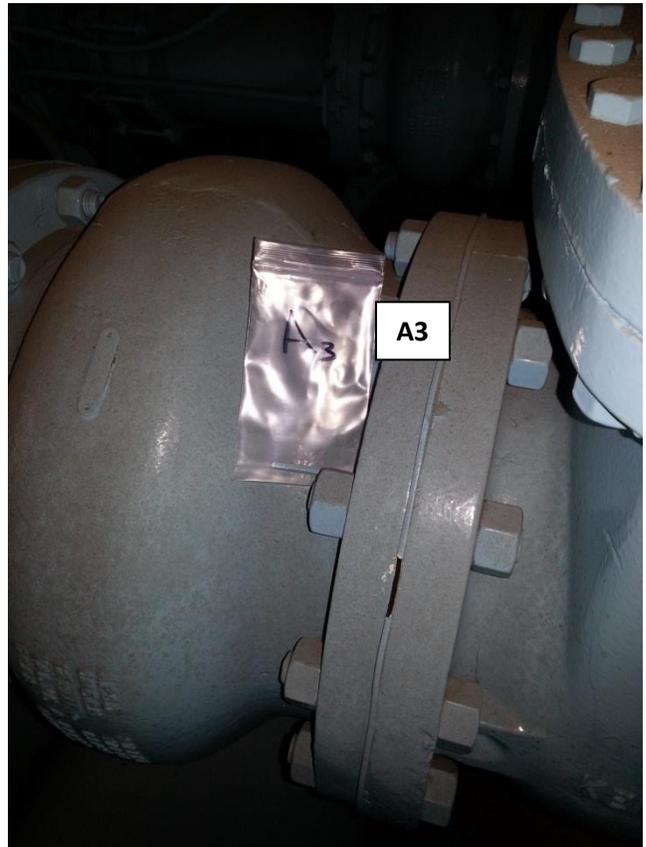
Gasket at flange wing valve pump #1

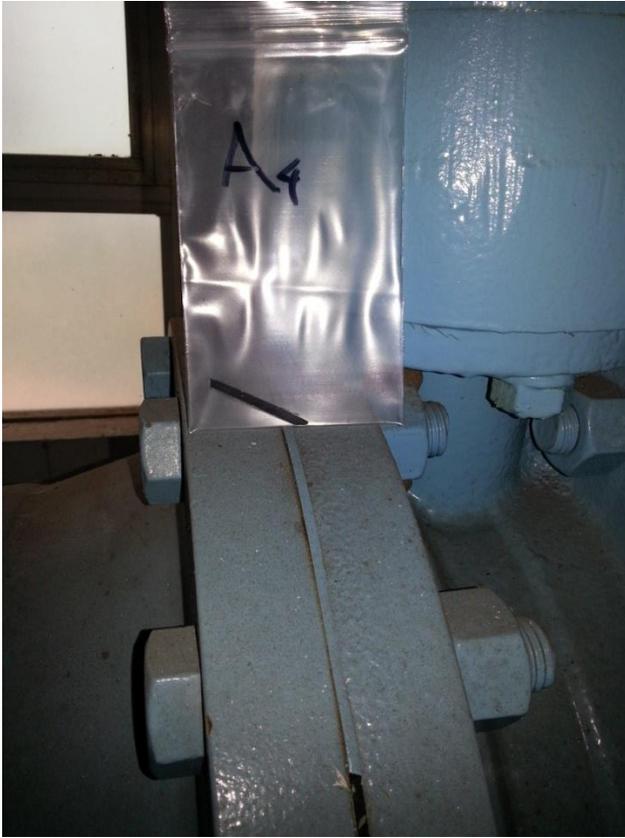
Gasket at flange pressure valve pump #1

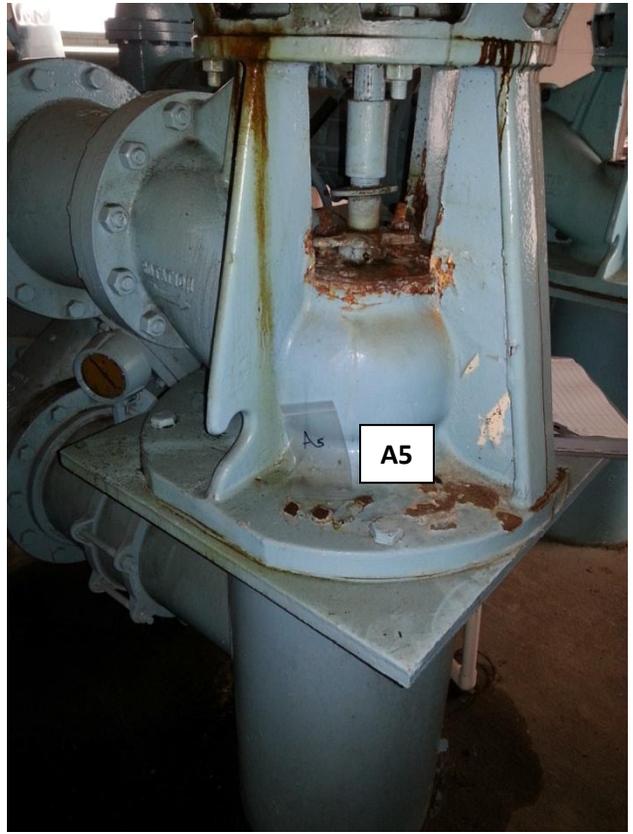
gasket at centrifuge pump #2 base

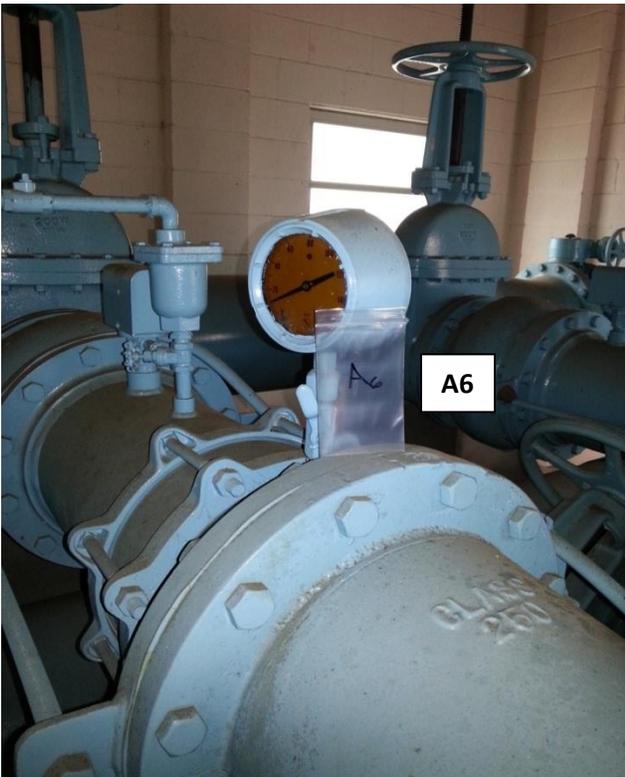
Gasket at horizontal flange pump system #2

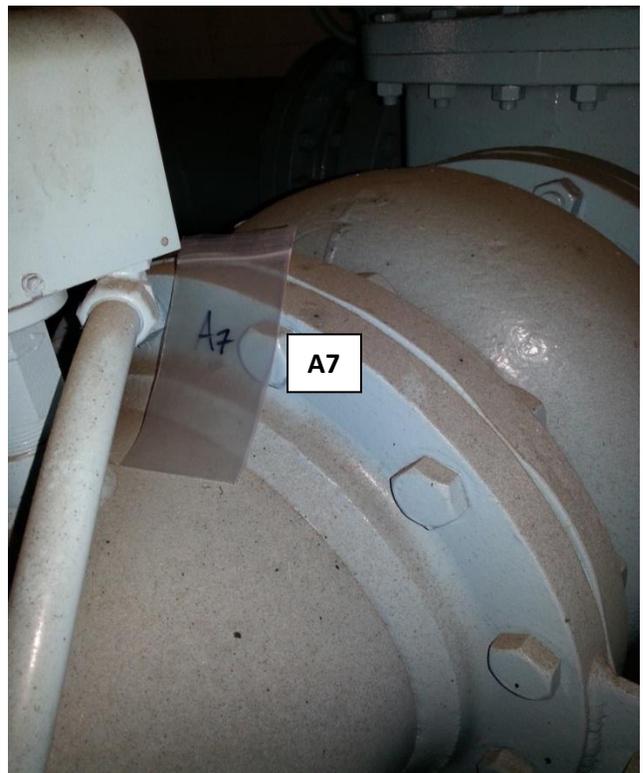
Gasket at flange wing valve pump #2

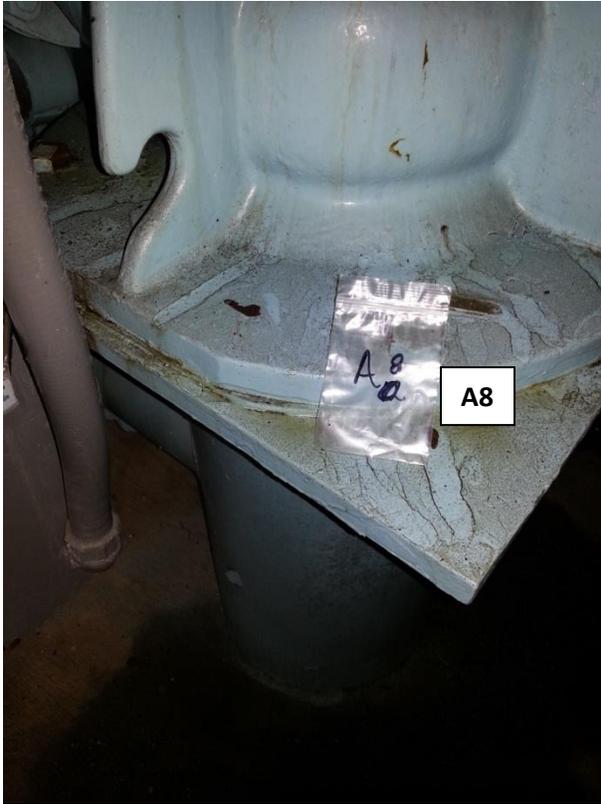
gasket at centrifuge pump #3 base

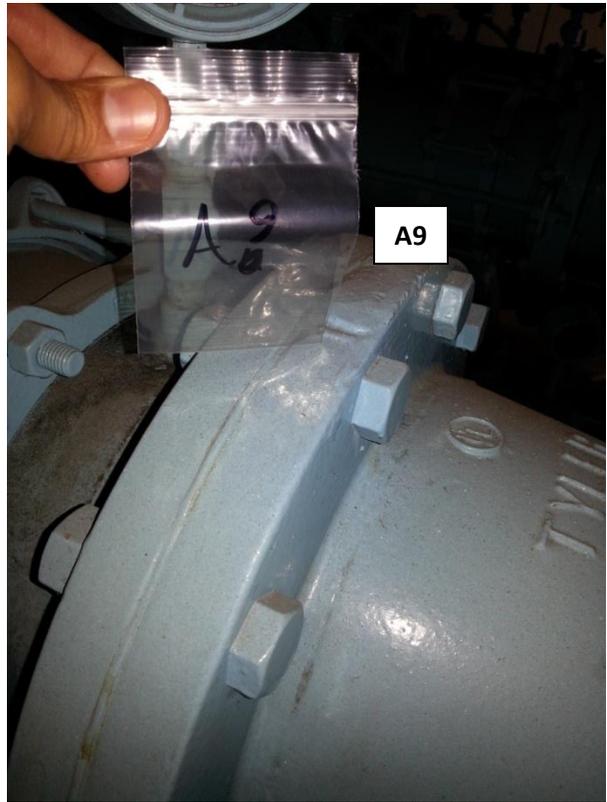
Gasket at horizontal flange pump system #3

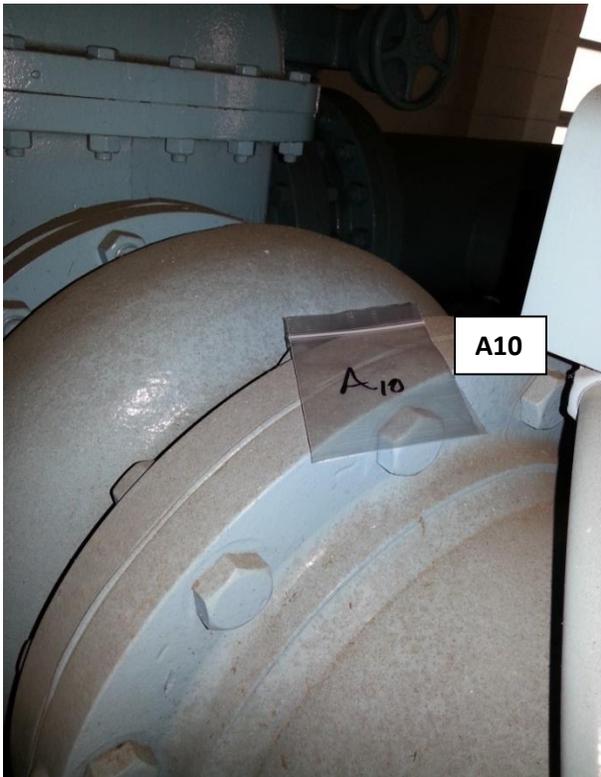
Gasket at flange wing valve pump #3

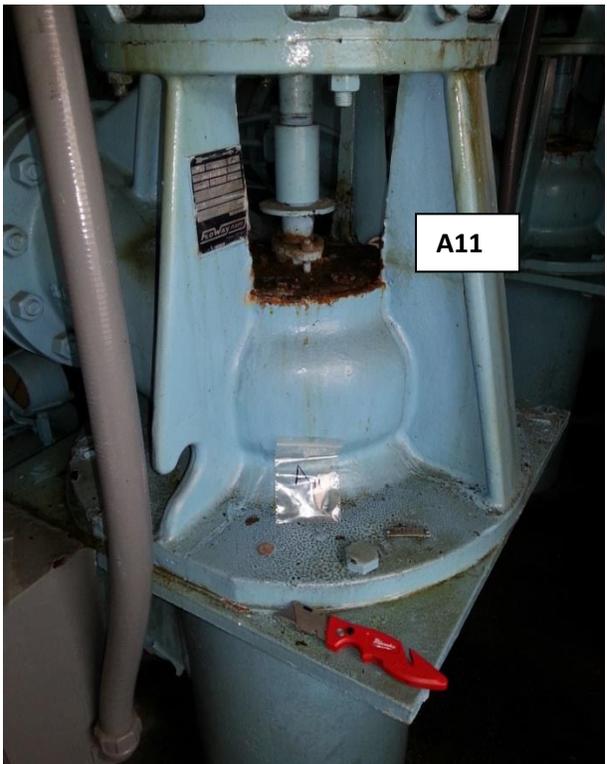
gasket at centrifuge pump #4 base

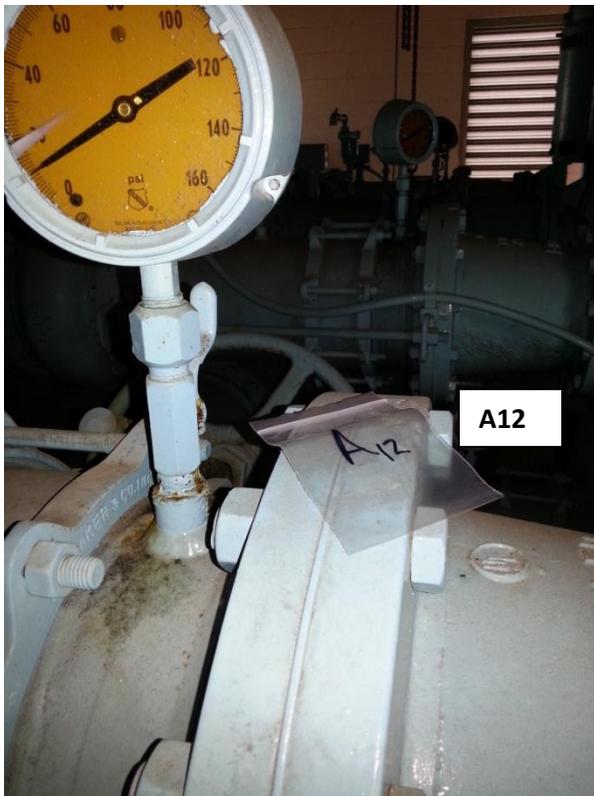
Gasket at horizontal flange pump system #4

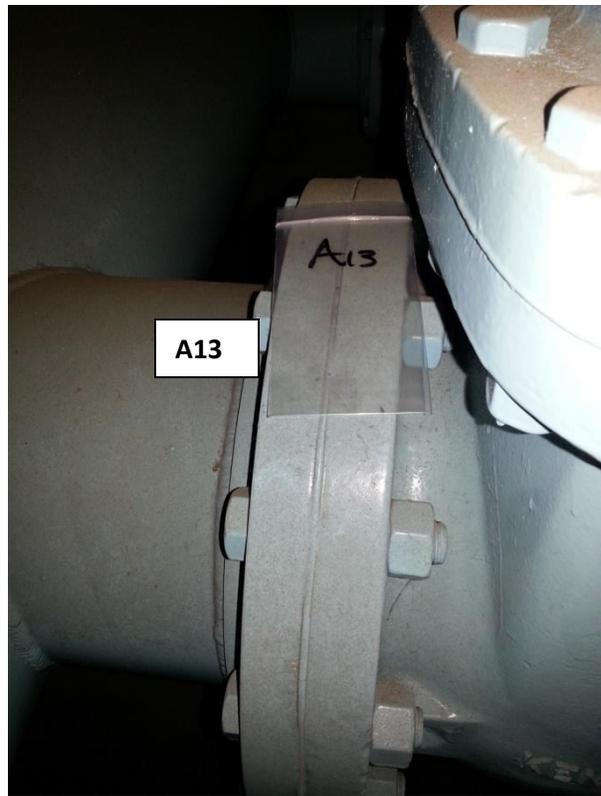
Gasket at flange wing valve pump #4

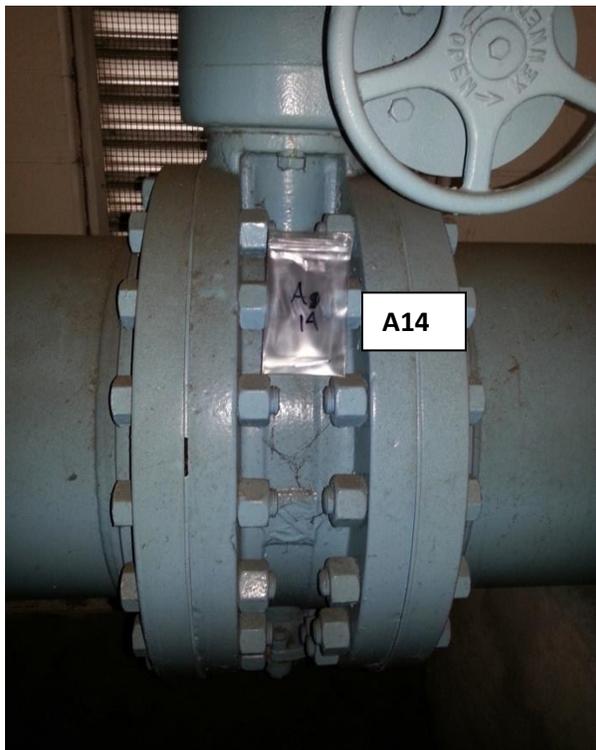
Gasket at double flange horizontal inlet line pump #4

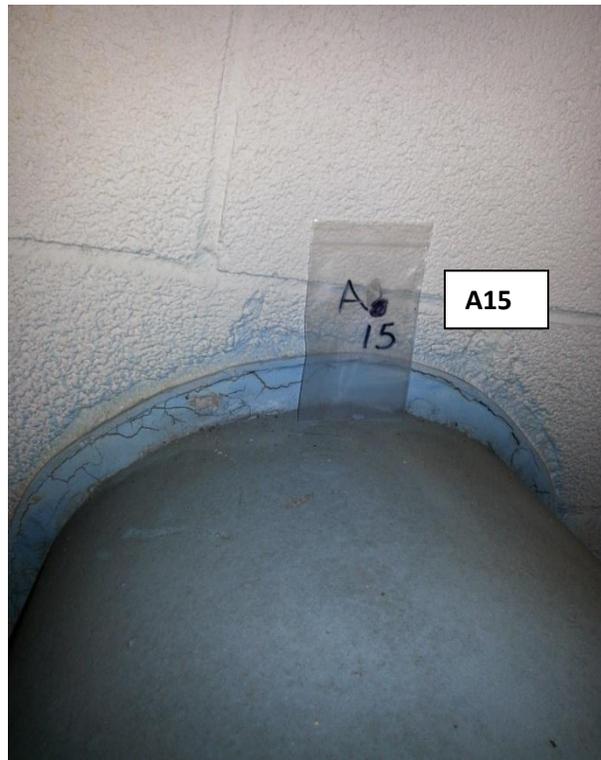
Wall - pipe sealant first stage inlet line east end

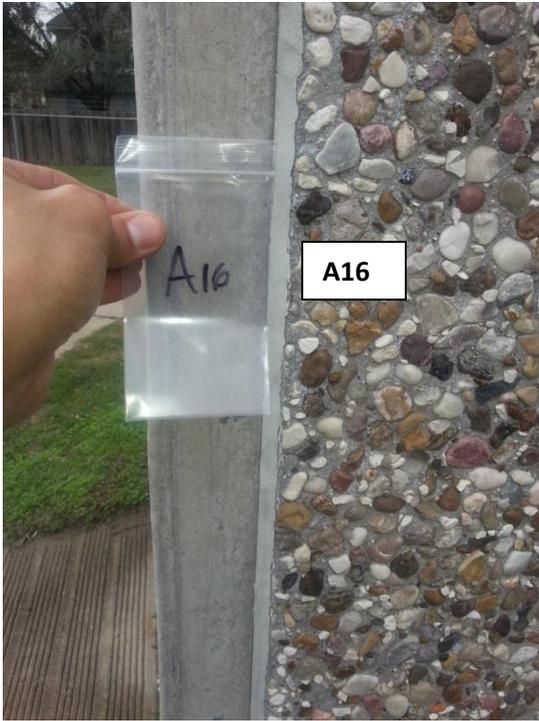
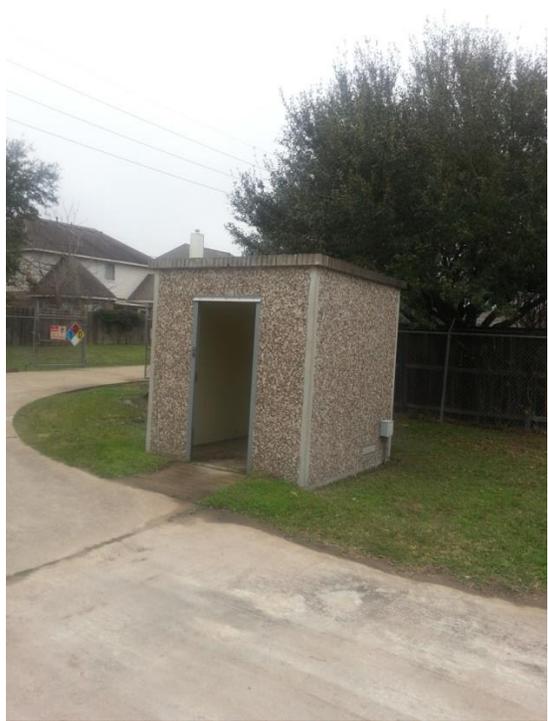
Expansion joint restroom outside wall

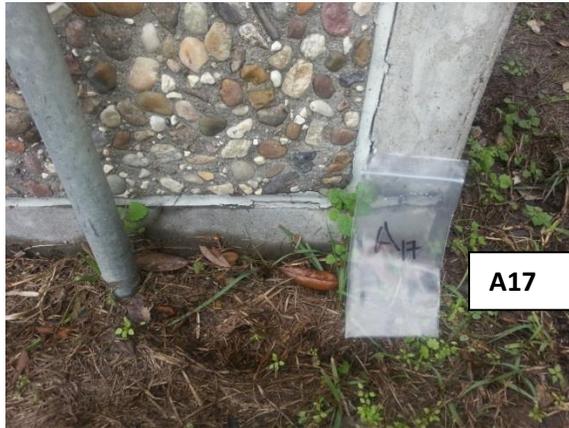
Expansion joint restroom base of foundation
