Subject: **FY13 STORM WATER PUMP STATION AND
FLOOD WARNING IMPROVEMENTS
5405 Mesa Drive
WBS NO. M-430241-0009-3**

Asbestos Survey Report

*FY13 Storm Water Pump Station & Flood Warning Improvements
5405 Mesa Drive
HOUSTON, TEXAS*

*WBS No. M-430241-0009-3
Task Number 14-10
ECMS Project Number: 3809*

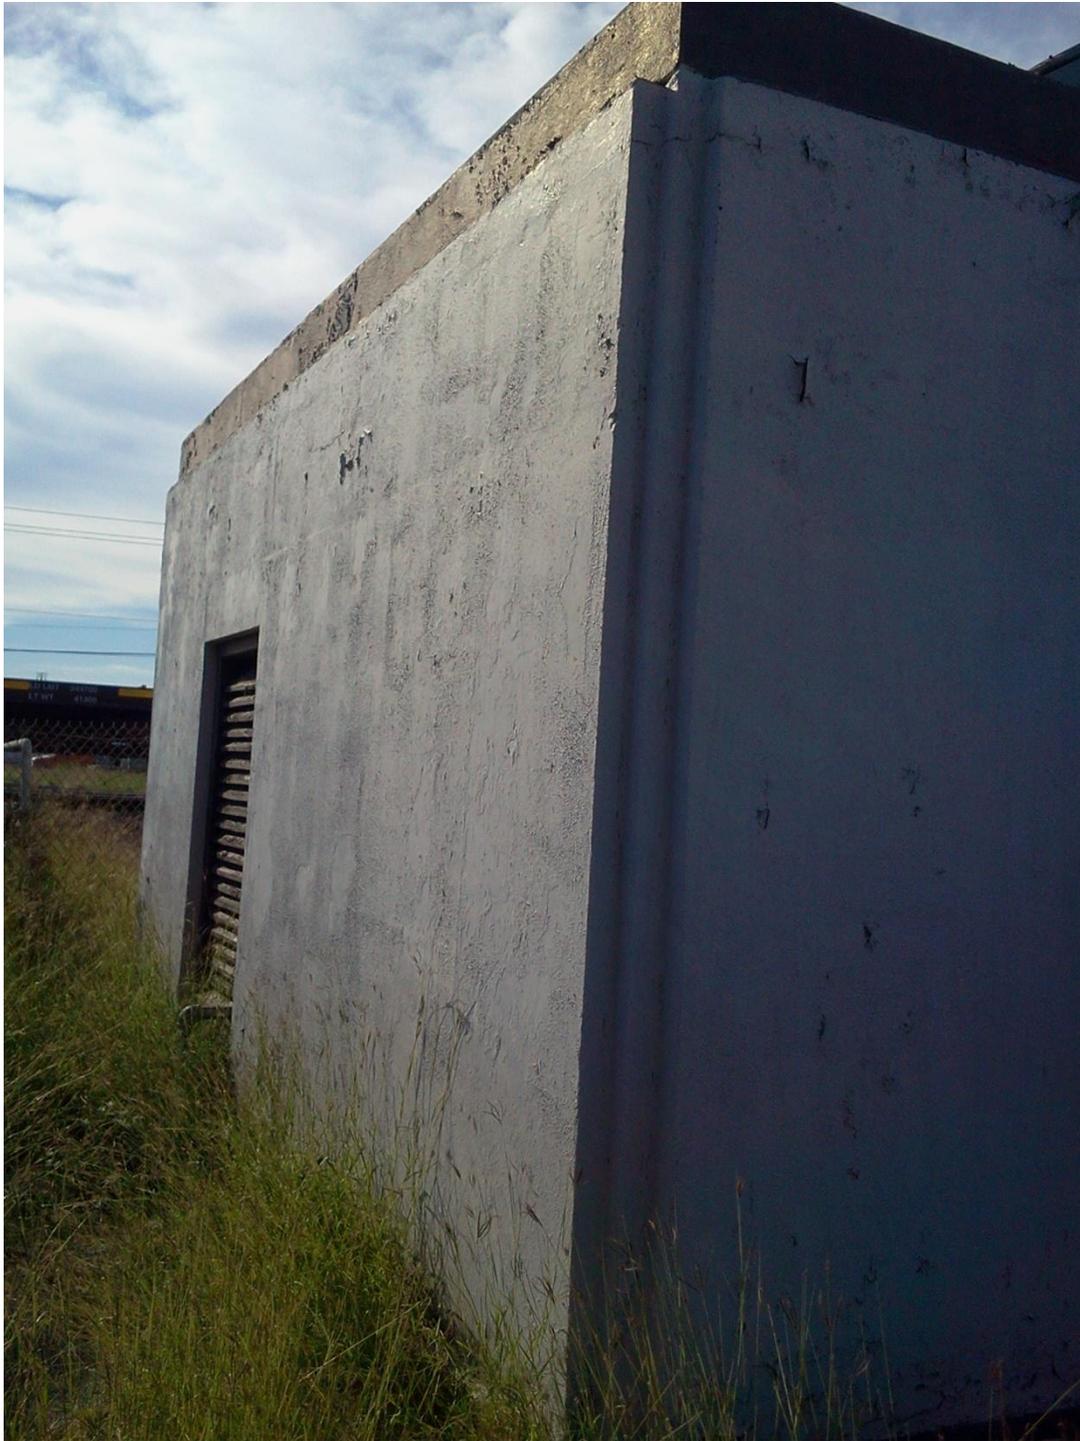
East view of Building-exterior sample

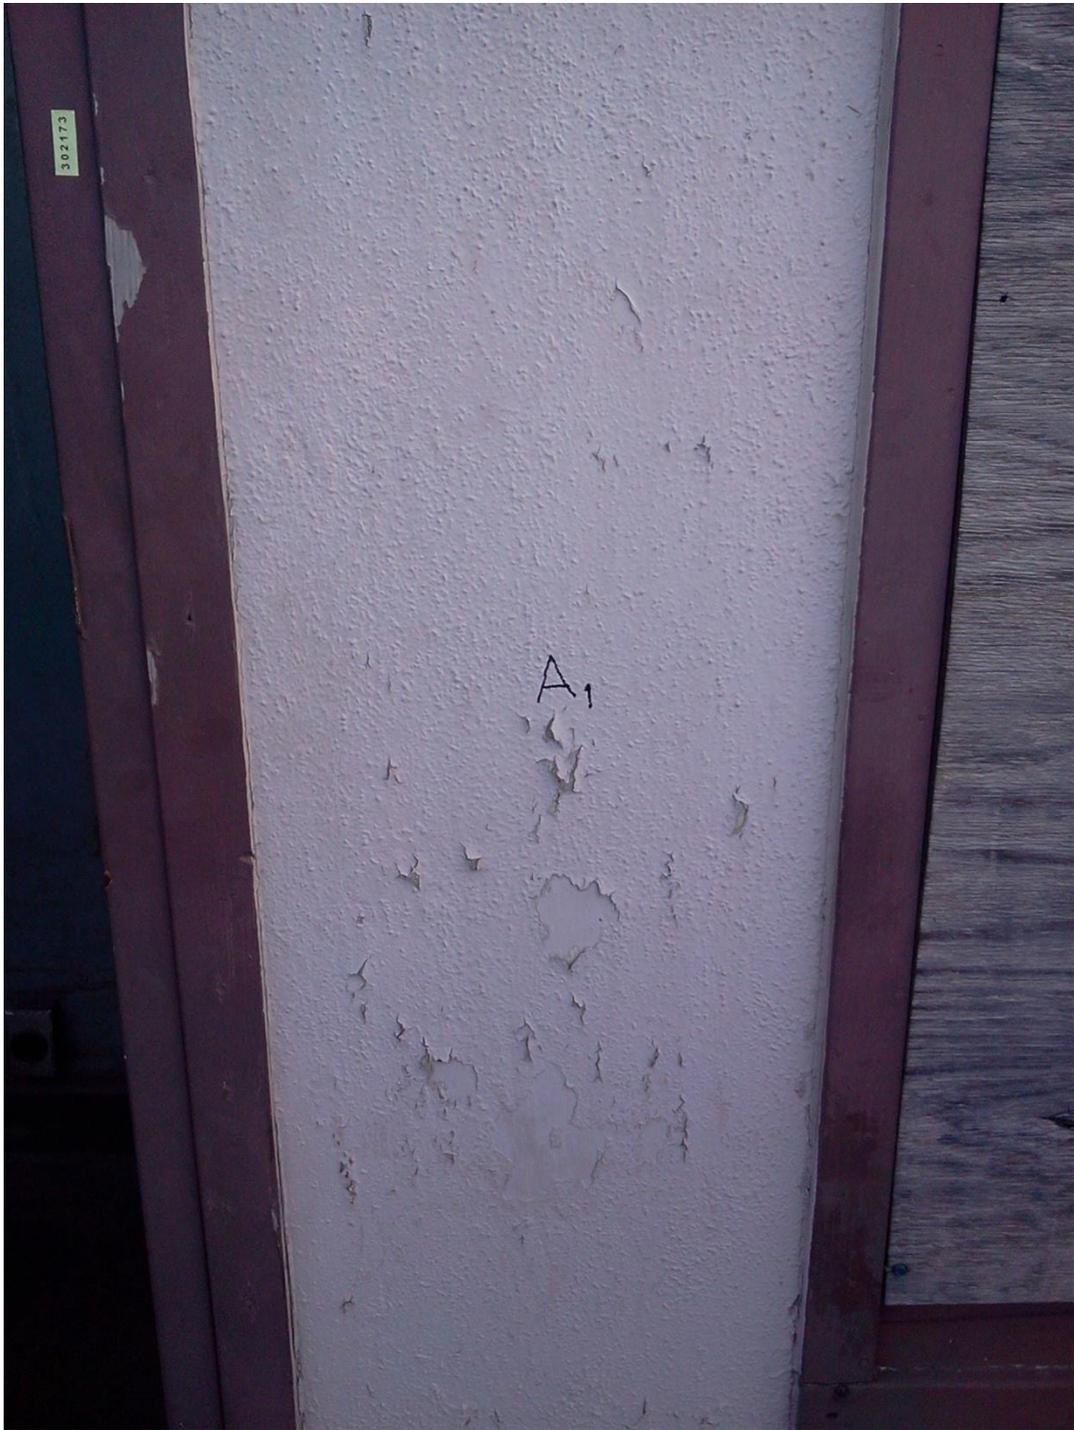
- Analytical results indicated that **asbestos content was detected** above the regulatory level of one percent (>1%) from two (2) samples collected from the **exterior cementitious from the North and East wall**.

Exterior sample-north wall

ECMS recommends abatement activities prior to any demolition/renovation activities.

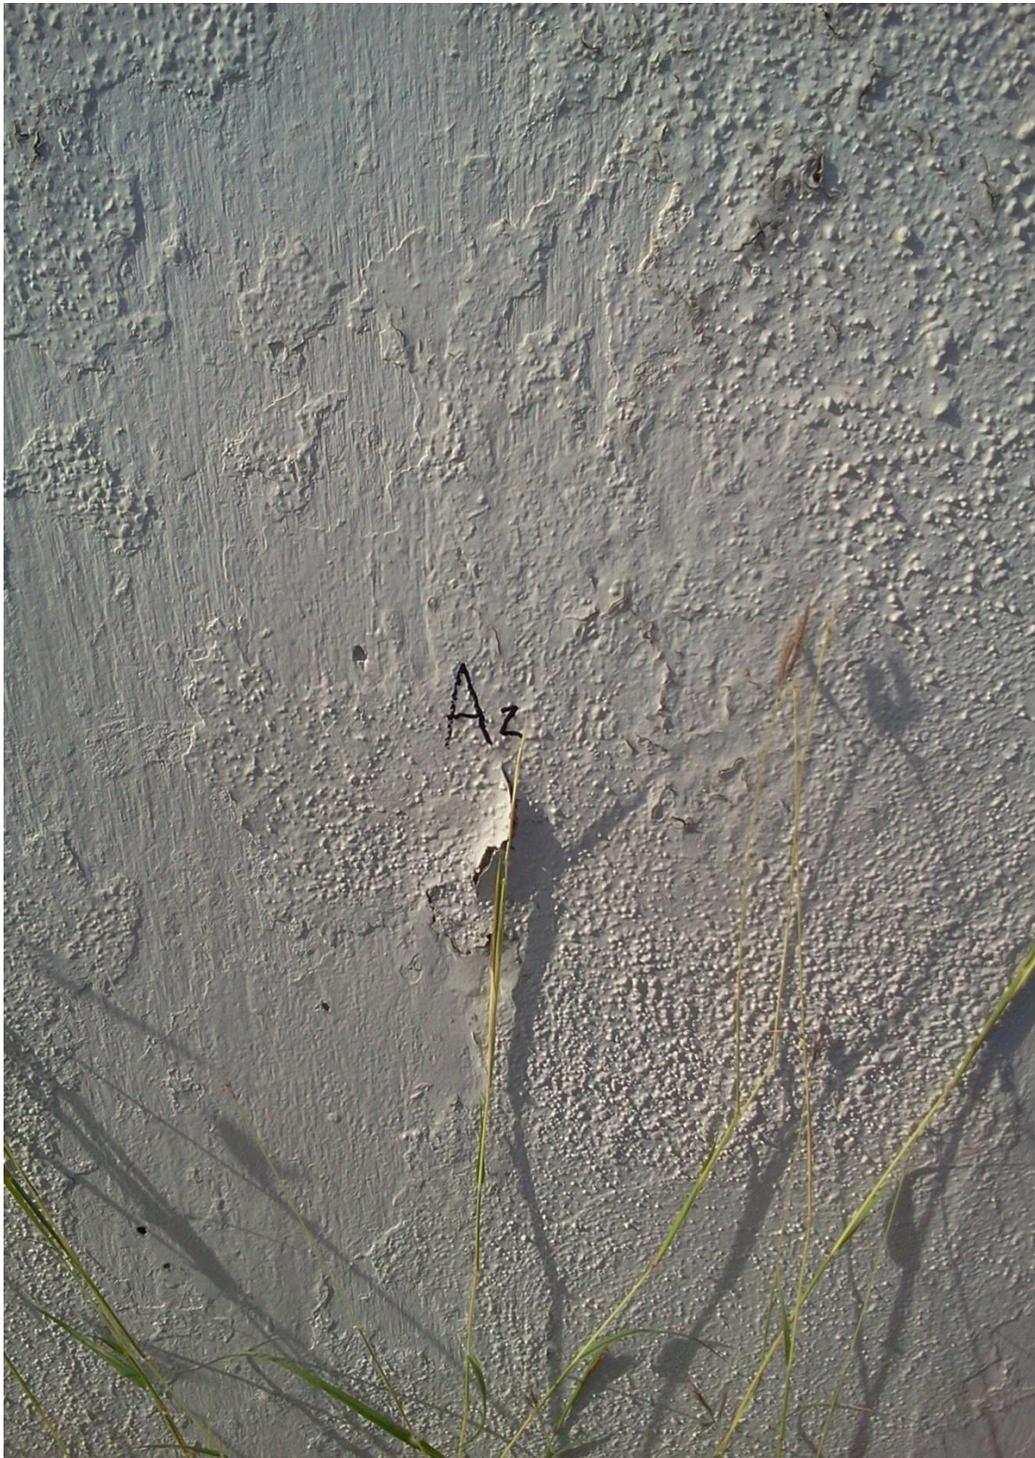
Exterior sample-east wall

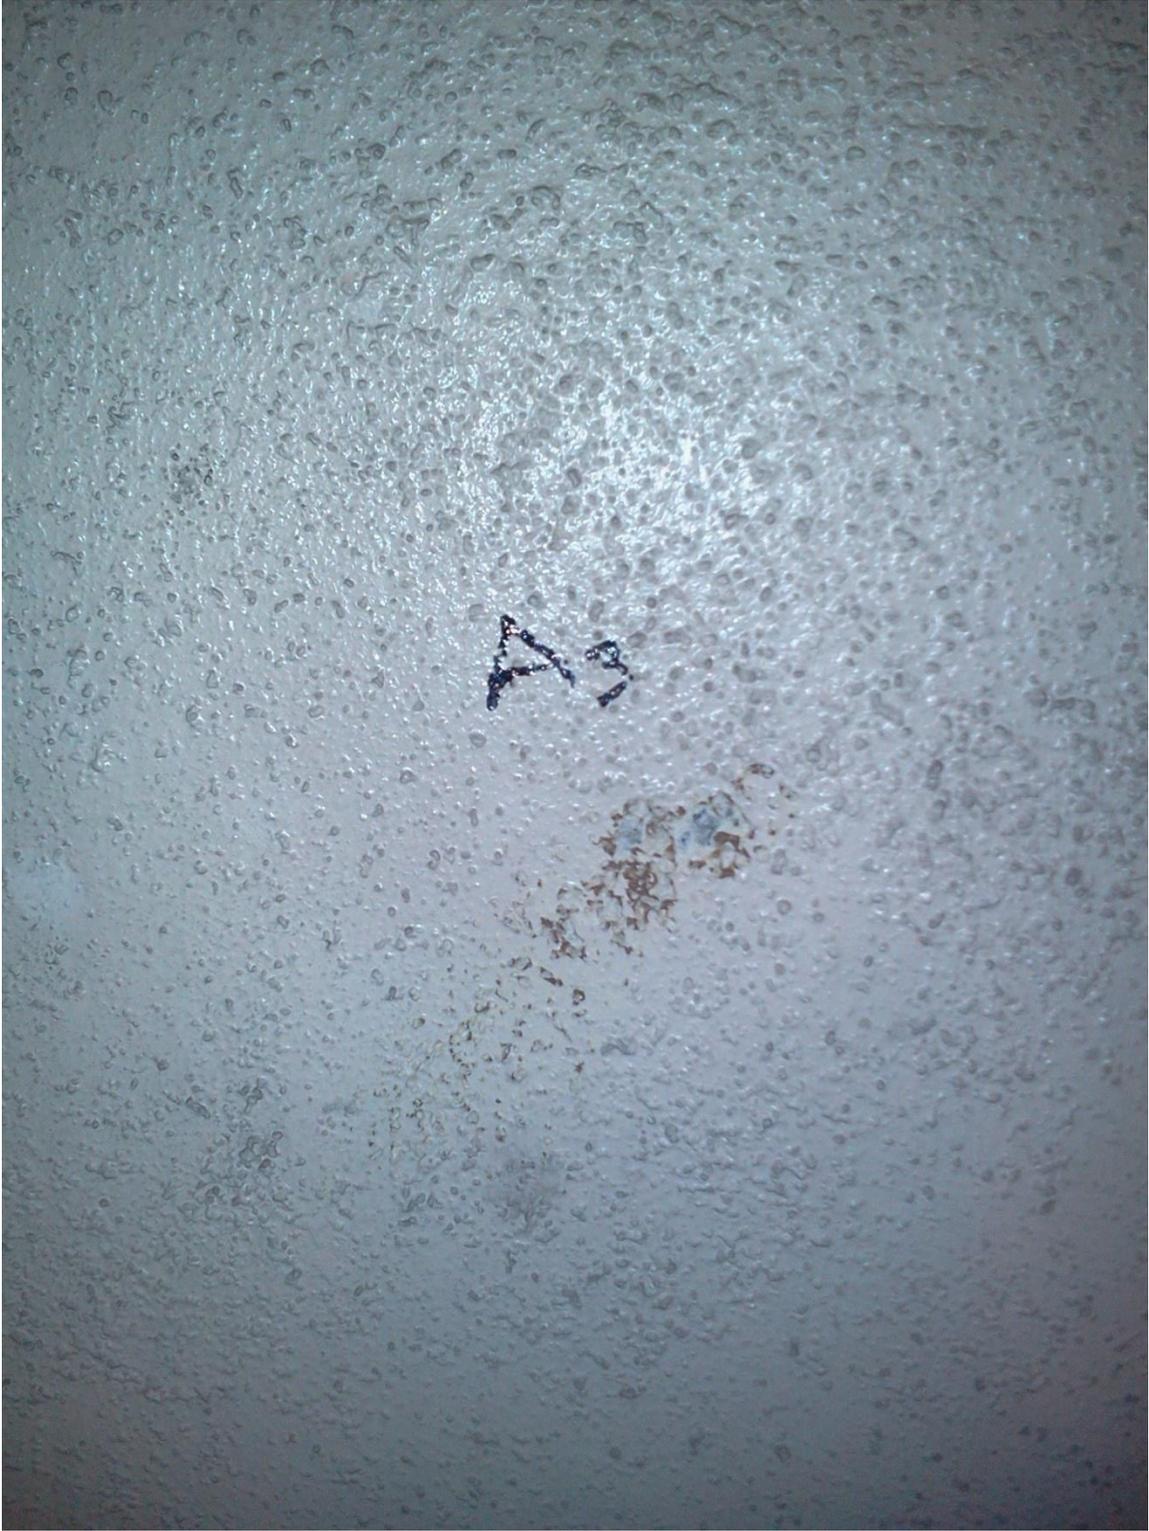
Interior grout material – West wall

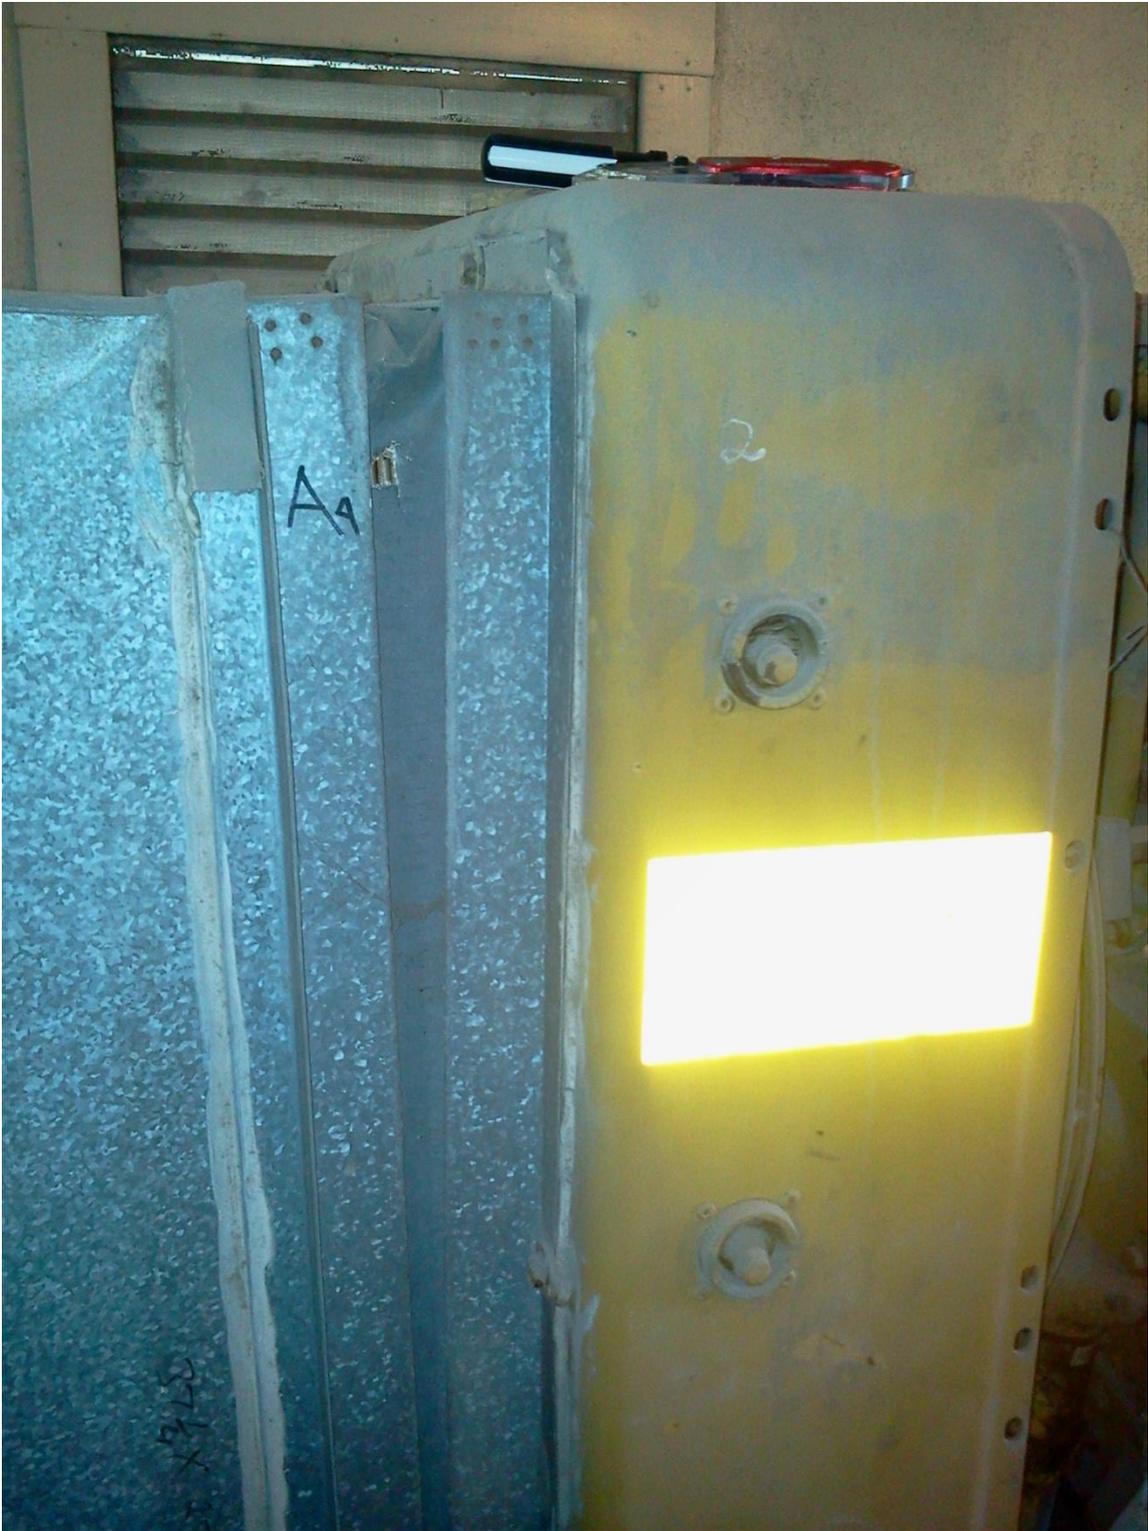
Vibration dampener on generator #2

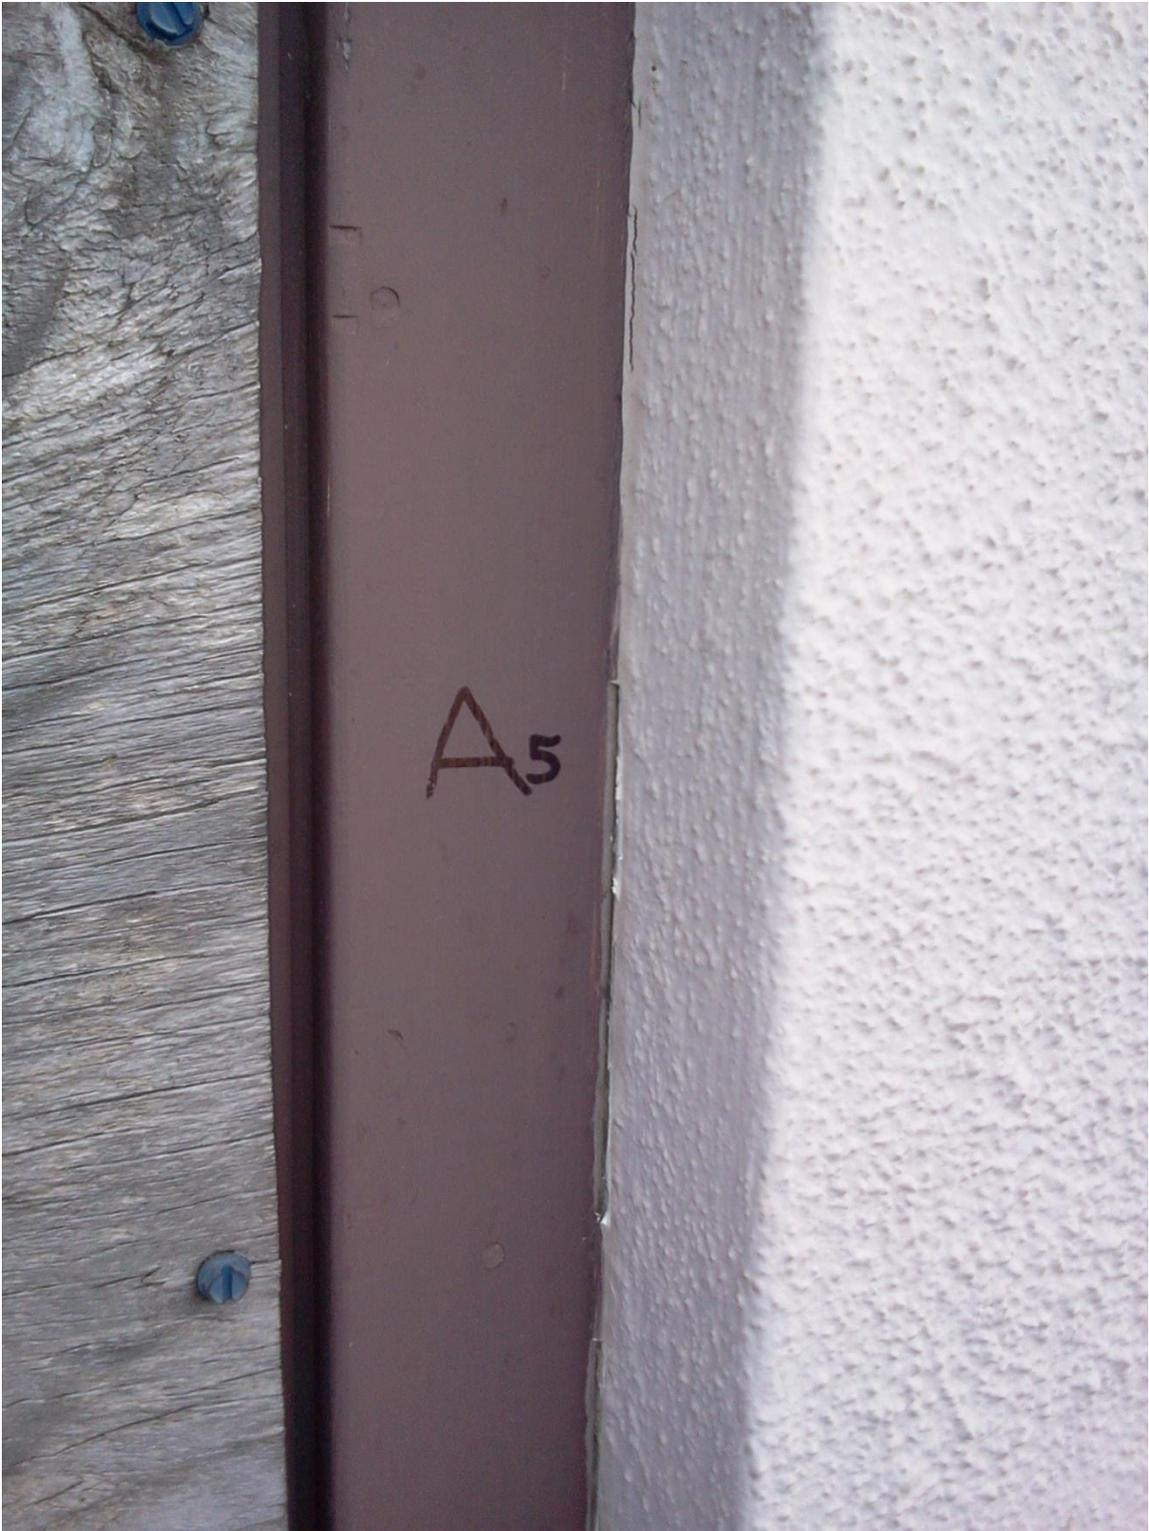
Window caulking N/NW window frame
