Subject: **SOUTHWEST WASTEWATER TREATMENT
PLANT
4211 BEECHNUT
WBS No. R-000265-0103-4**

Asbestos Survey Report

Southwest Waste water Treatment Plant
4211 Beechnut
HOUSTON, TX

WBS No. R-000265-0103-4
Task Number 15-04
ECMS Project Number: 3830

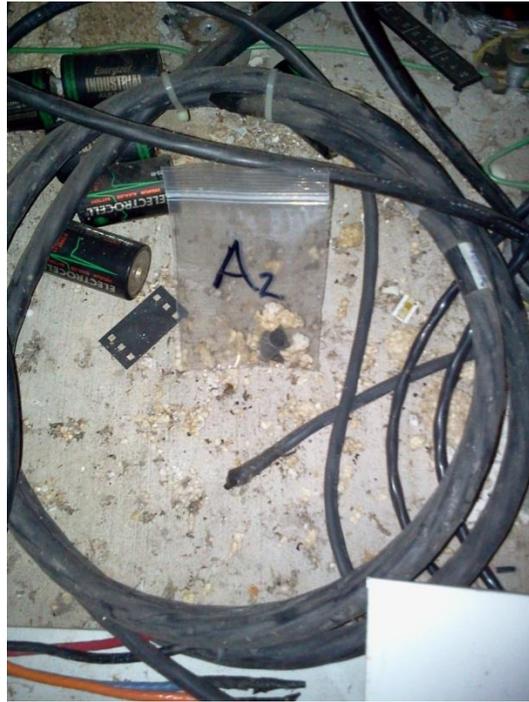
Loose Debris – Control Panel Cabinet

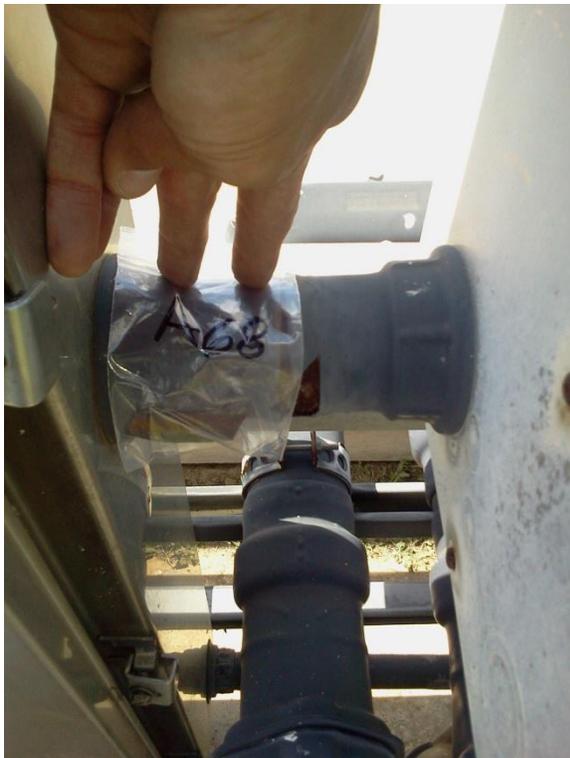
Pipe Coating Resin at PP5A2A Panel

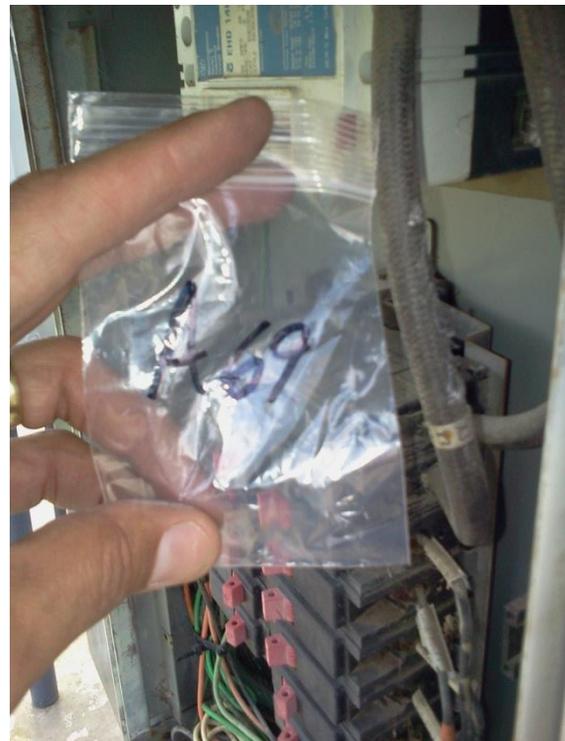
Old Wire Insulation at IP5A2A Panel

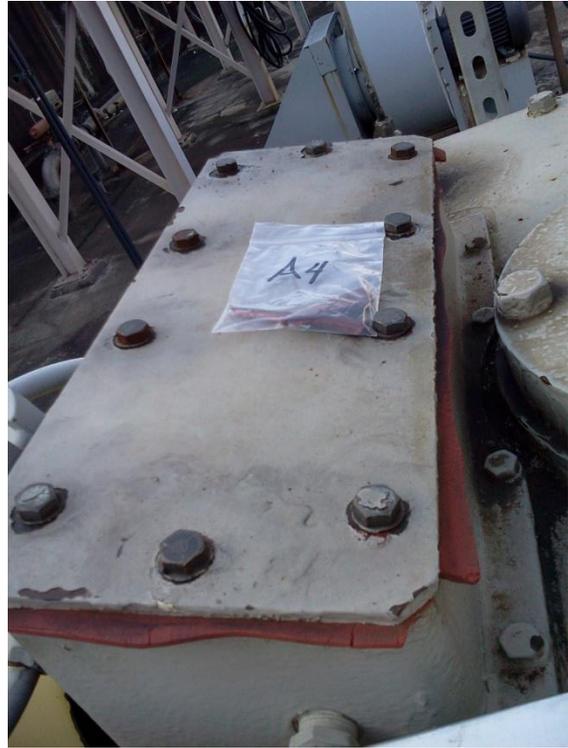
Gasket top Plate of Mixer #030230 S/SE

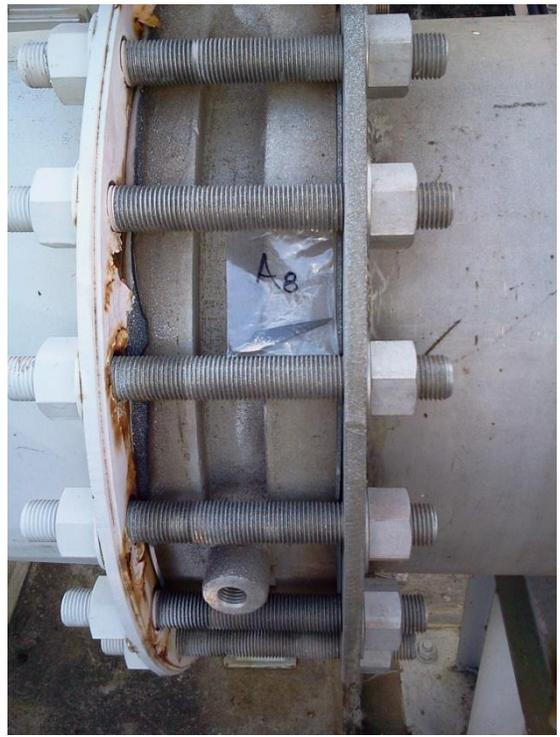
Large Flange Gasket Blower #030266 Extreme SE Corner

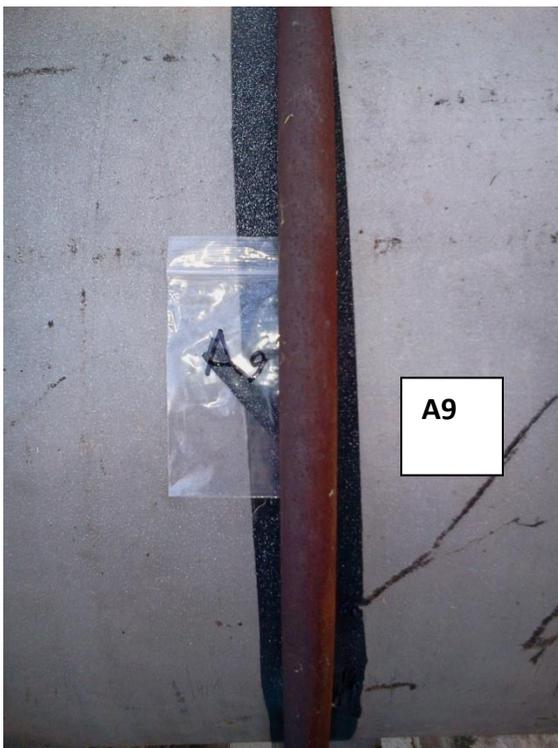
Large Pipe – Strap Band for Stabilizing Pipe
Blower #030266 Extreme SE Corner

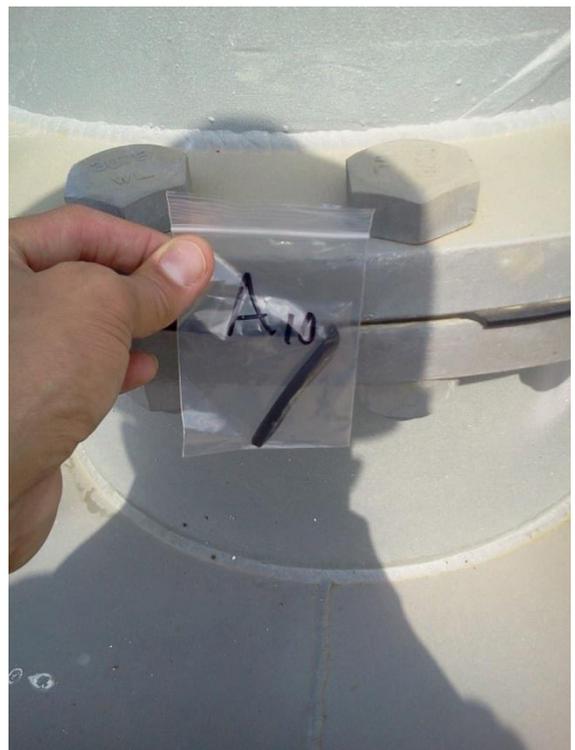
Large Flange Gasket at Base of Blower
Blower #117539 N/NW Corner

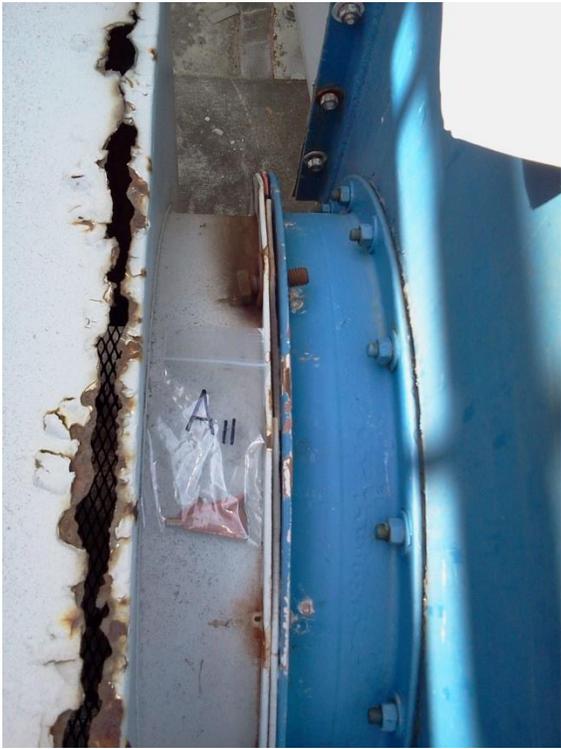
Large Pipe – Strap Band for Stabilizing Pipe
Blower #306947 Extreme SE Corner

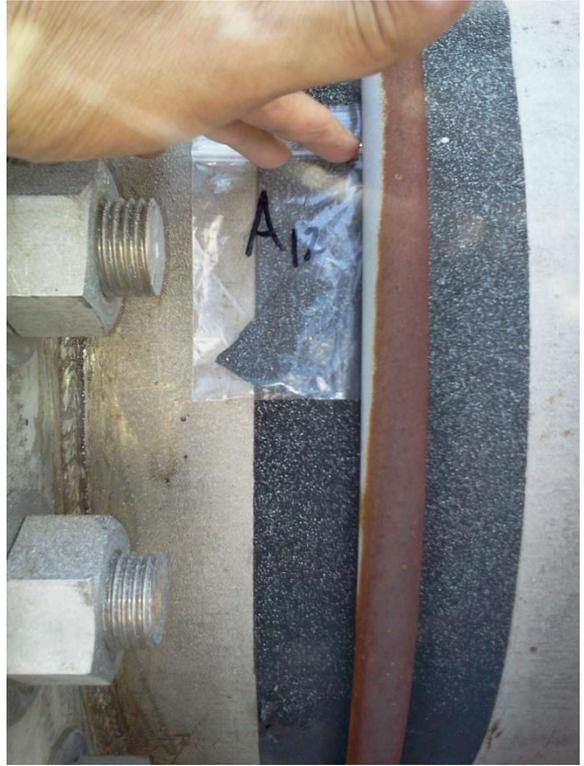
Large Flange Gasket Blower
Opposite of motor side #306947 SE Corner

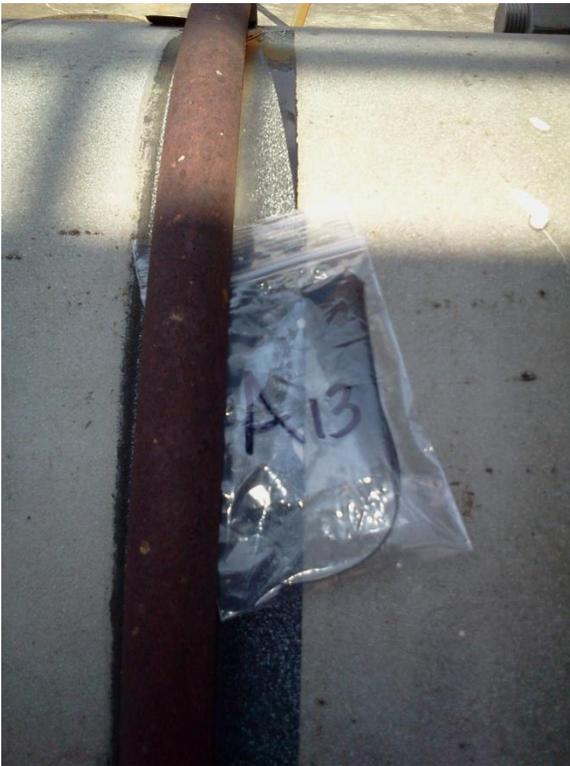
Large Pipe – Strap Band for Stabilizing Pipe
Blower #030268 Extreme E\SE Area

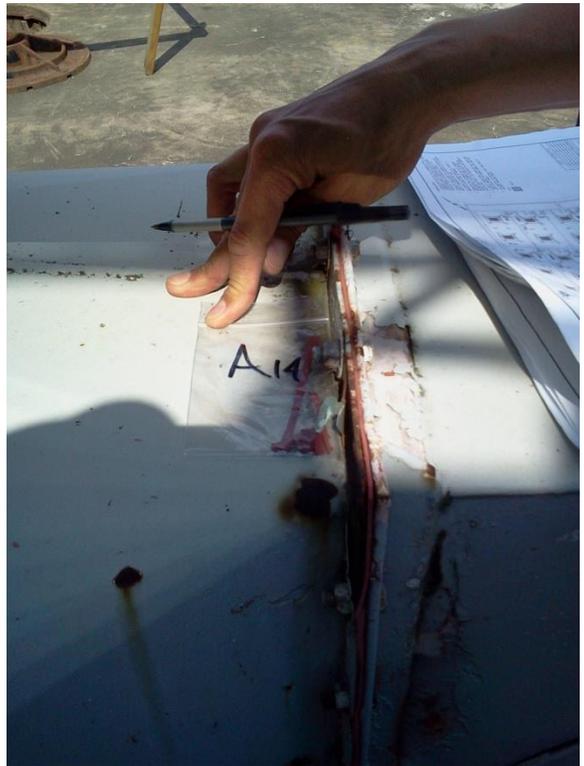
Large Square Flange Connector
Blower #030268

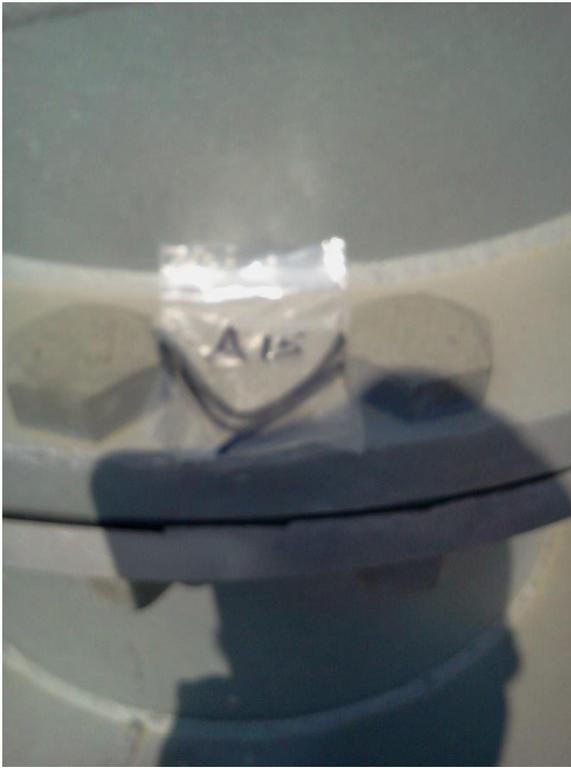
Large Flange Gasket – Blower #117550

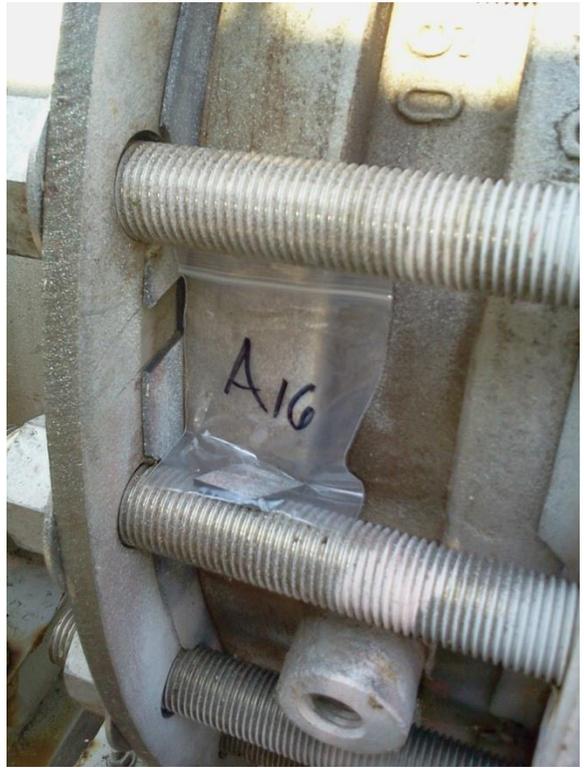
Large Flange Gasket Blower #116344

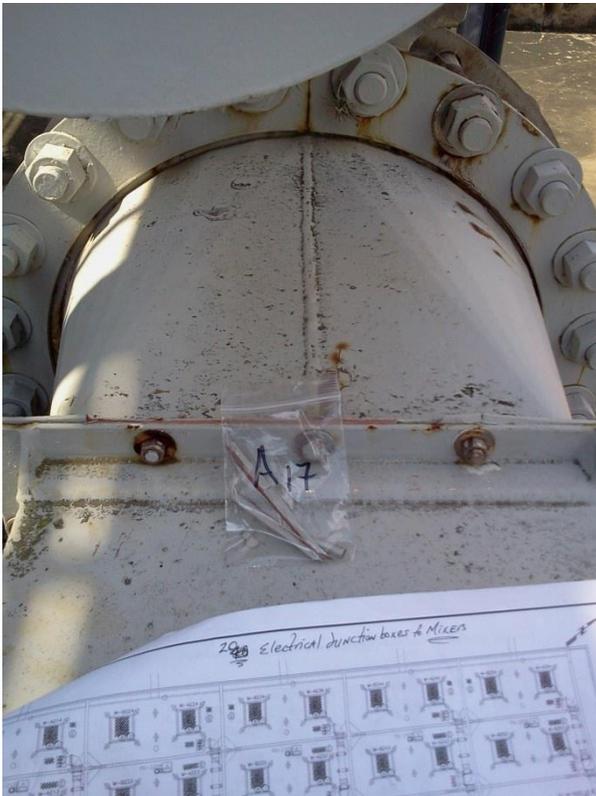
Large Square Flange Connector
Blower #116344

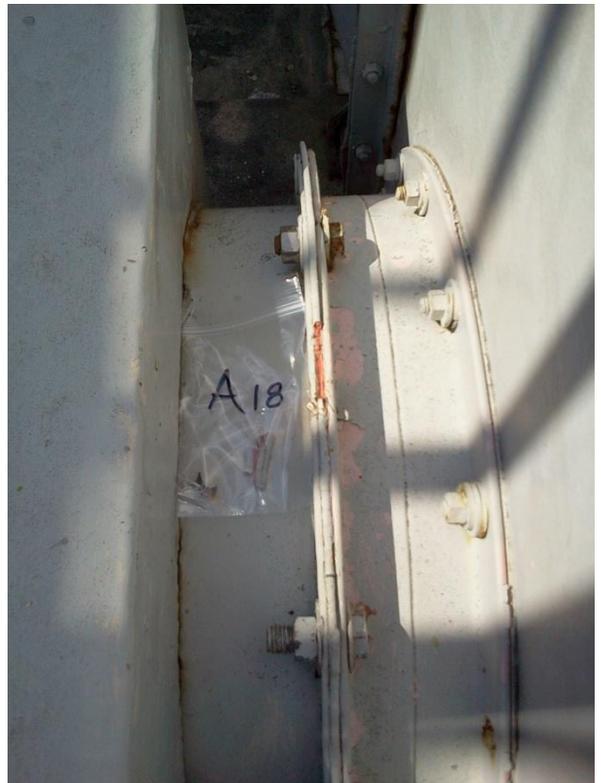
Large Flange Gasket at Blower Intake-Air
Blower #030266 SE Corner

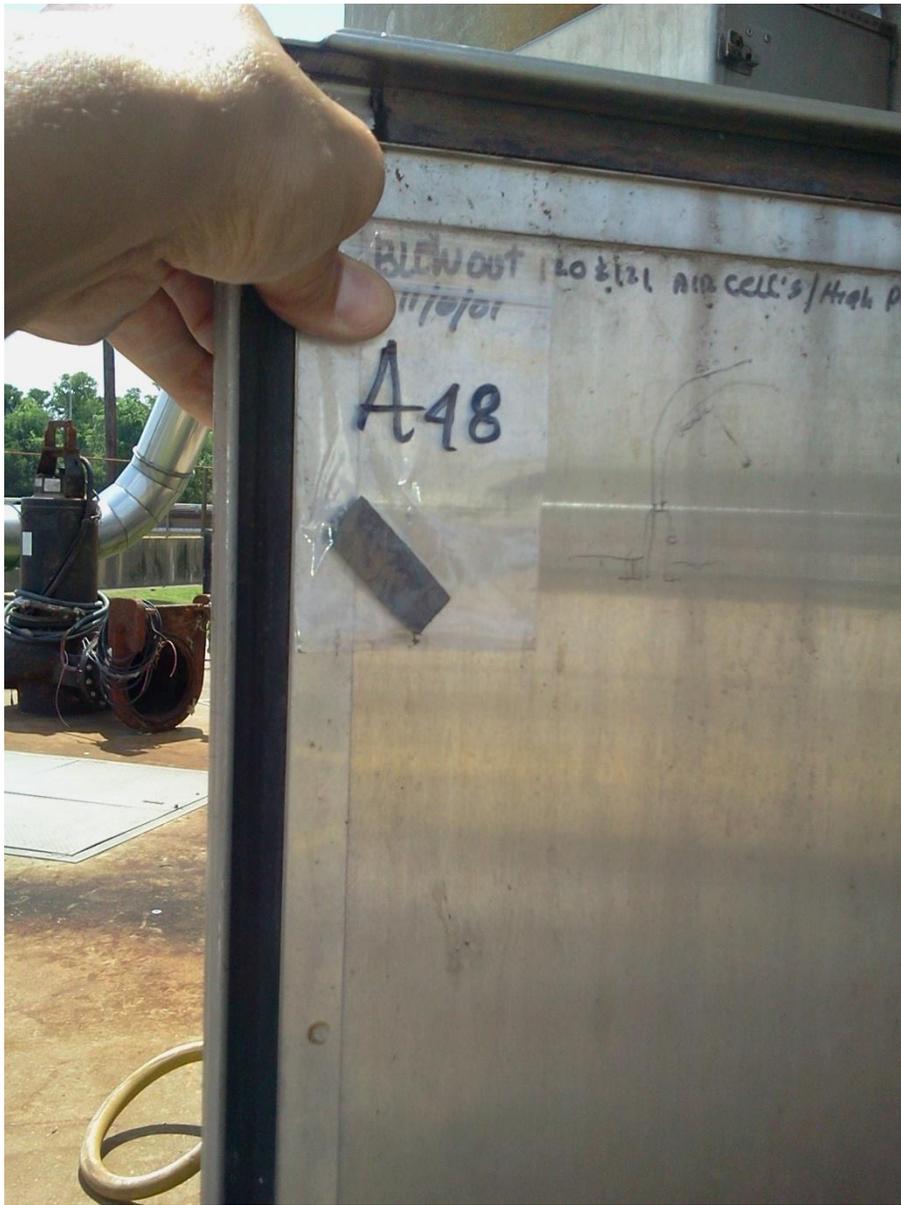
Door Seal Gasket Panel FIP-121A

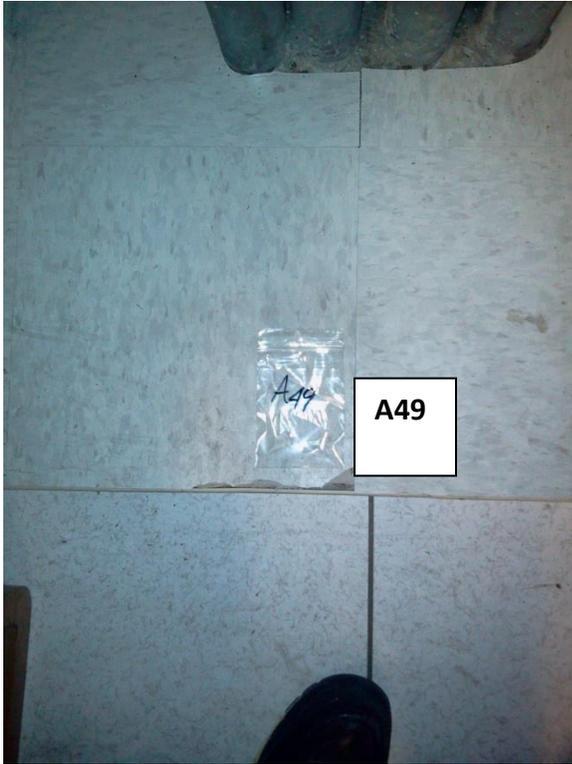
TABLE 2: ACM ANALYTICAL RESULTS						
Homogenous Area No.	Material	Location	Type*	Damaged*	Hazard Risk*	Asbestos Content (ND= None Detected)
1	Floor Tile 12 x 12	MCC-A Building	Non-friable	Fair Condition	C-3	3%

Four 12 x 12 medium grey floor tiles at the MCC-A Building were collected, referenced in Table 2 above, tested positive for asbestos content.

12x12 floor tile east area of bulidng under panel FIP-120-C

Based on the analytical findings and site observation; No action necessary unless renovation, remodeling, or demolition is planned. (City of Houston Hazard Category C-3).

Estimated cost for floor tile abatement is \$7.00 per sq./ft. (including disposal cost).

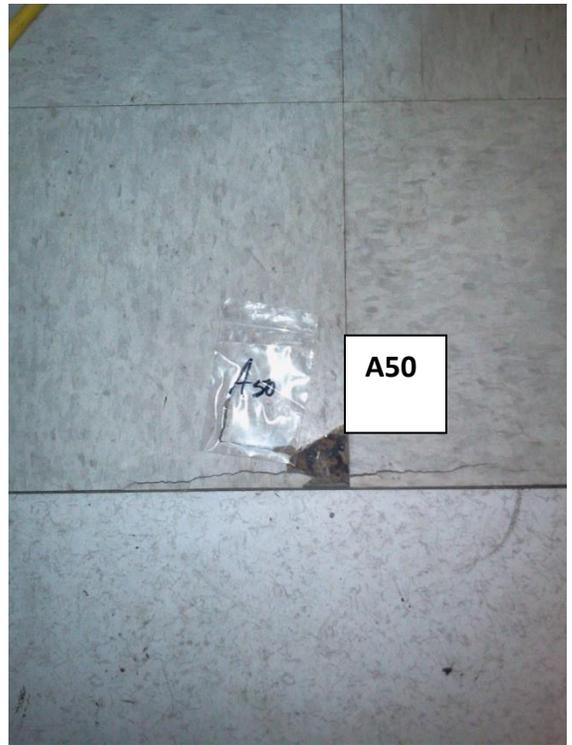
12x12 floor tile S/SW at door entrance

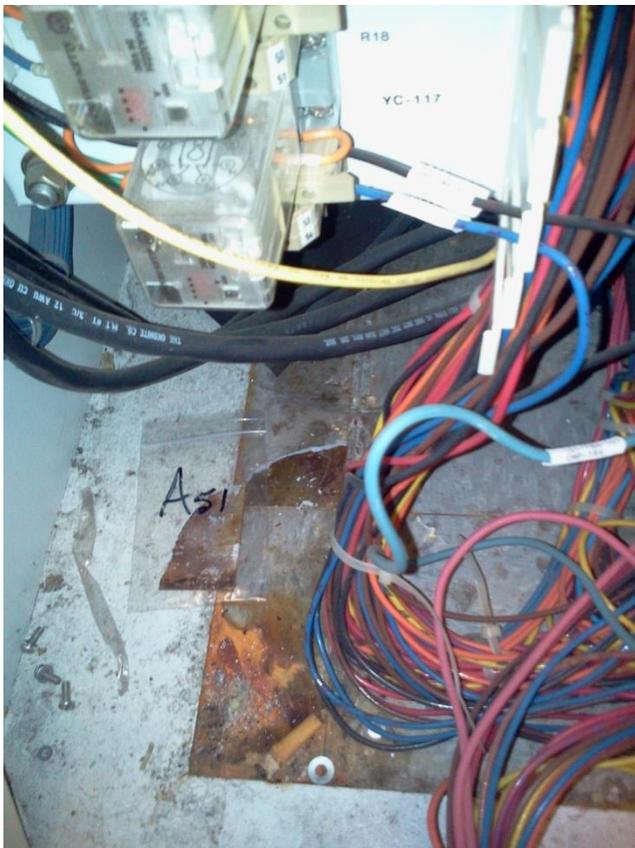
12x12 Dark Grey Tile floor area inside panel PS1&PS2

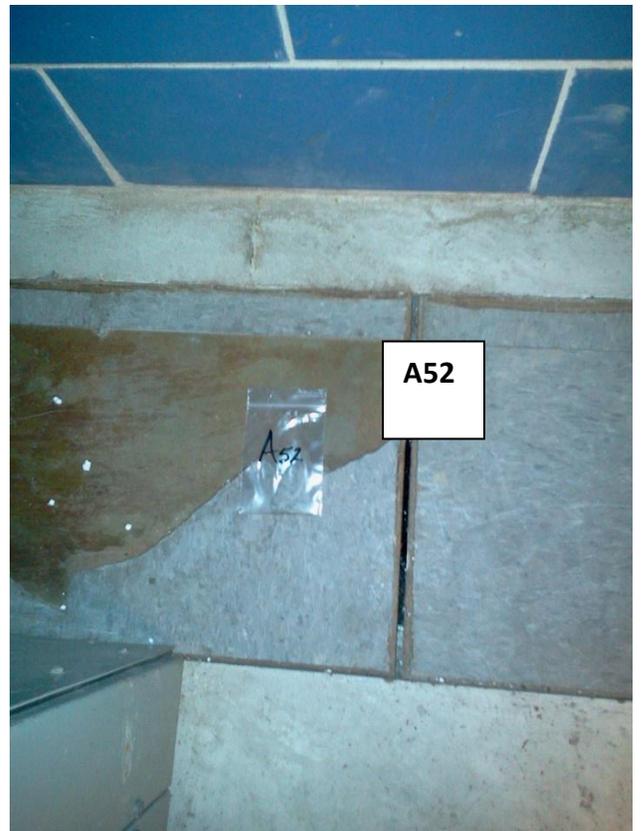
12x12 Dark Grey Tile floor area W/SW corner of building

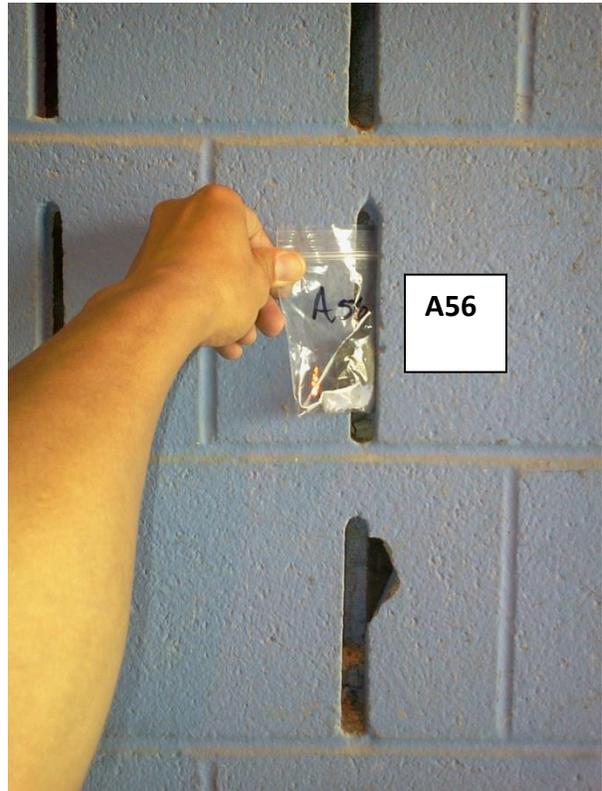
Insulation Material behind wall w/NW wall area

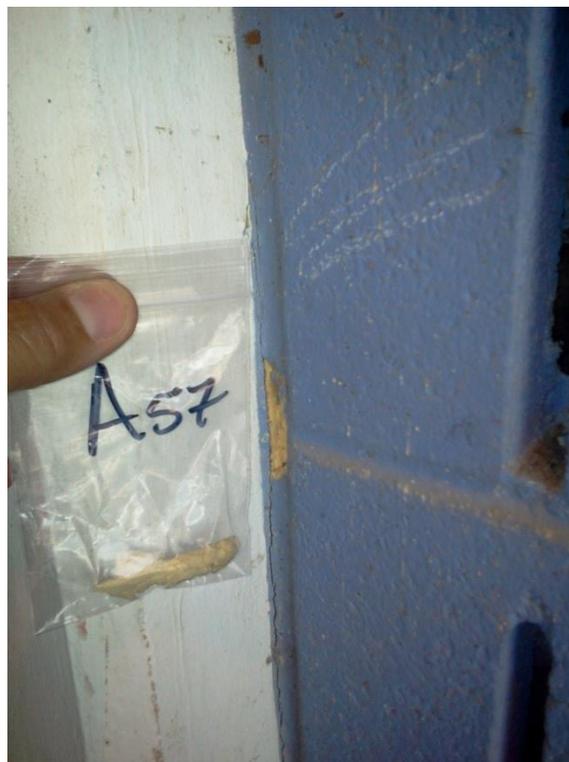
Expansion Joint Adjacent to wall and support column
