Subject: **WILLOWBROOK WASTEWATER
TREATMENT PLANT IMPROVEMENTS
7101 W. Greens Road
WBS NO. R-000265-0104-3**

Asbestos and Lead Survey Report

***Willowbrook WWTP
7101 W. Greens Road
HOUSTON, TEXAS***

***WBS No. R-000265-0104-3
Task Number 14-04
ECMS Project Number: 3797***

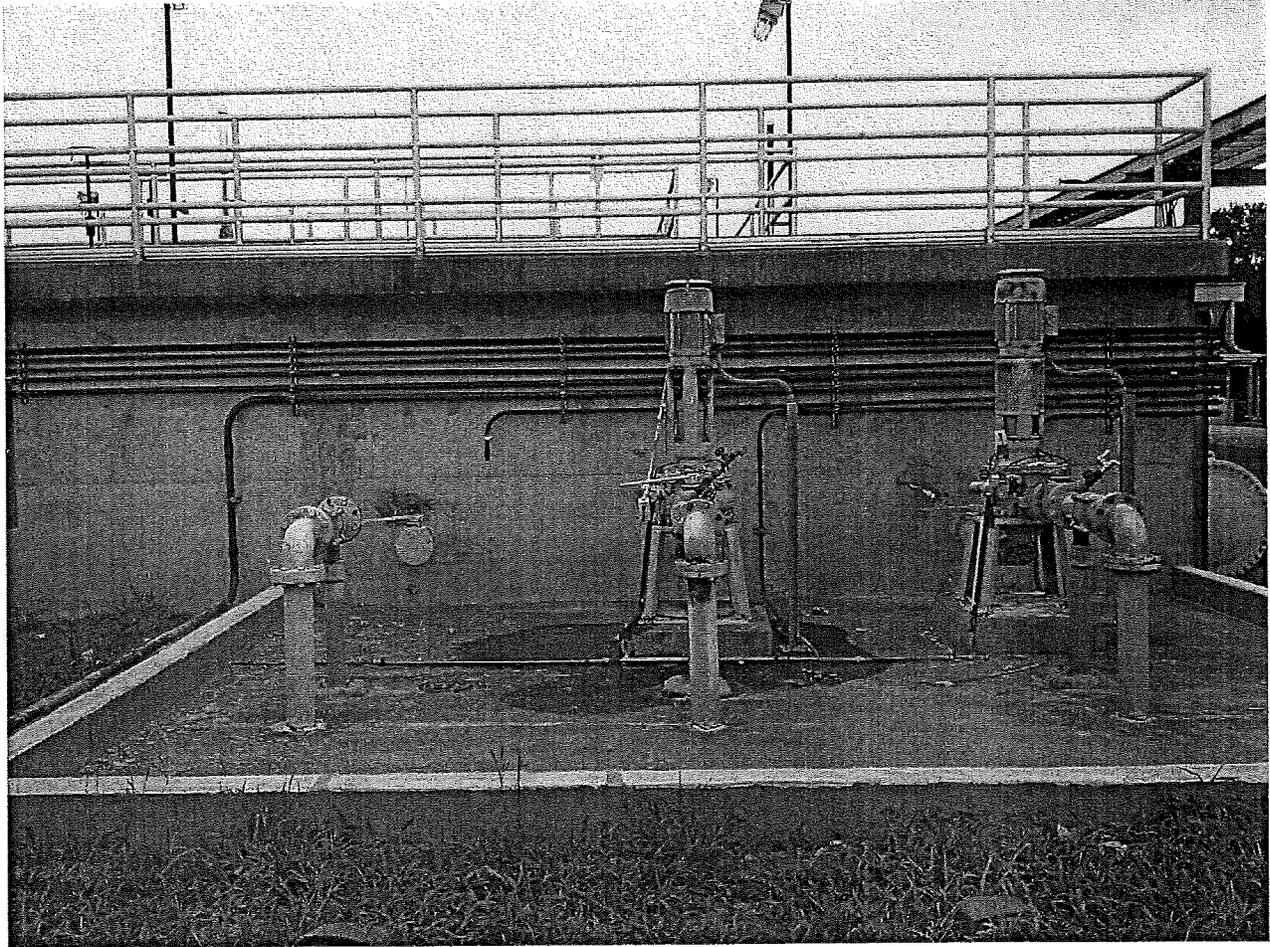
Beige paint on a Vertical Centrifuge Pump at area 3 above grade contains lead levels at 223.7 ppm sample #L11. This is a City of Houston Hazard Category A. Allowable Lead Level, paint material. OSHA regulations apply to workers during demolition or renovation.

Area 3 existing pumps and valves
Not in use.

Recycle all metal components including those with lead containing paint. No lead abatement is required.

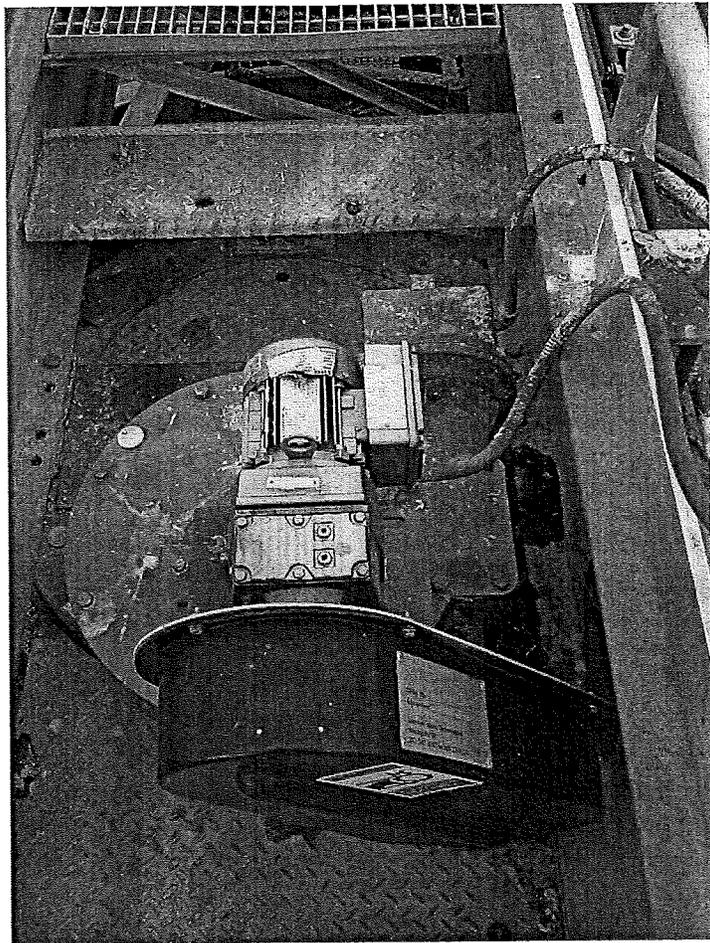
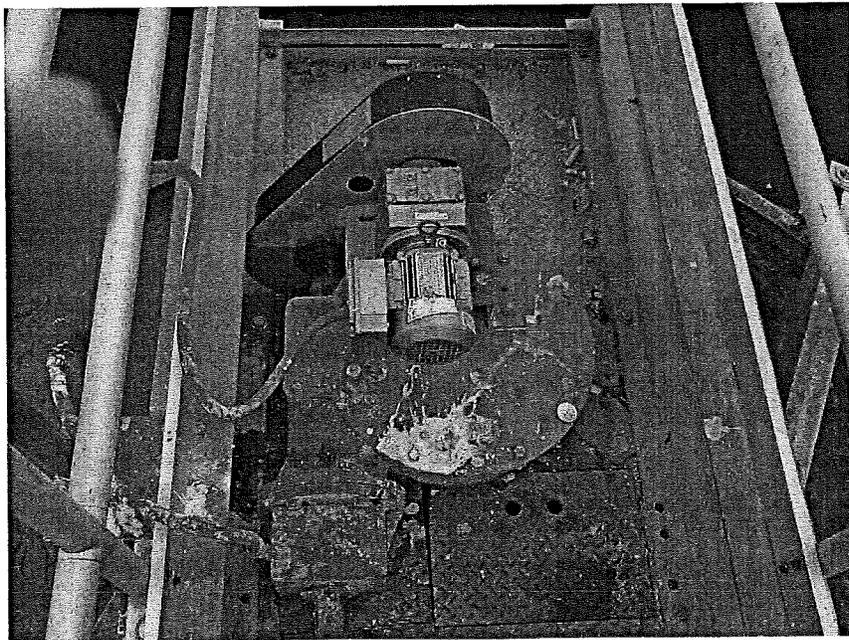
Blue paint on pump motor of secondary clarifier at area 4 contains lead levels at 172.4 ppm sample #L15. This is a City of Houston Hazard Category A. Allowable Lead Level, paint material. OSHA regulations apply to workers during demolition or renovation.

Area 4 clarifier mechanism

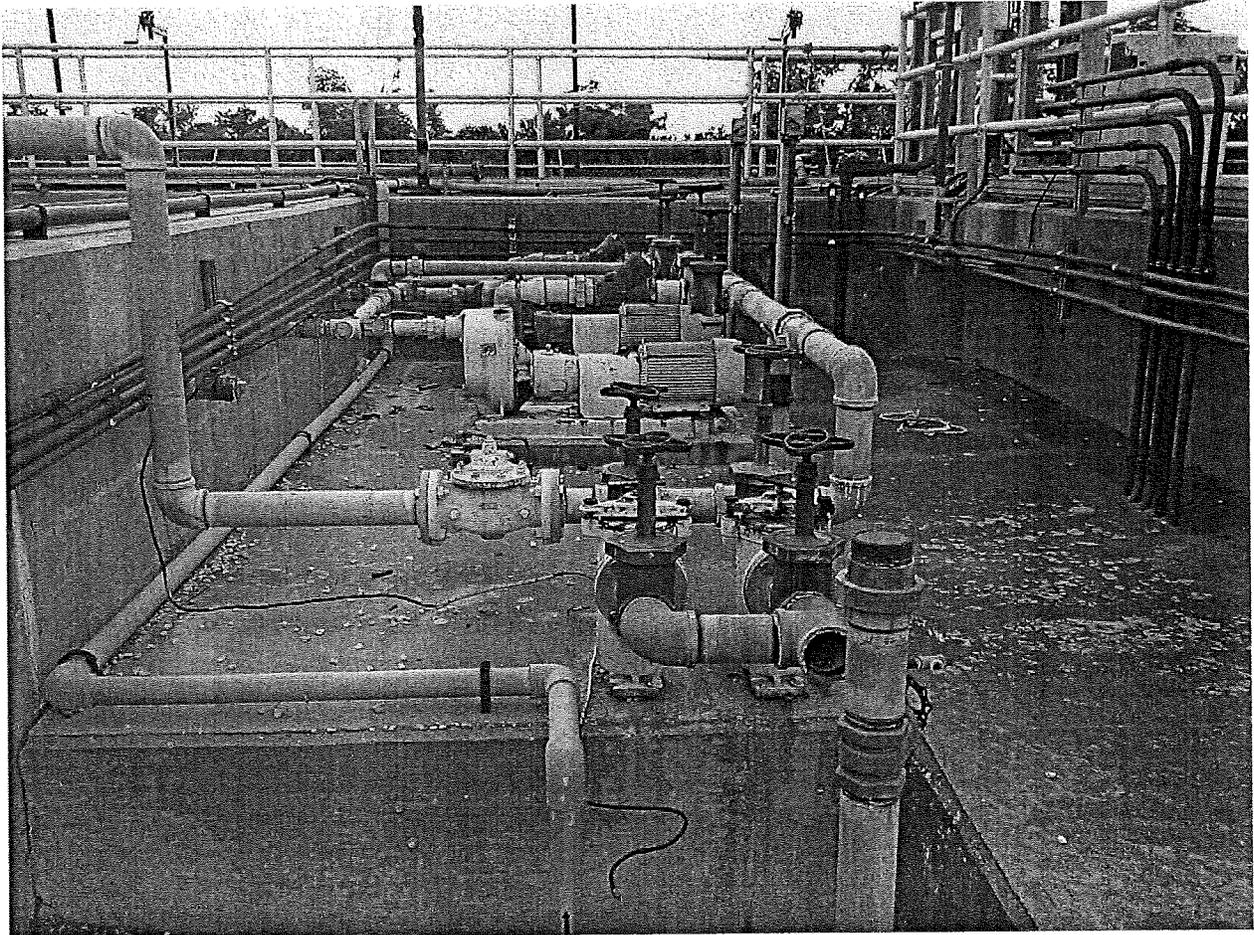
Light Grey paint on pump system at area 5 contains lead levels at 141.1 ppm sample #L18. This is a City of Houston Hazard Category A. Allowable Lead Level, paint material. OSHA regulations apply to workers during demolition or renovation.

Area 5 non-potable water pump station
