Date: August 22, 2014

ATL Job No: G14-202

Reference: Phase I Fault Investigation  
Proposed Neighborhood Street Rehabilitation – Project 464  
Springdale (Sec. 1&2) and Restridge (Sec. 1&5)  
WBS No. N-000397-0001-3  
File No. 4600011023  
Houston, Texas

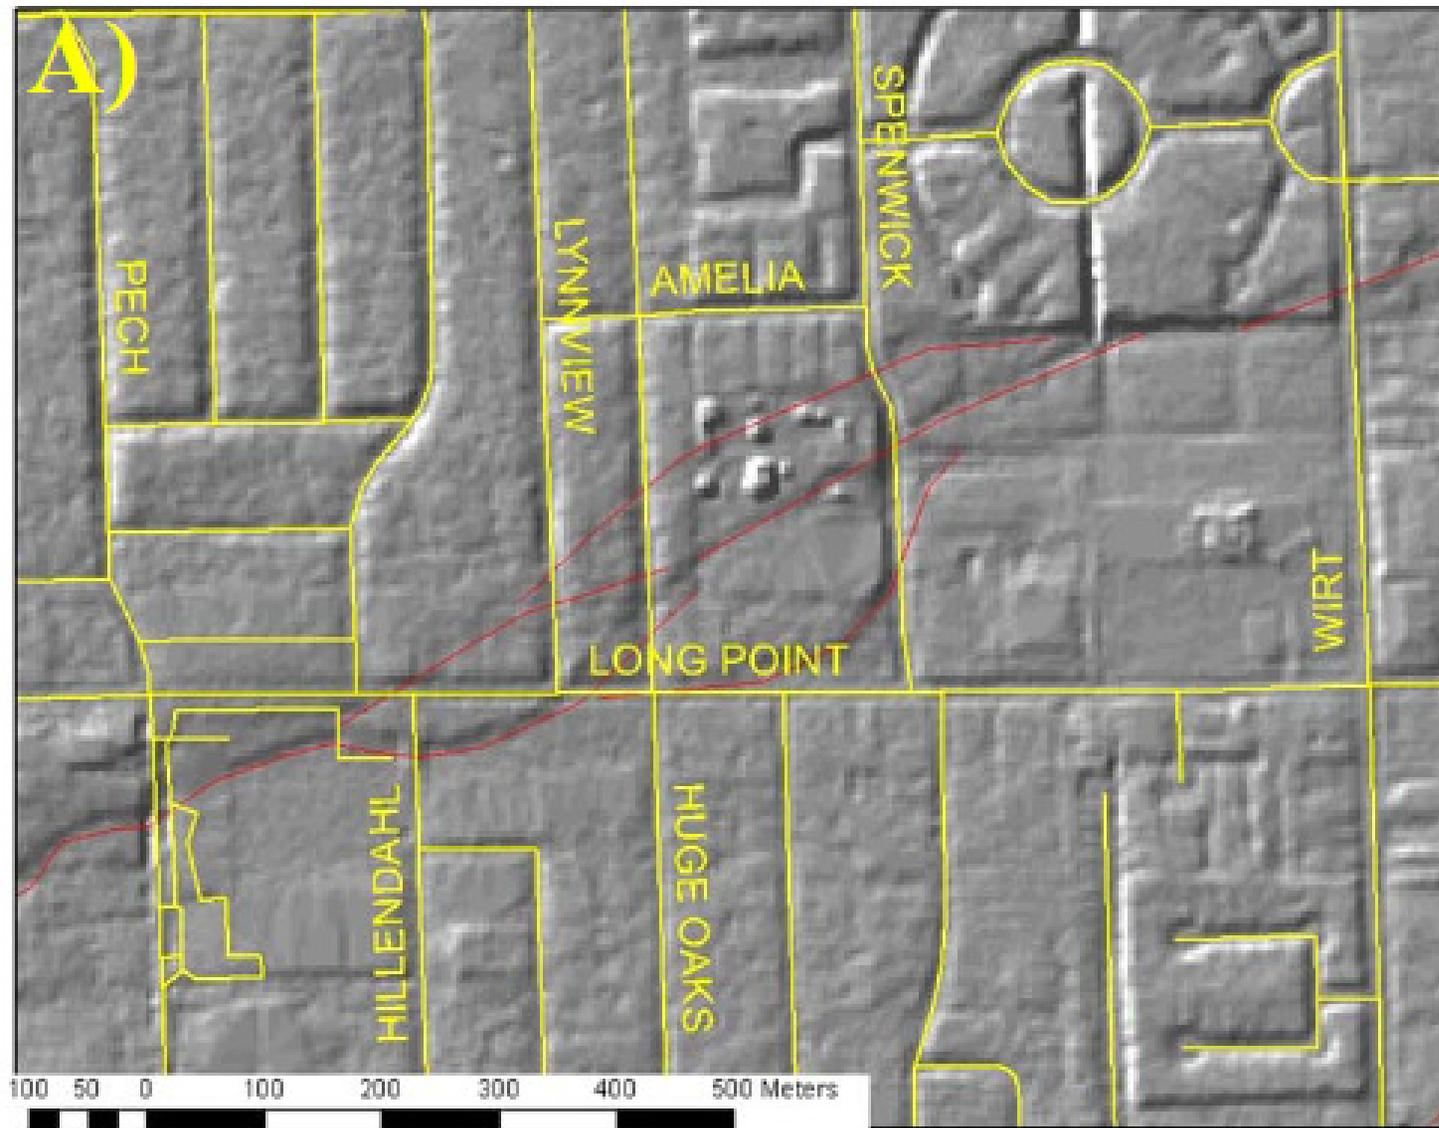
Lidar Hillshaded Image of Several Branches of the Long Point Fault  
(Engelkemeir and Khan, 2018)

Based on these maps, it appears that the Long Point Fault crosses near the southern portion of the project alignments, most probably near the southern end of the Lynnview Drive alignment. The Lidar imagery in Figure 4 also shows that the fault band crossing the Lynnview Drive project alignment widens as the fault splintered into three branches.

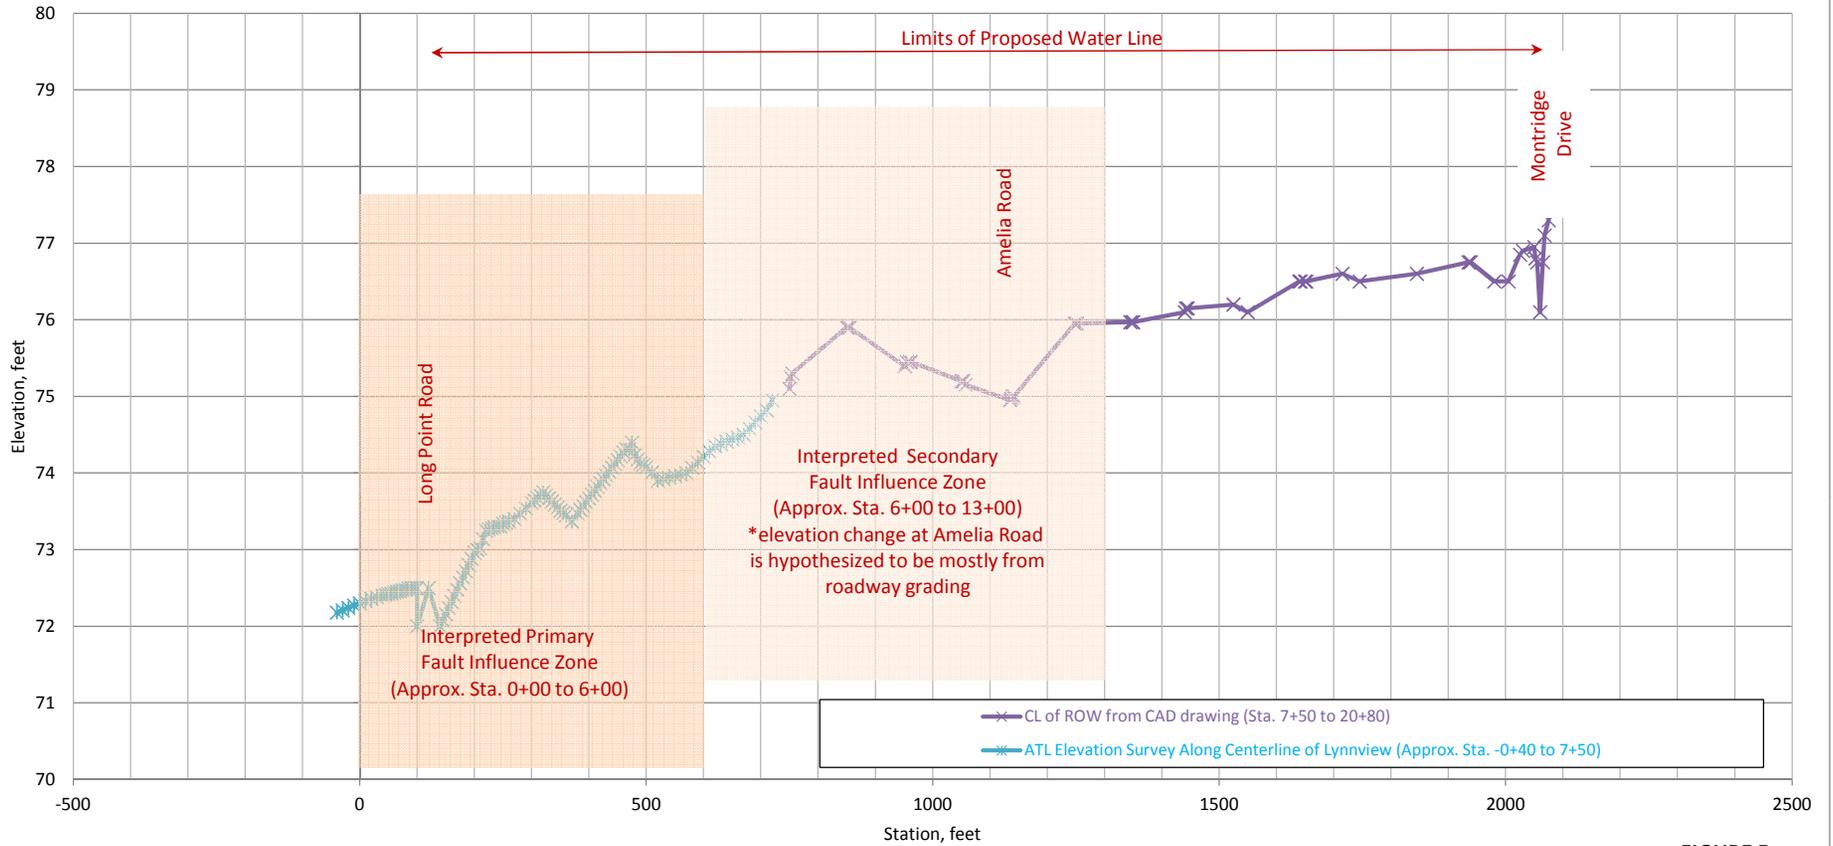
FIGURE 5

Results of the simple elevation survey for a distance of approximately 600 feet along the center line of Lynnview Drive from the Long Point Road/Lynnview Drive intersection is presented in Figure 5. Also presented in Figure 5 is the elevation profile along the center line of the right-of-way (ROW) conducted by the project surveyor at larger spacing.

Based on the findings from the elevation survey and the observation from the site reconnaissance, ATL recommends that the proposed Lynnview Drive project alignment between Sta. 0+00 and 6+00 be designated as the Primary Fault Influence Zone, and Sta. 6+00 and 13+00 be designated as the Secondary Fault Influence Zone, as shown in the elevation profile plot in Figure 5.

The historical movements of the Long Point Fault average about 0.3 inches per year, but episodes of faster movements of 1 to 1.5 inches per year had been recorded. ATL recommends that the proposed storm sewers and water lines be designed for the following average fault movements over the design life:

<b>Fault Influence Zone</b>	<b>Estimated Annual Fault Movement Rate, Inches/Year</b>
Primary (Sta. 0+00 to 6+00)	0.3
Secondary (Sta. 6+00 to 13+00)	0.15

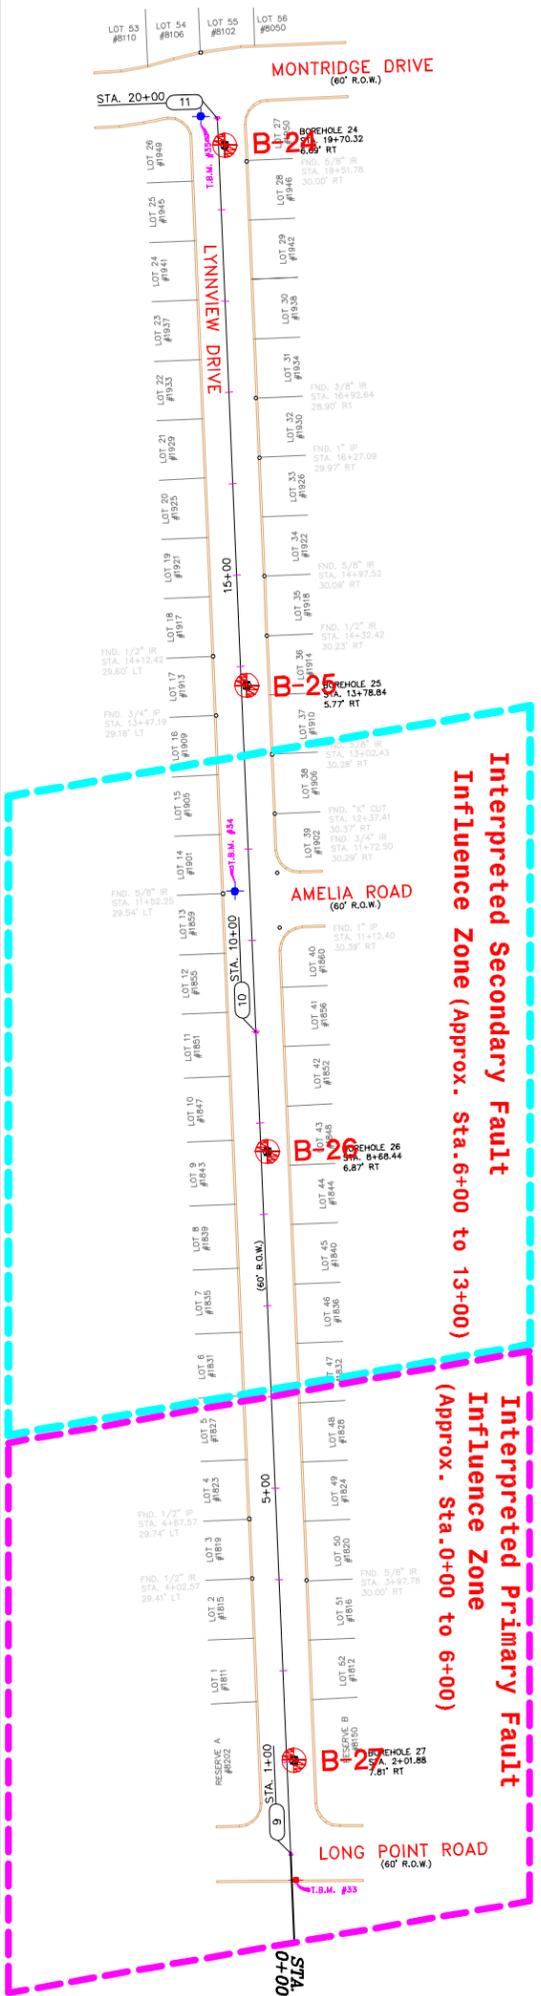
Long Point Fault is one of the longest documented growth faults in Houston area. It extends from the southwest on Westella Drive (near intersection with Westmead Drive) to approximately Hempstead Road just northeast of the Silber Road intersection. The fault typically downthrown towards the southeast. Near the Long Point Road/Lynnview Drive intersection, the Long Point Fault crosses the Long Point Road at an approximate angle of 33 degrees. The interpreted Primary and Secondary Fault Zone along Lynnview Drive site plan is shown in the plan in Figure 6.
