**PHASE I GEOLOGIC FAULT ASSESSMENT
SKYSCRAPER SHADOWS LOCAL DRAINAGE PROJECT
STORM SEWER AND PAVING
WBS NO. M-000126-0070-3
HOUSTON, HARRIS COUNTY, TEXAS**

**PREPARED BY
HVJ ASSOCIATES, INC.
HOUSTON, TEXAS
FEBRUARY 17, 2015**

**REPORT NO. HE1510720
KEY MAP 575 P & Q**

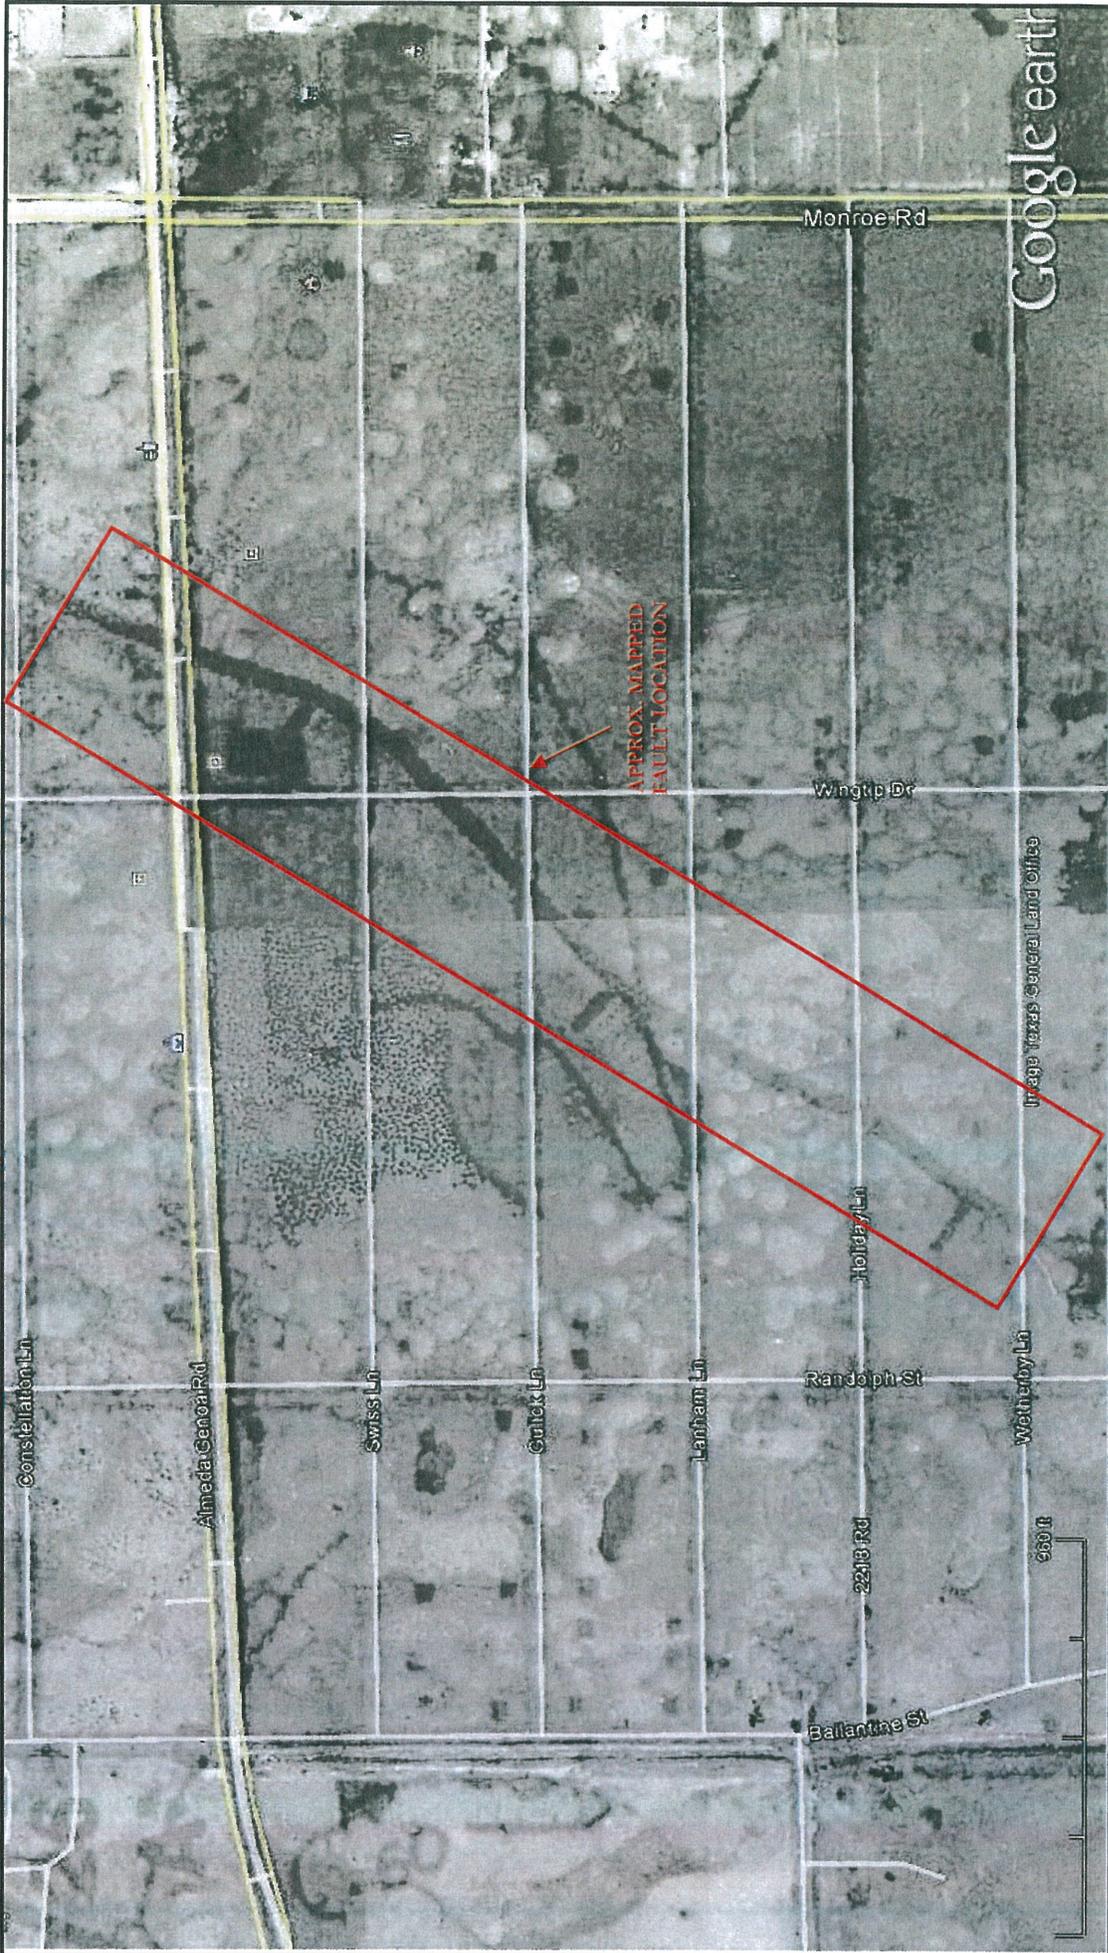
Plate 4B
 Approximate Mapped Fault Location Map
 on 1944 Aerial Photograph
 Skyscraper Project Area
 Houston, Harris County, Texas

HVJ Associates reviewed a series of aerial photographs from 1944 through 2012 for the Subject Project Alignments area. The 1944 aerial photograph showed some shading and drainage alignments which may be indicative of Geologic Fault 25. No other obvious fault(s) were observed due to modifications of the landscape.

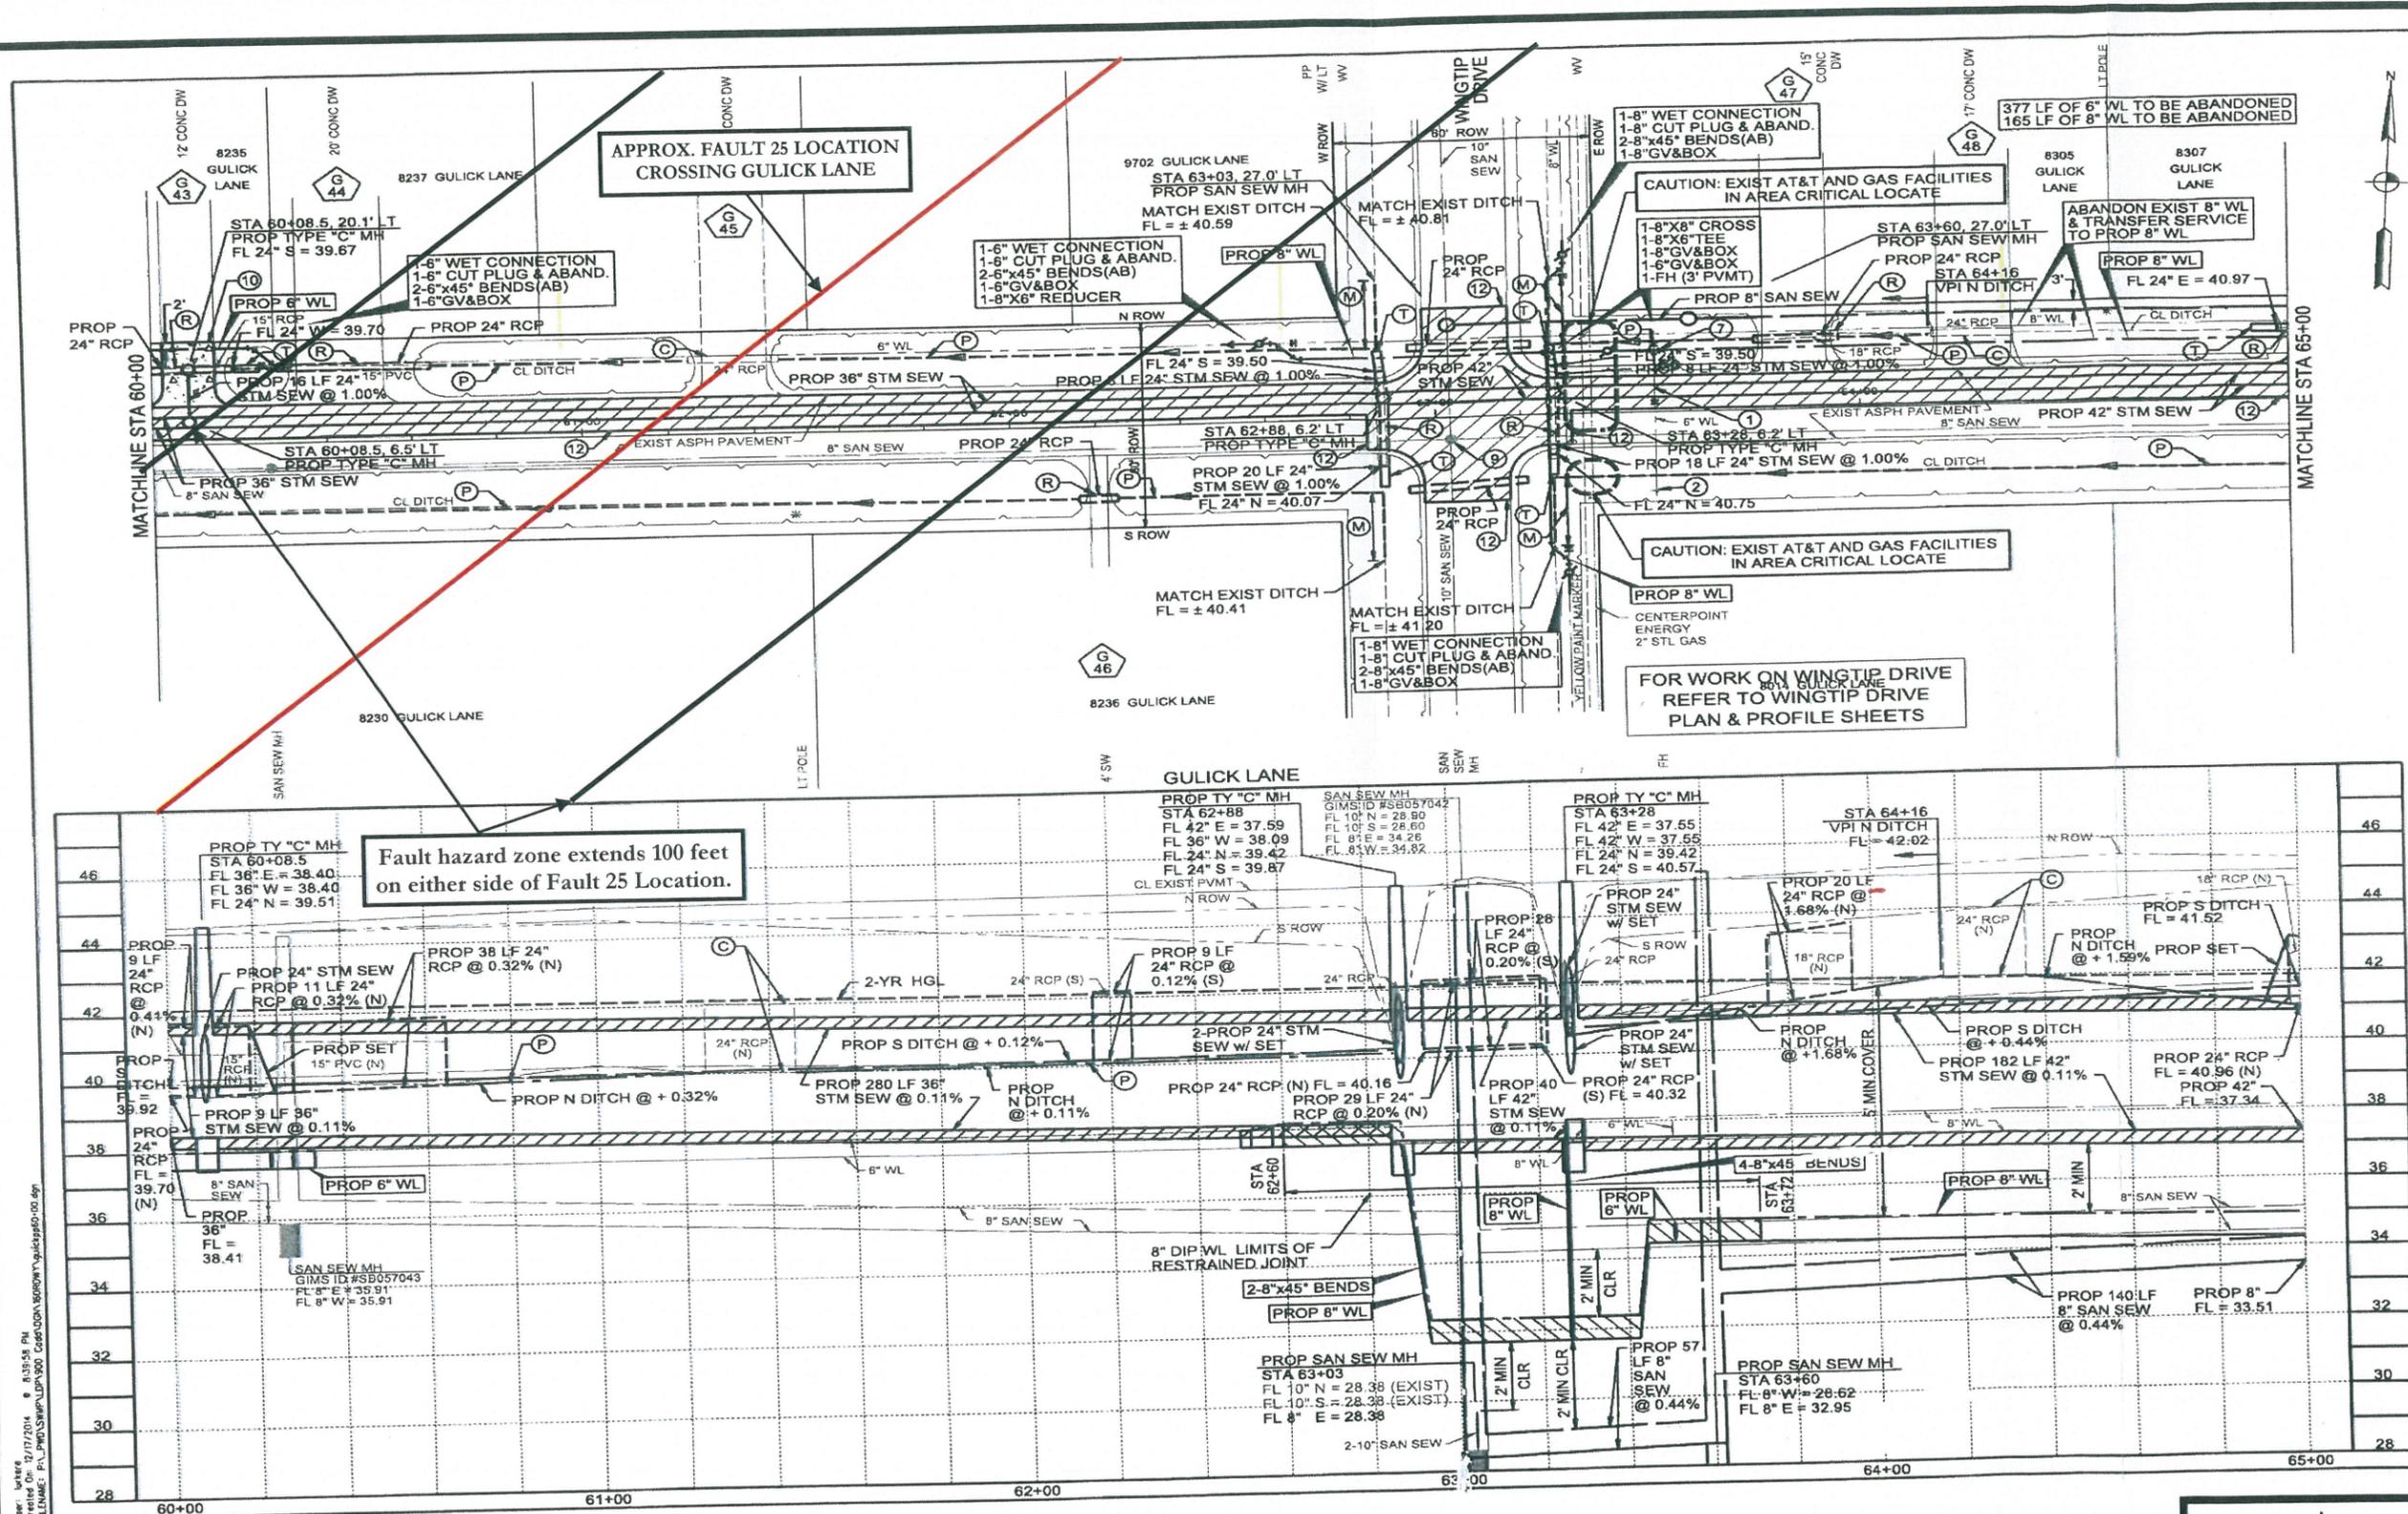
PROJECT NO.: HE1510720 DRAWING NO.: PLATE 5A

- Geologic Fault 25 is mapped crossing Gulick Lane near the intersection of Wingtip from and at Holiday Lane between Wingtip and Randolph. The upthrown zone of fault influence for this fault is estimated to extend 100 ft. southeast of the approximate fault location. The

downthrown zone of influence for this fault is estimated to extend 100 feet northwest of the fault location.

We recommend that, during construction planning, consideration be given to the proximity of the fault to the project area. Construction should take into account the potential for fault movement. It should be noted that movement rates are not consistent along the fault and that the rate goes to zero at either end. We anticipate fault zones of influence on either side of the approximate fault traces shown in Plates 5A & 5B.

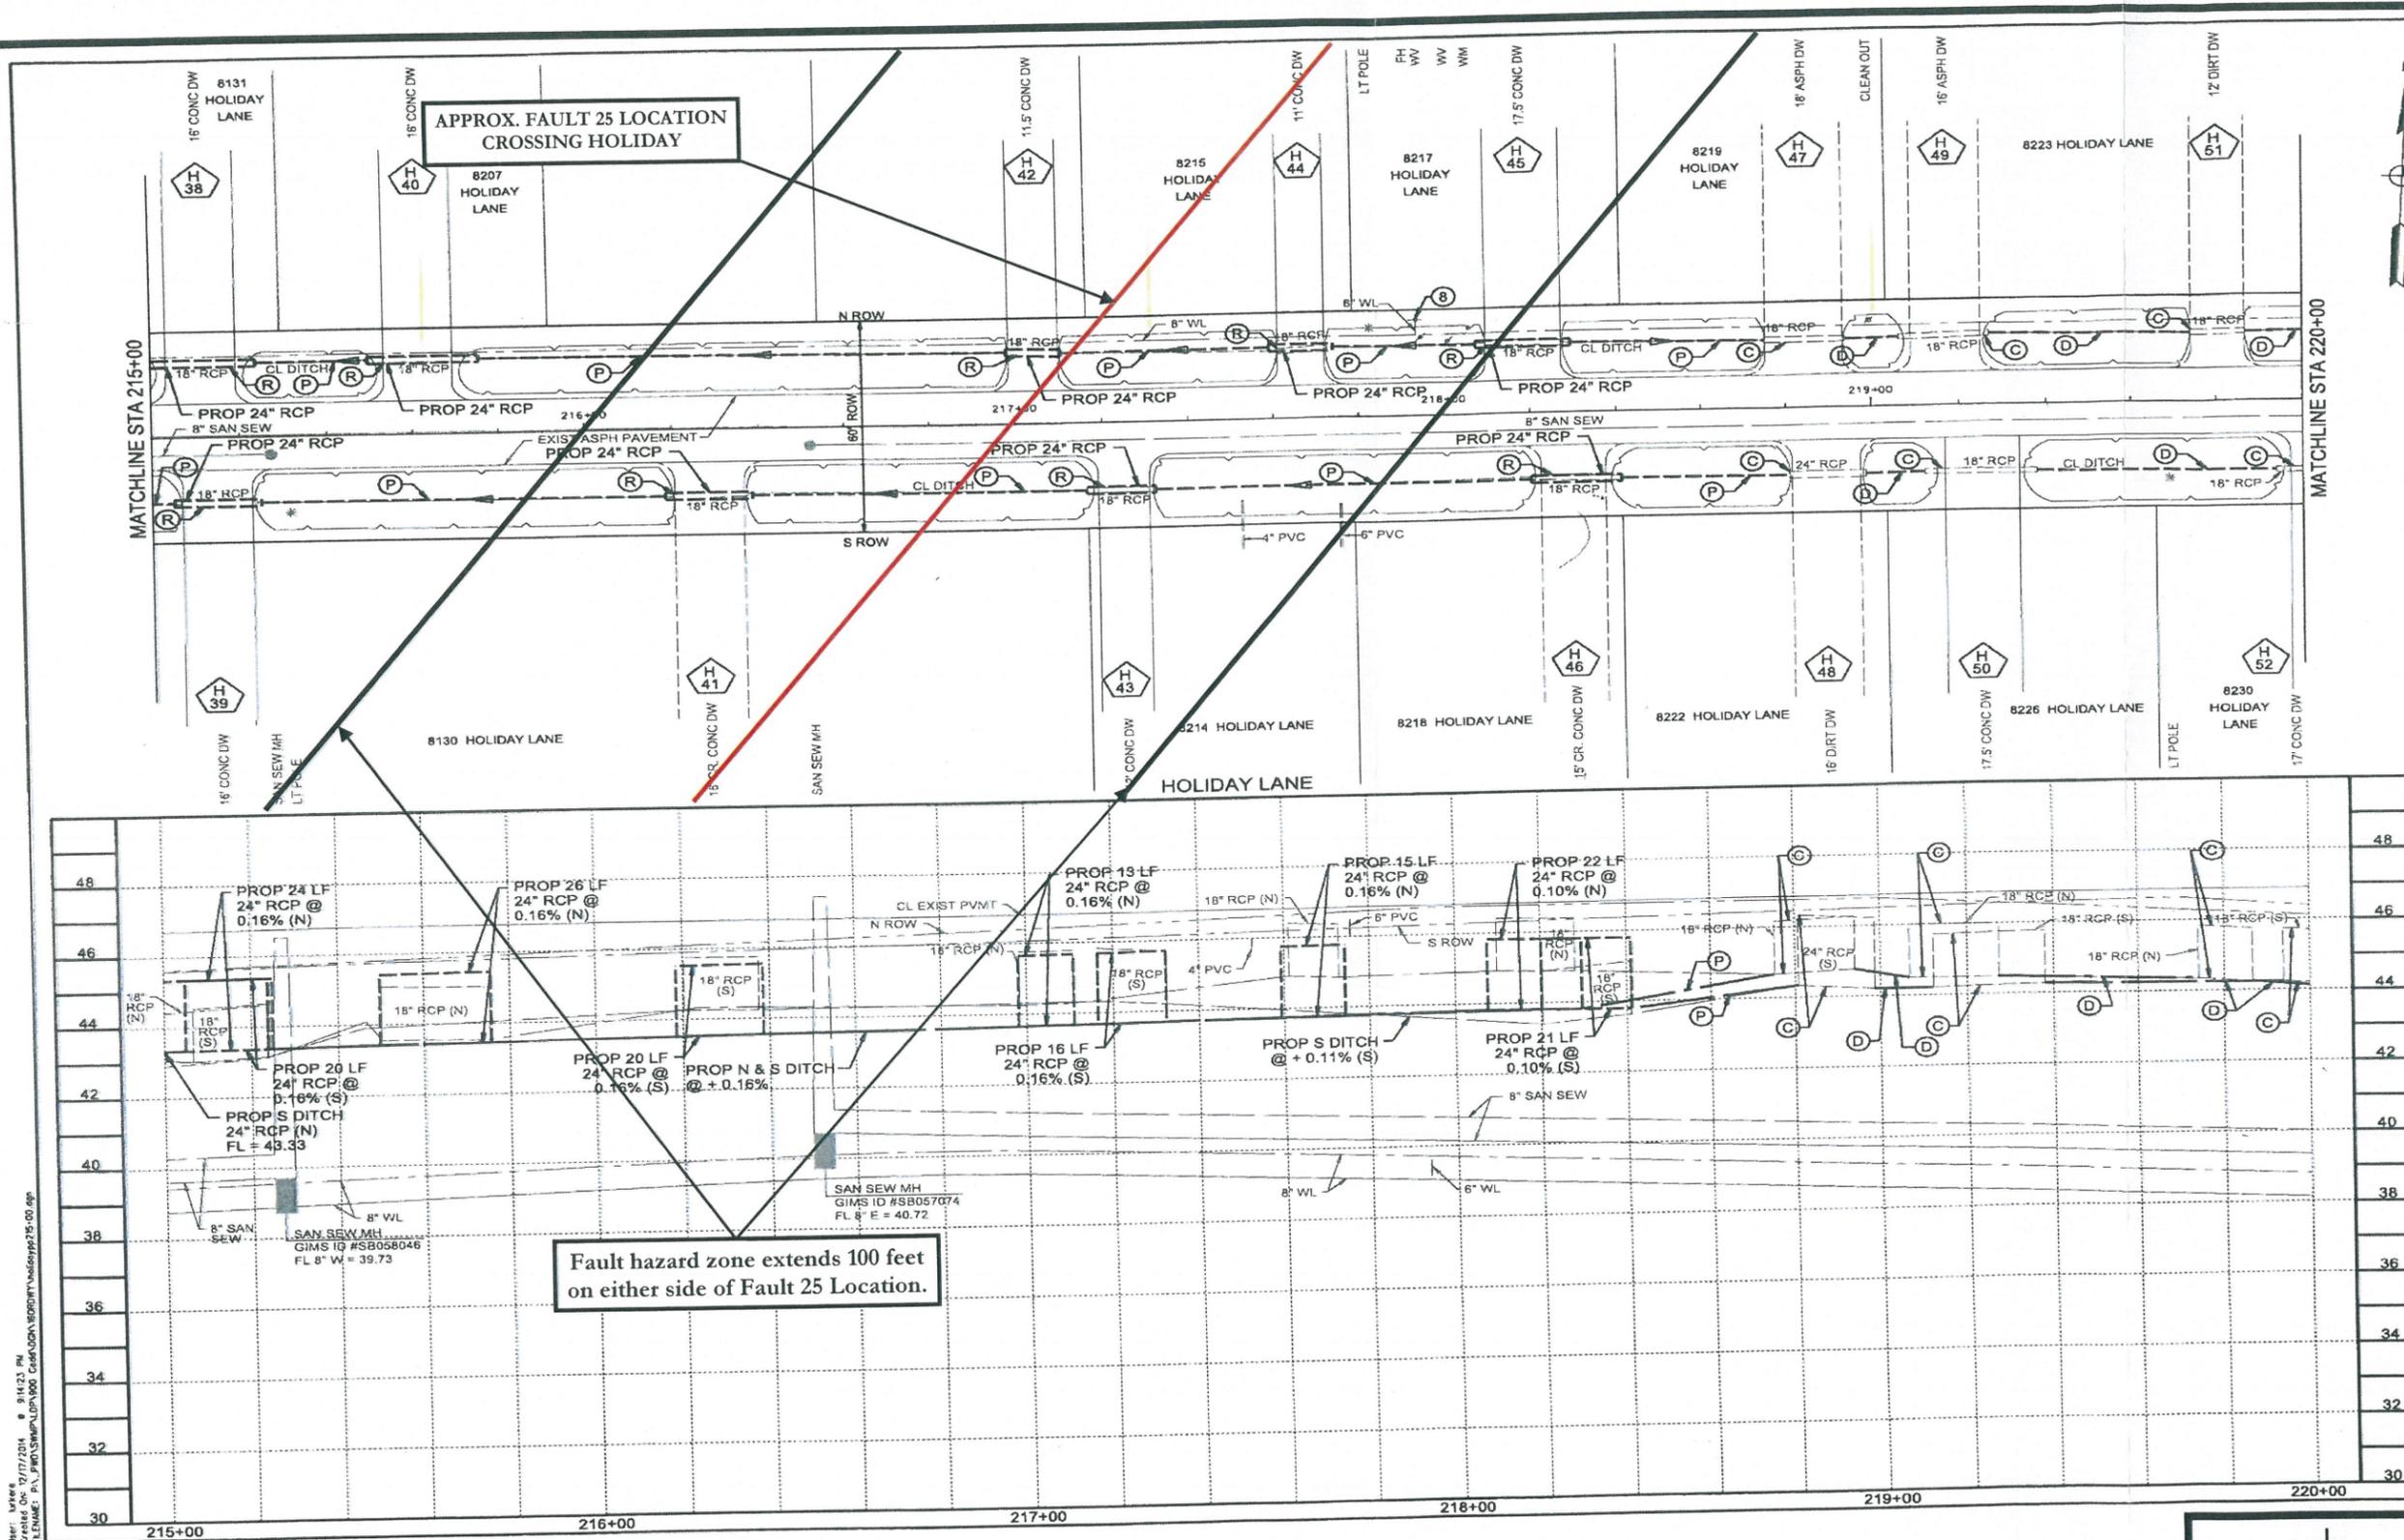
DATE: 2/12/2015	APPROVED BY: EH	PREPARED BY: NL
Skyscraper Geologic Fault Assessment Fault 25 Location along Holiday		
PROJECT NO.: HE1510720	DRAWING NO.: PLATE 5B

APPROX. FAULT 25 LOCATION
CROSSING HOLIDAY

Fault hazard zone extends 100 feet
on either side of Fault 25 Location.

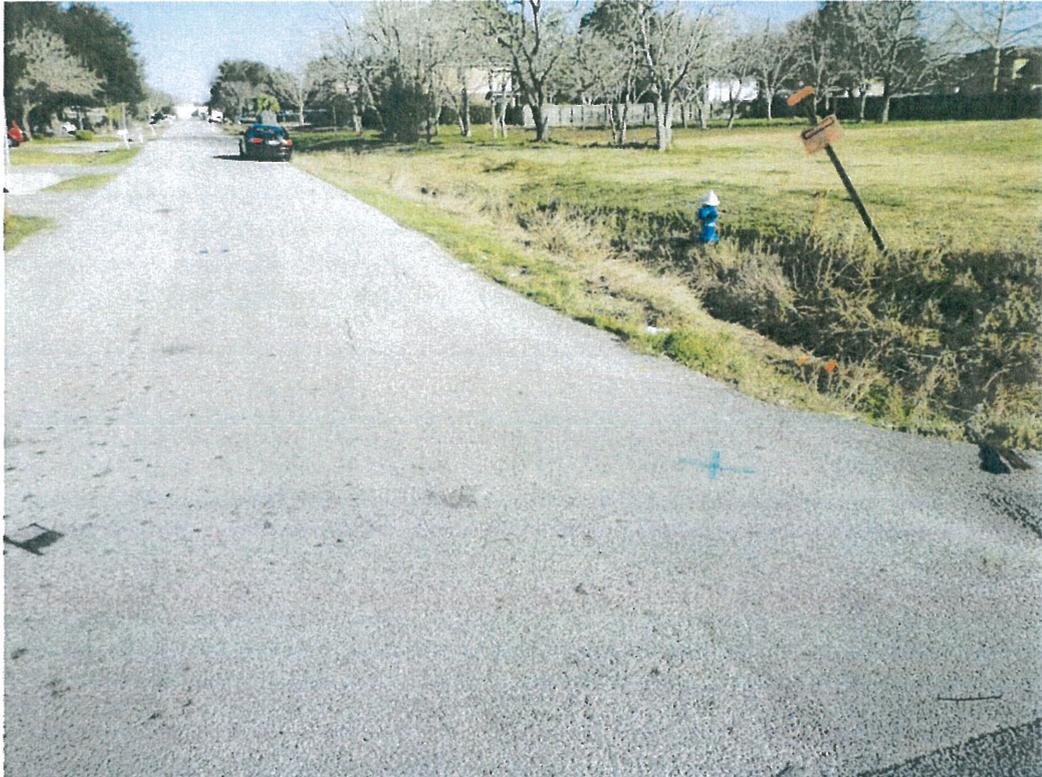
- Cracked paving was observed at the southeast corner of the intersection of Gulick Lane and Wingtip. This may be related to the documented fault in the area. No obvious building damage indicating recent fault movement was observed.

Photo 1. View of possible faulted area near the southeast corner of the intersection of Gulick Lane and Wingtip.

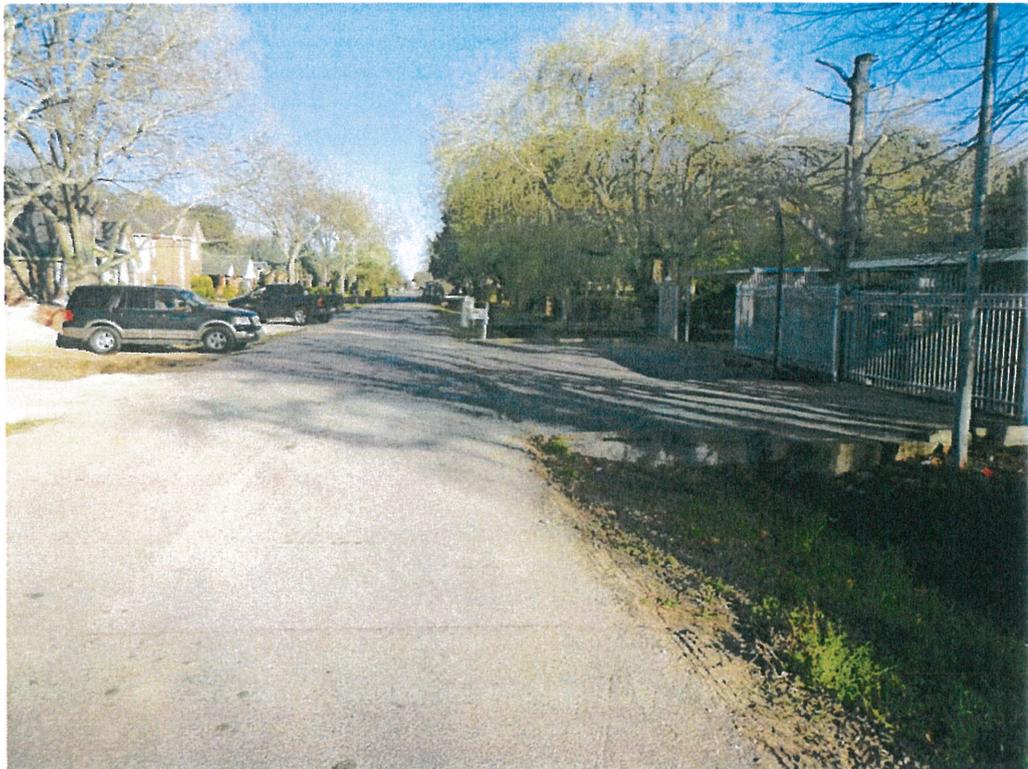
Photo 2. View looking east along Holiday Lane showing possible area of fault crossing the project alignment.

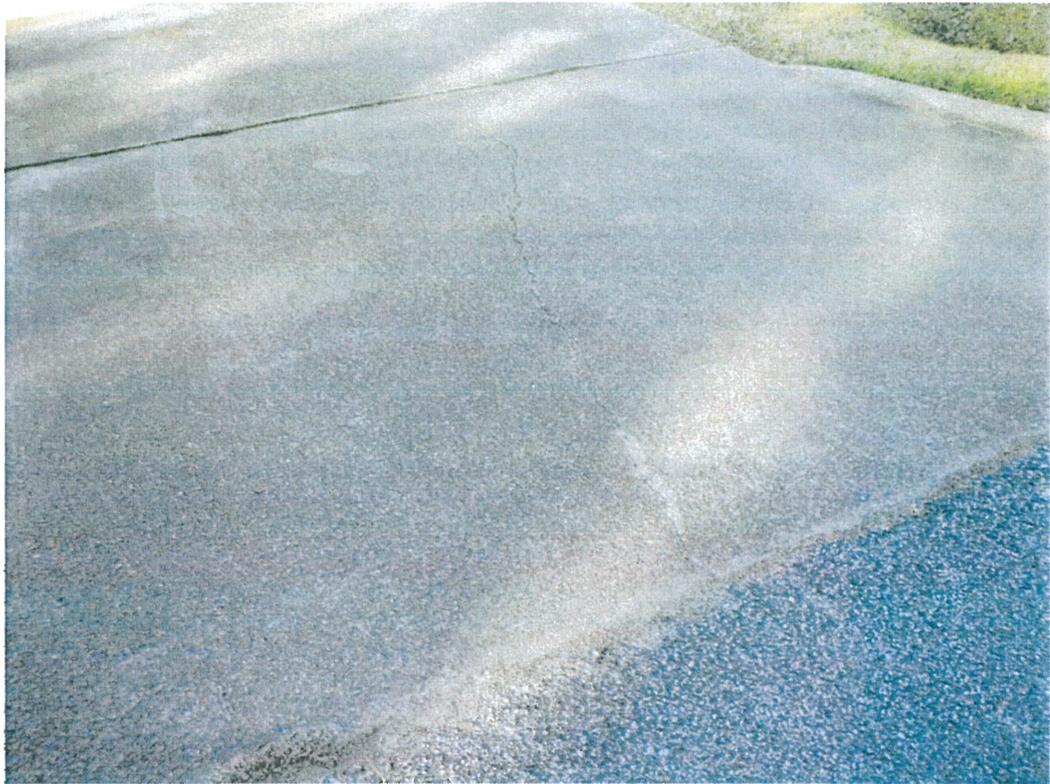
We observed no vertical relief at the mapped fault locations. We observed pavement damage and cracks near the mapped fault location along Gulick Lane. We observed an area of patched paving on Holiday Lane which may be indicative of faulting. No obvious building damage indicating recent fault movement was observed (a series of site photos showing these locations is provided in Appendix A). No significant scarp development was observed on vacant land adjacent to the pavement areas.

Photo 3. View of patched paving area along Holiday Lane.

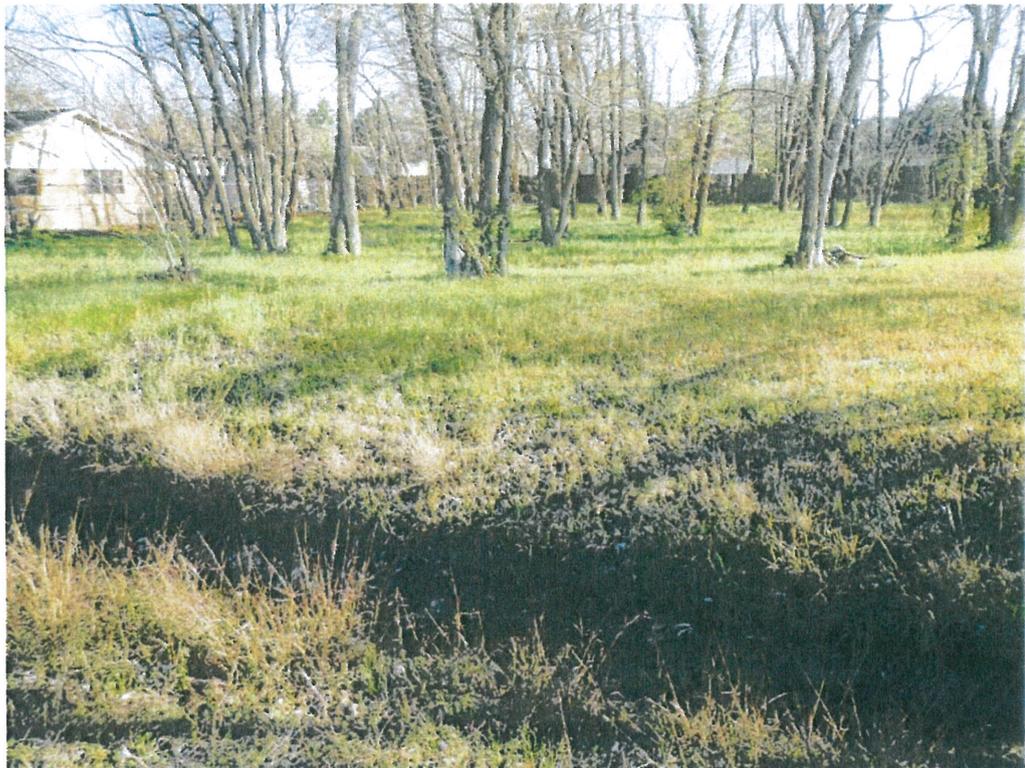
Photo 4. View vacant tract along Holiday Lane near area of mapped fault crossing the project alignment.

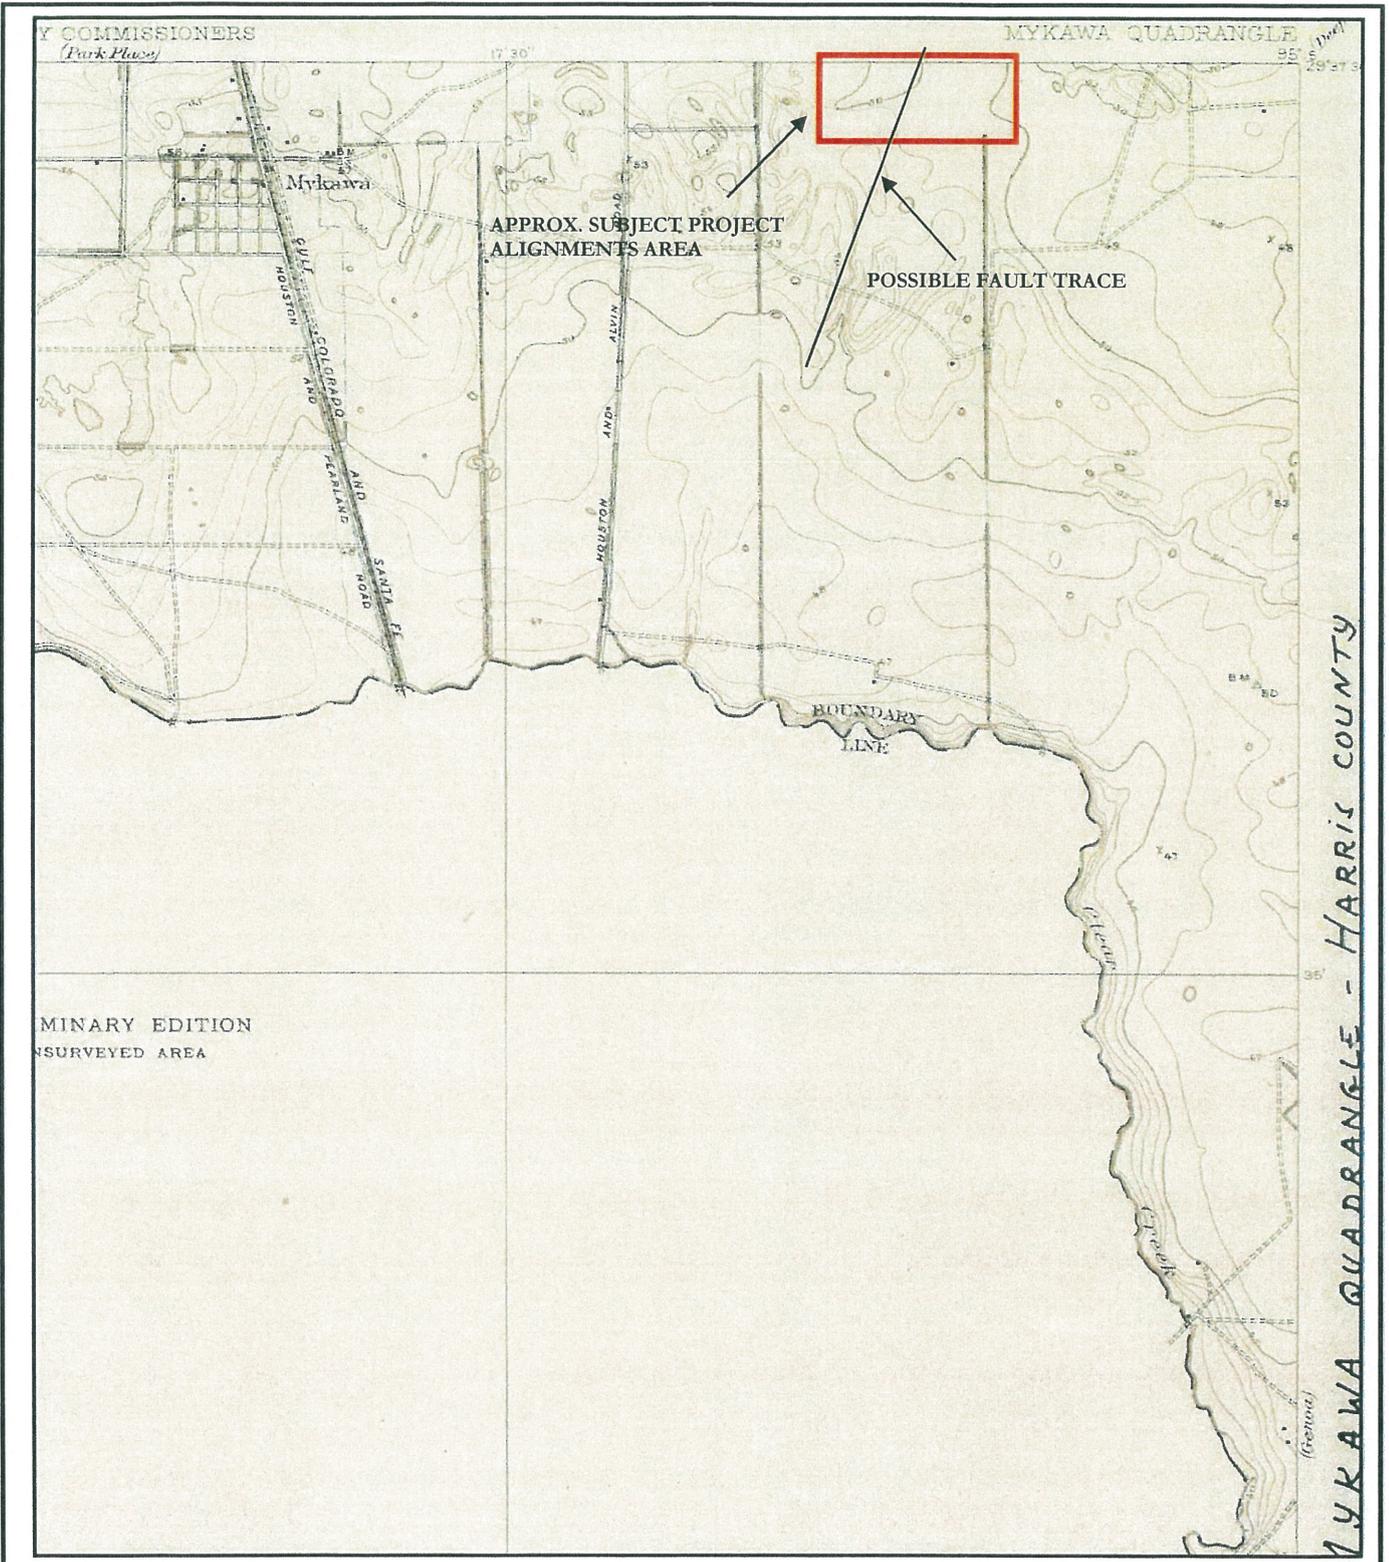
Source: U.S. Geological Survey (1915 Mykawa Quadrangle)

- Examination of the oldest available historical topographic map for the 1915 Mykawa Quadrangle revealed topographic features and/or stream and drainage patterns that could be related to faulting.
