PHASE I GEOLOGICAL FAULT INVESTIGATION
CITY OF HOUSTON WATER LINE
REPLACEMENT IN
KICKERILLO AREA
WBS NO. S-000035-0185-3
HOUSTON, TEXAS

REPORT NO. 1140194602

GEOTEST ENGINEERING, INC.
Houston, Texas

December 20, 2013

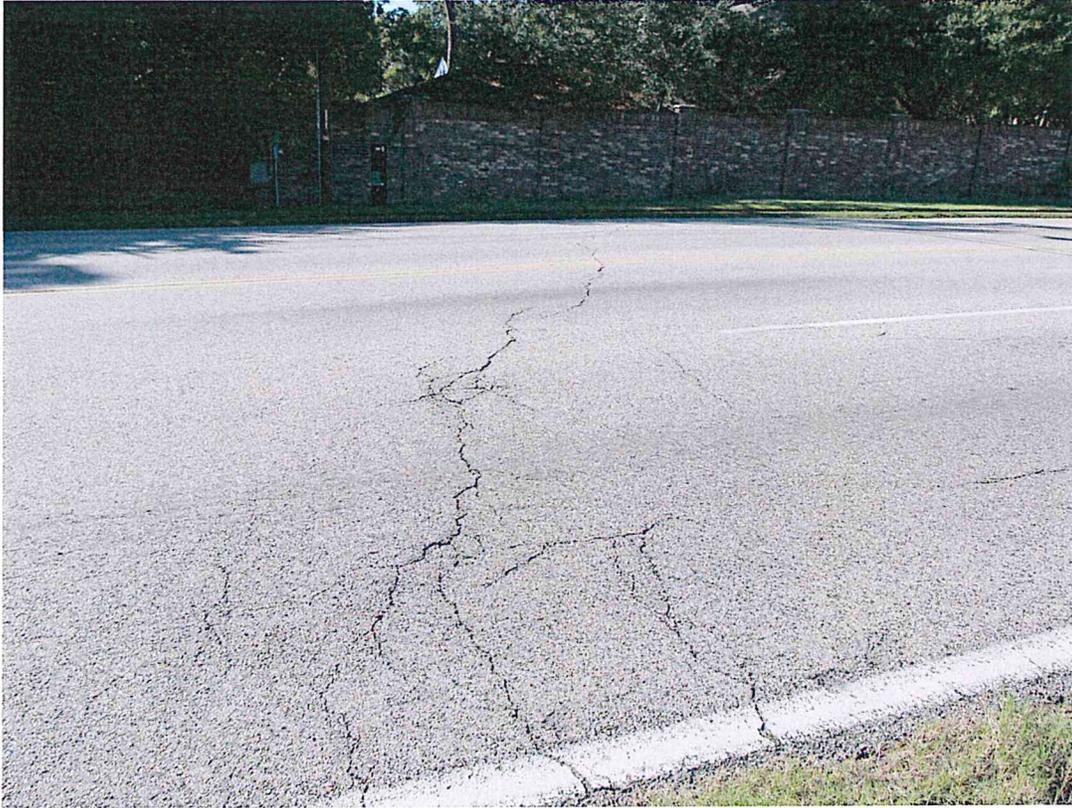
Visible Long Point Fault crossing at Memorial Drive outside the project area.

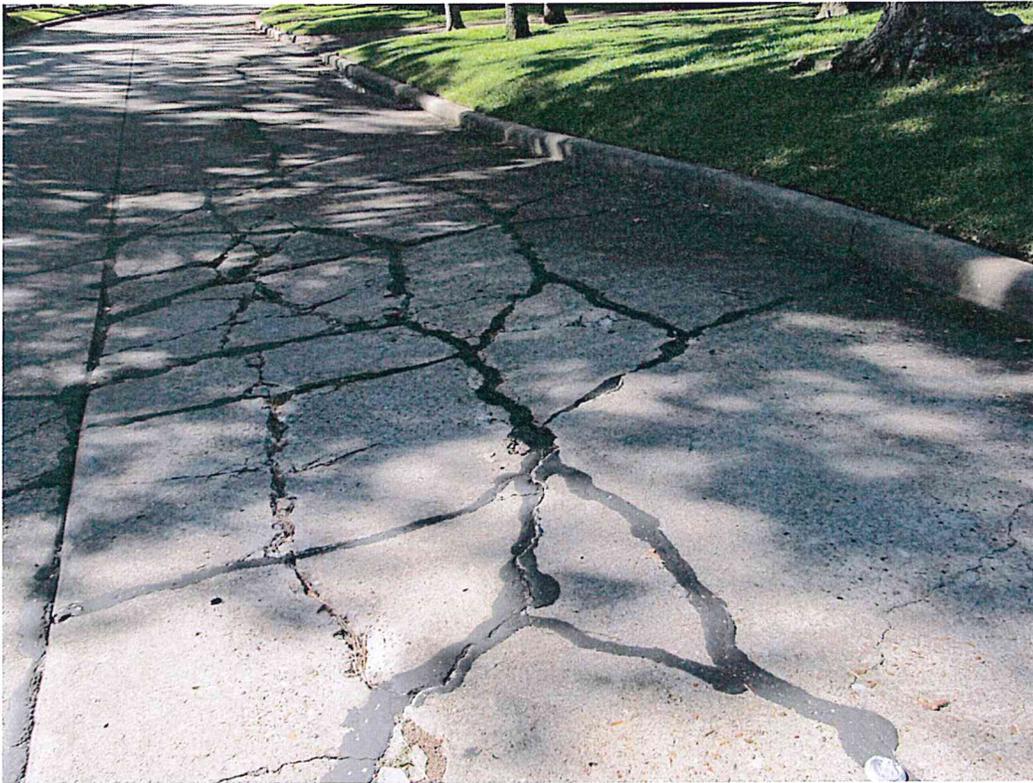
Visible Long Point Fault at West Forest Drive outside the project area.

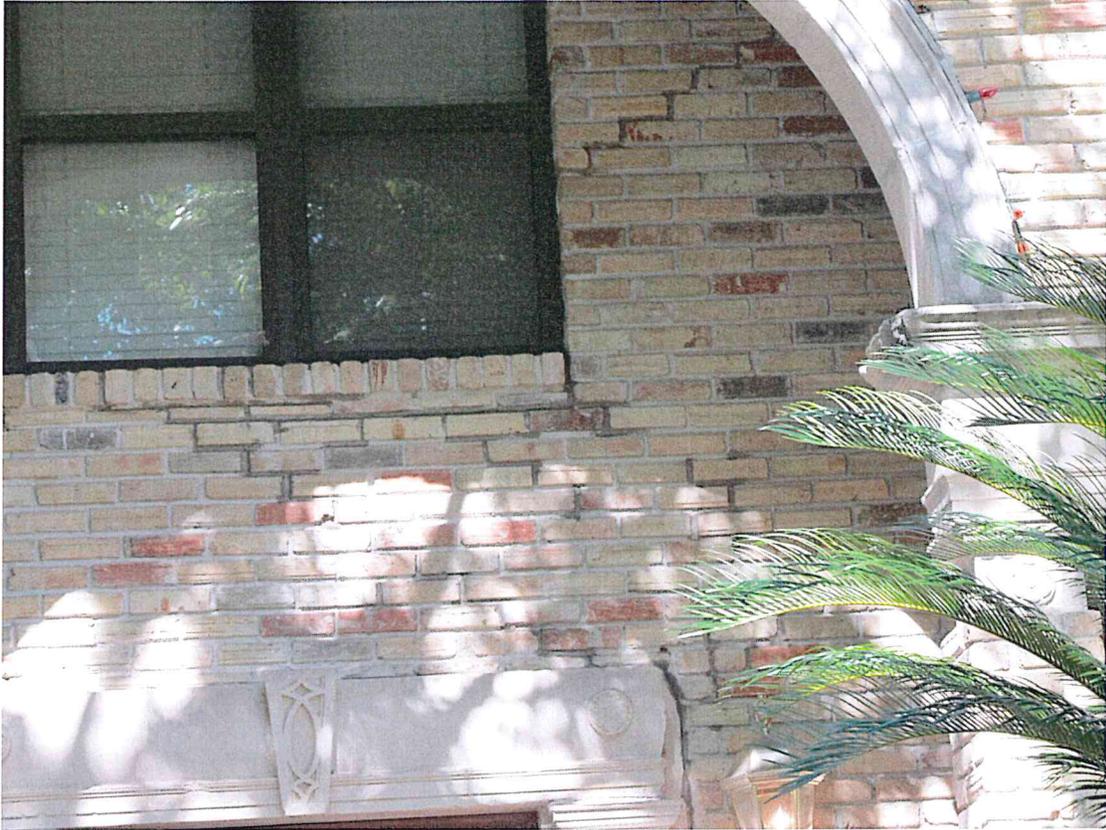
Cracking in the house near the intersection of Rancho Bauer and Apple Tree Lane.

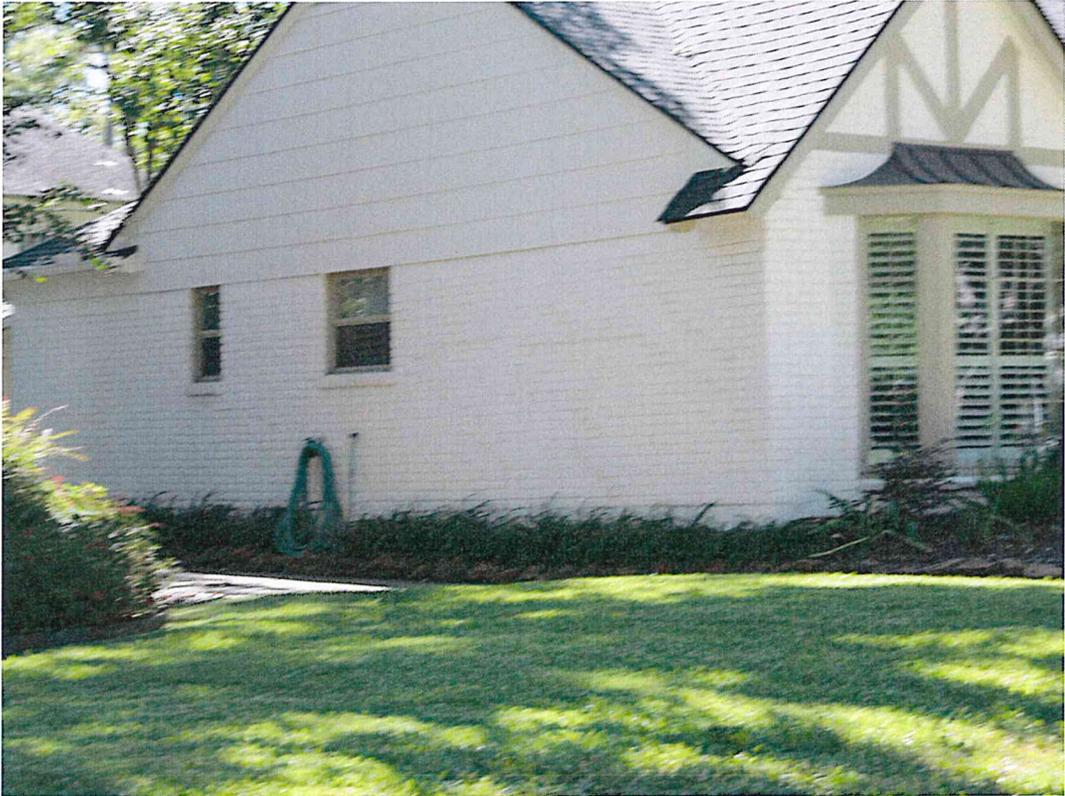
Distressed house due to fault crossing at 14215 Cindywood Drive.

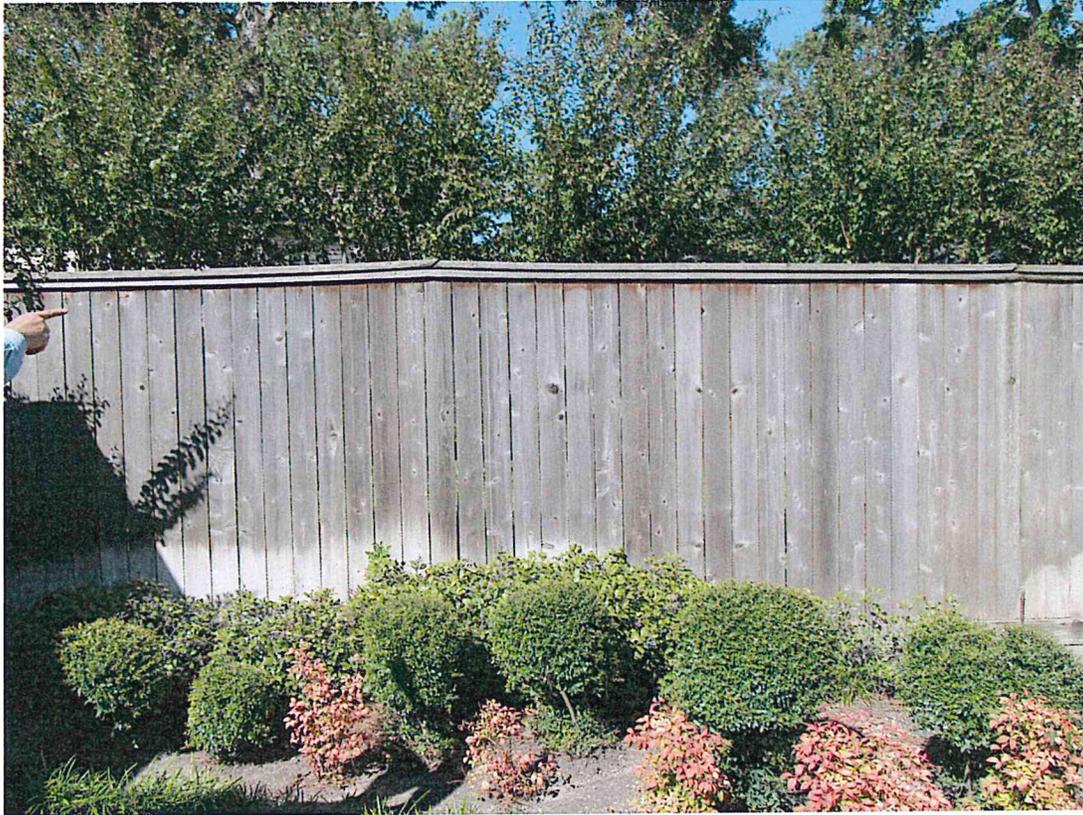
Failure in the fence due to fault crossing near Cardcrest Drive.

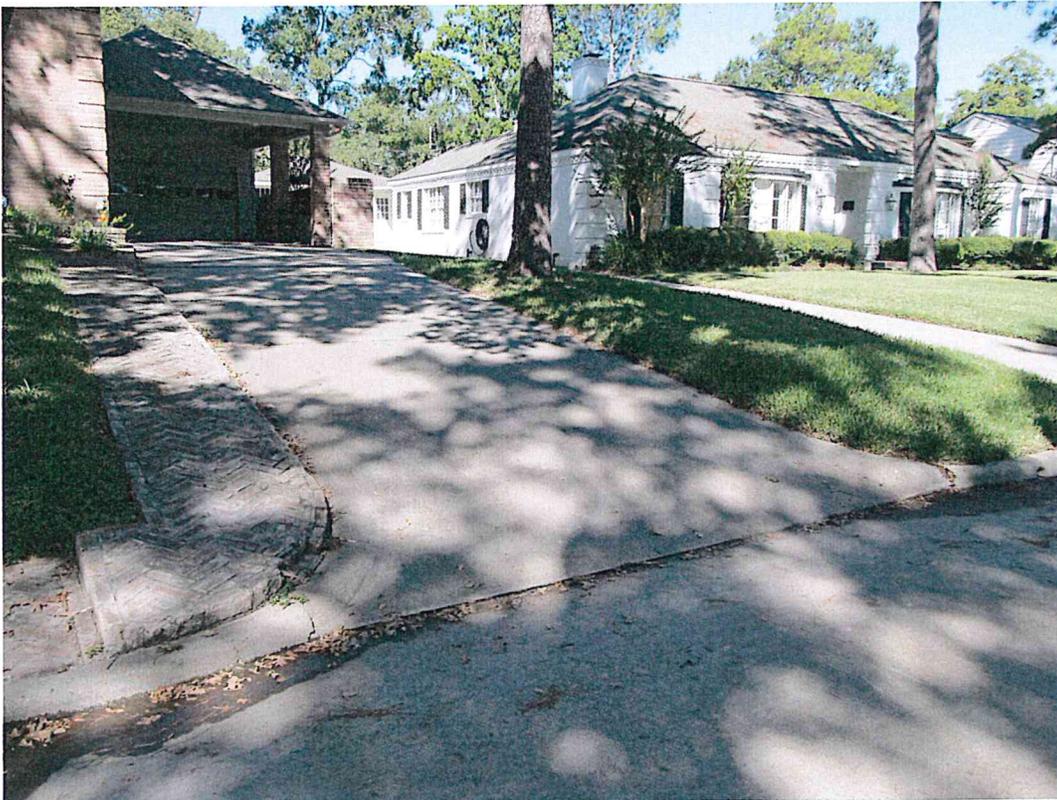
Failures in the curb along Carolcrest Drive due to fault crossing.
