**PHASE I & III GEOLOGIC FAULT INVESTIGATION  
FOR  
WATER LINE REPLACEMENT IN THE SHEPHERD FOREST II AREA**

**A CITY OF HOUSTON PROJECT  
(COH WBS NO. S-000035-0192-4 & ATL NO. G13-196)**

**PROJECT NO: 1401LN-06**

**APRIL 28, 2014**

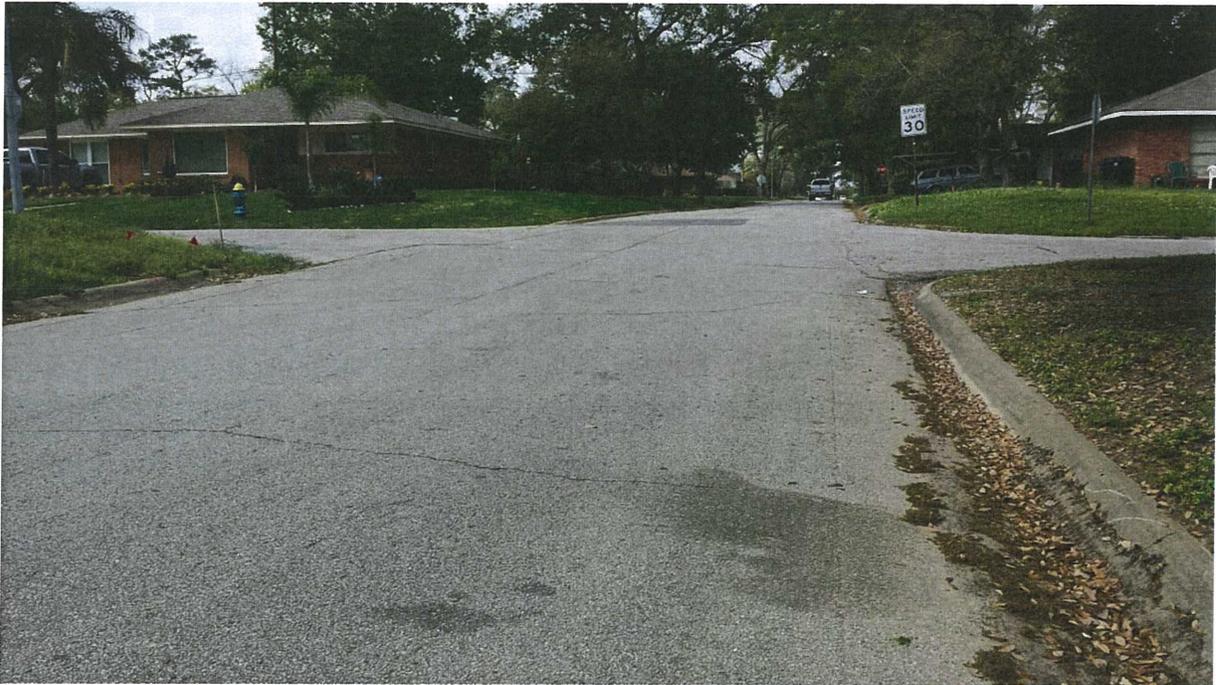
Photo 1 – View to the north across the Eureka Heights fault on Alba Road at West30th Street.

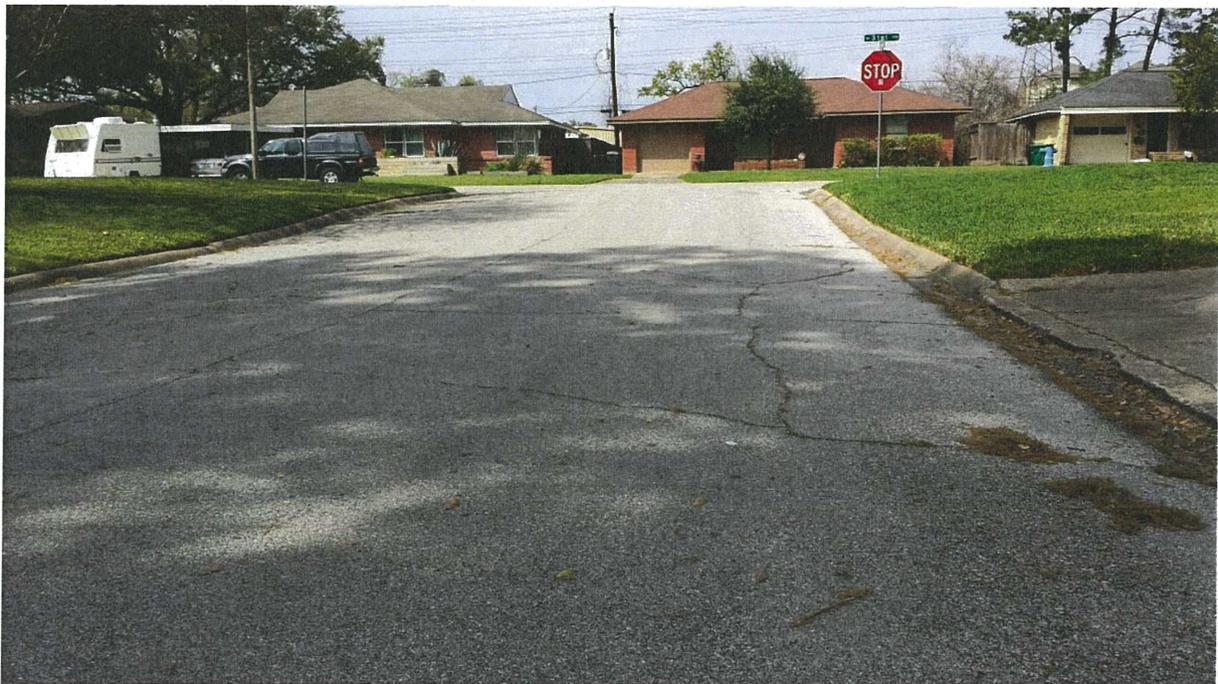
Evidence that the Eureka Heights fault may still be moving is indicated by cracks in the road surface where the fault crosses Dunsmere Road and West 31st Street. The cracks in of themselves do not provide a rate of movement, however.

Photo 2 – View to the north across the Eureka Heights fault on Dunsmere Road at West31th Street.

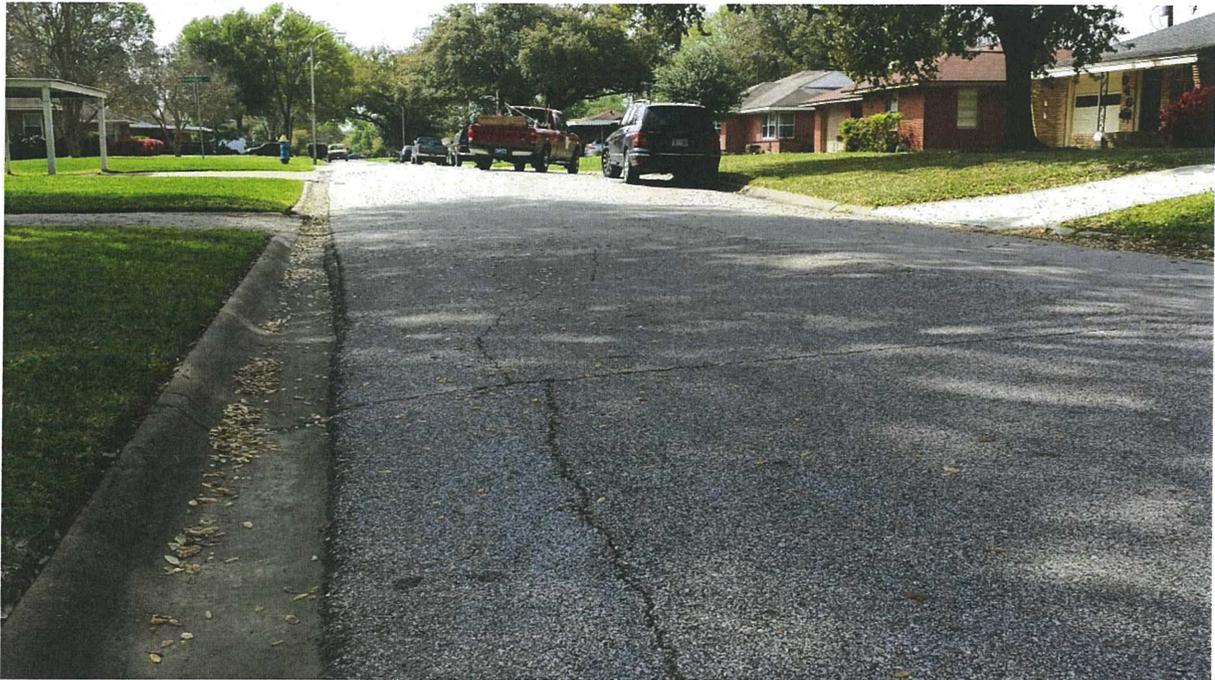
Photo 3 – View to the west across the Eureka Heights fault on West 31st Street at Dunsmere Road.
