PHASE I ENVIRONMENTAL SITE ASSESSMENT

**WATER LINE REPLACEMENT IN
HUGHES ROAD AREA – PACKAGE I**

Houston, Texas

WBS No. S-000035-0187-4

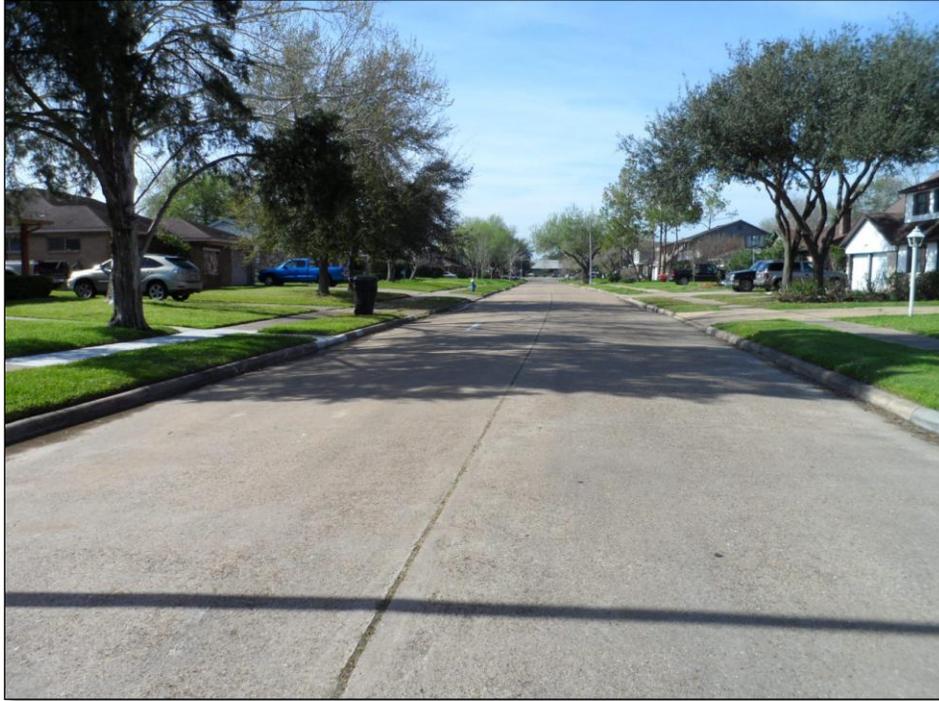
Photo 1: View of project right-of-way at Sageburrow Drive, facing north.

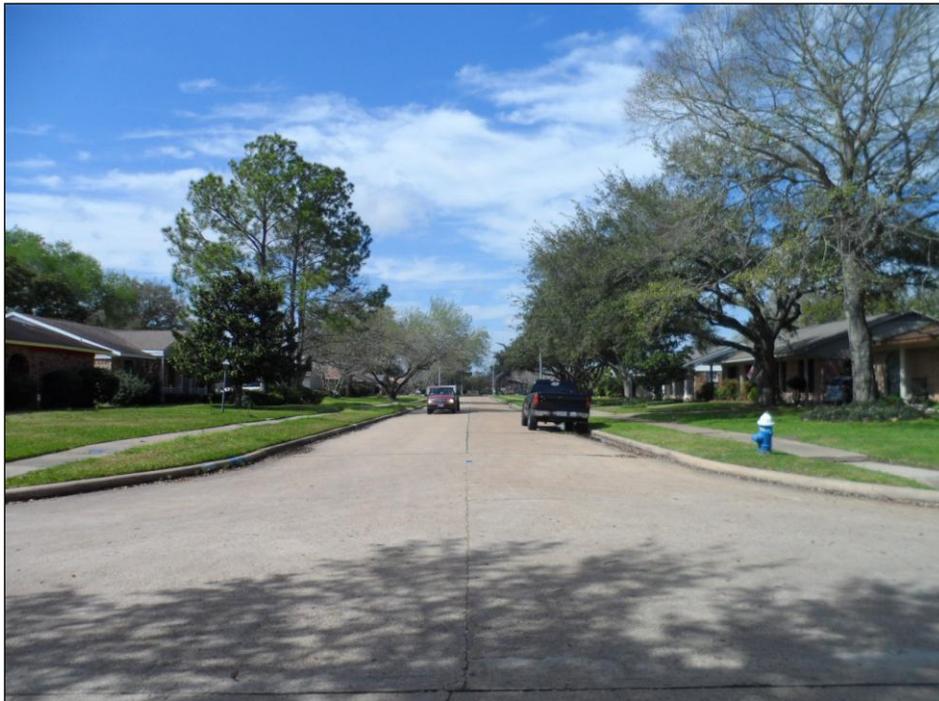
Photo 2: View of project right-of-way at Sagetrail Drive, facing north.

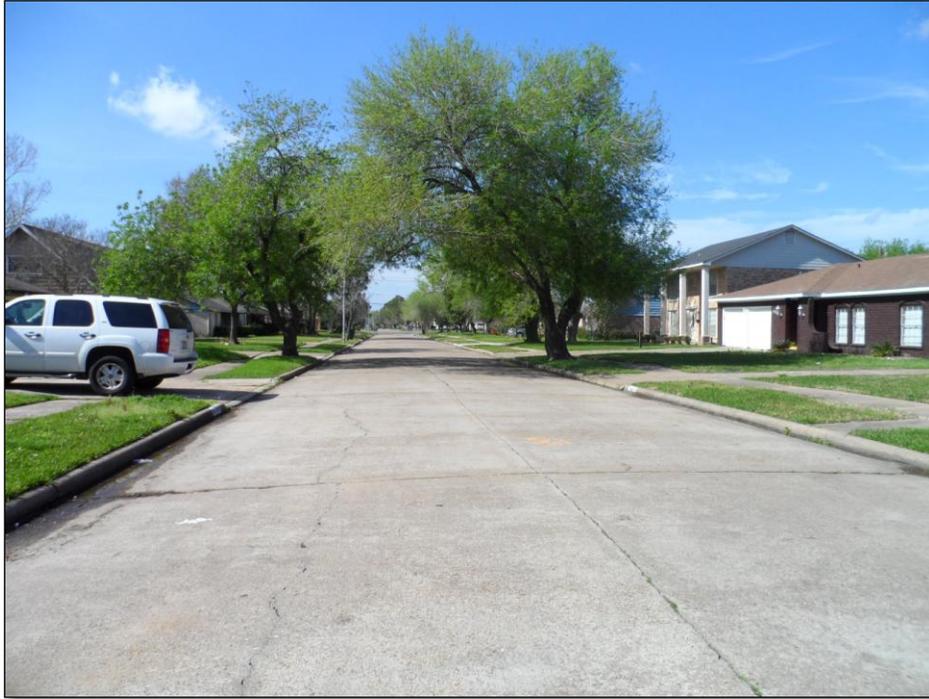
Photo 3: View of project right-of-way at Sagevalley Drive, facing north.

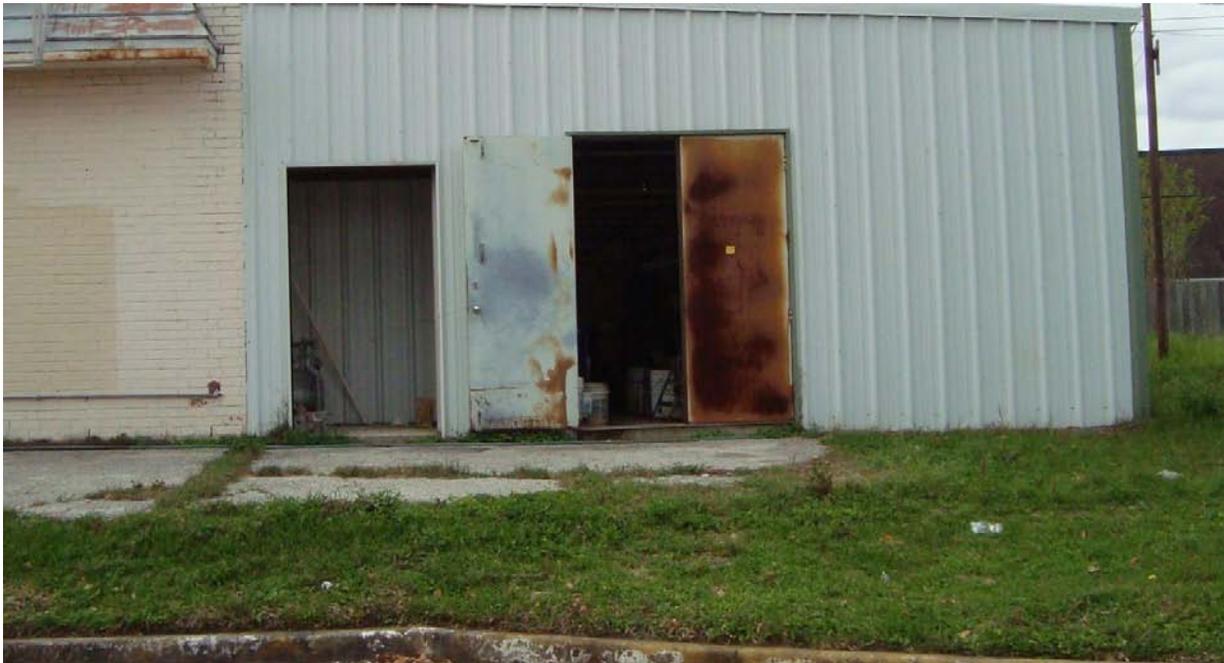
We observed residential land but no industrial activity along the project rights-of-way. We visited a gasoline station and a dry cleaning store (Star Cleaners) at the corner of Hughes Road and Sagevalley Drive and saw no evidence of recognized environmental conditions on these properties.

We interviewed the owner of Star Cleaners, at the corner of Hughes Road and Sagevalley Drive. The purpose of this interview was to obtain more information about how the dry cleaning store handles the hazardous materials used for dry cleaning. The owner stated that these materials were stored inside the property and picked up regularly by a waste recycling company.

Photo 4: View of tanks keeping waste at Star Cleaners, 10835 Hughes Road, facing north.
