**CITY OF HOUSTON
BUCKINGHAM LIFT STATION
314 ½ FRIAR TUCK LANE
HOUSTON, TEXAS**

ASBESTOS AND LEAD SURVEY REPORT

**BUCKINGHAM LIFT STATION
314 ½ Friar Tuck Lane
Houston, Texas**

Re: Comprehensive Asbestos and Lead-Based Paint Survey
Buckingham Lift Station
314 ½ Friar Tuck Lane
Houston, Texas
ECS Project Number: 50222028
City of Houston Contact Number: 53564

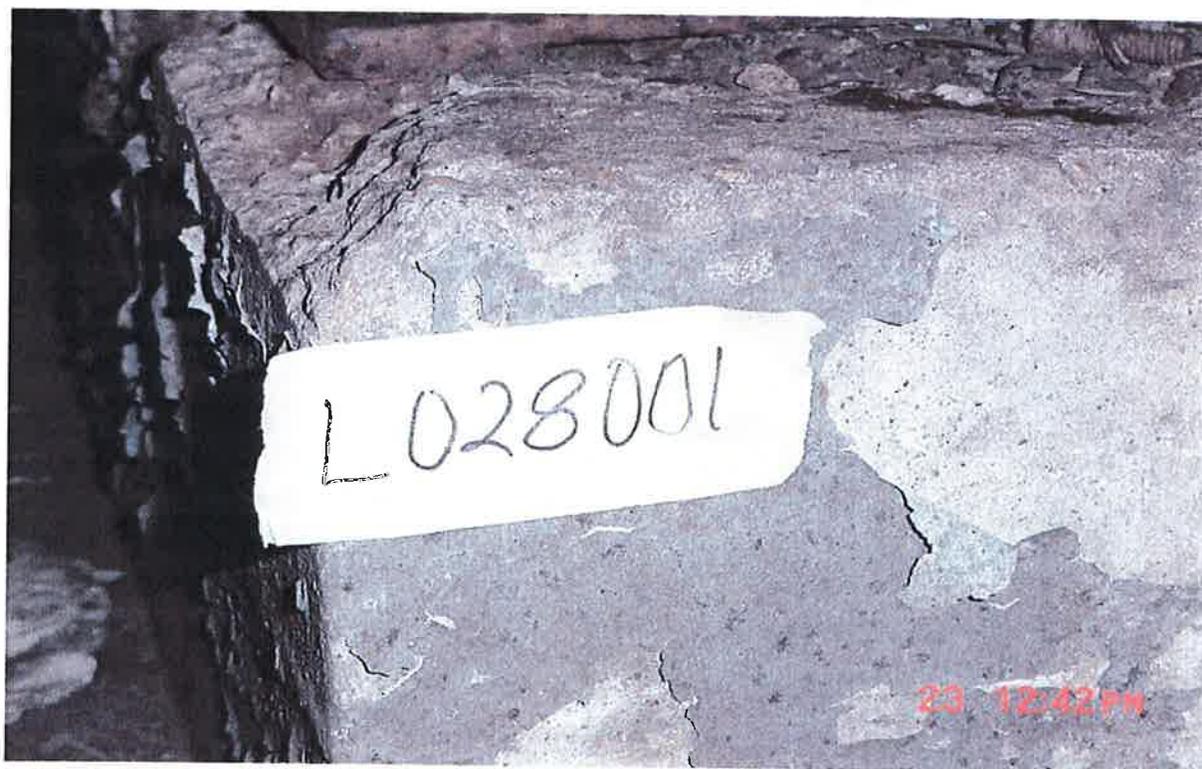
1. Analytical results of the gray paint located on the control box and associated piping indicated lead concentrations of 0.06% by weight. These materials appeared to be in good condition at the time of our facility visit. Approximately three hundred (300) square feet of this paint exist. No abatement deemed necessary (City of Houston Hazard Category A).

Photo No. 2: L028001 - Gray paint on pumps base floor

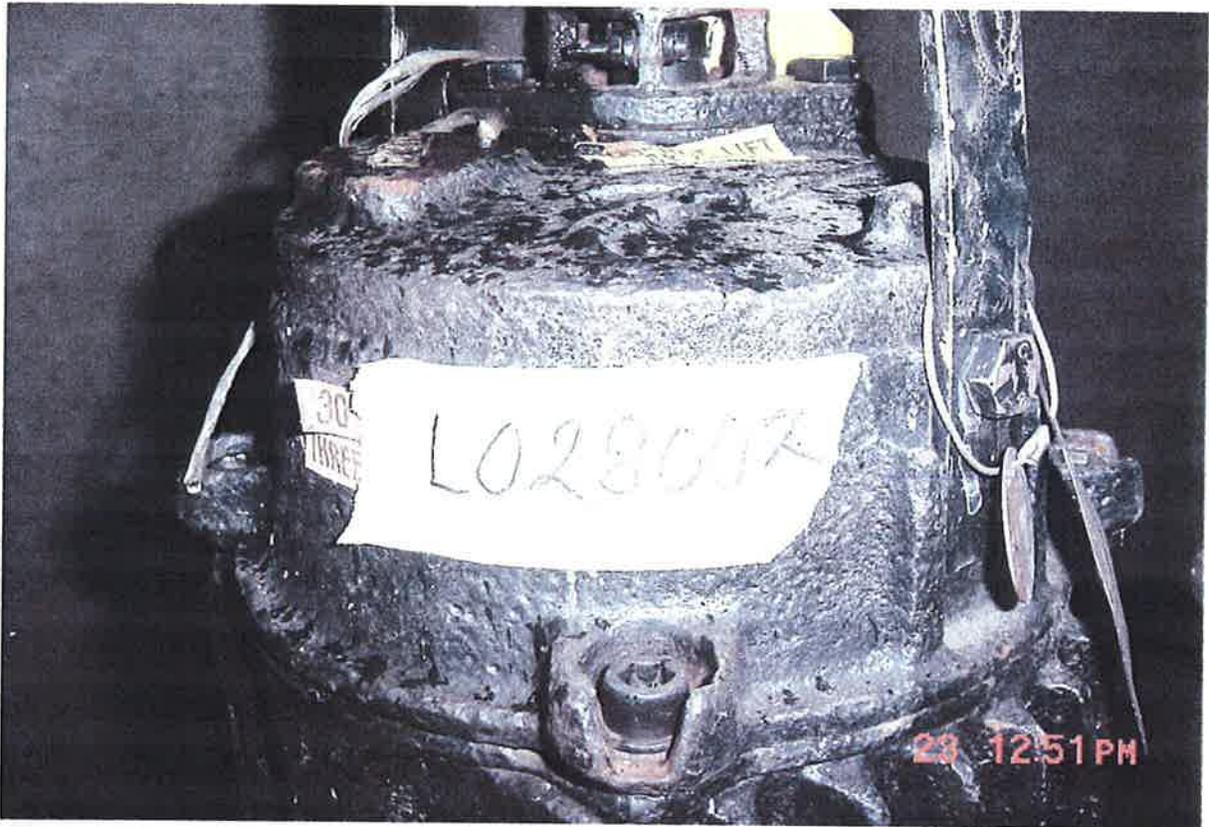
2. Analytical results of the black paint located on the pump motors and associated piping indicated lead concentrations of 0.29% by weight. These materials appeared to be in a damaged condition at the time of our facility visit. Approximately one hundred (100) square feet of this paint exist. Abatement of this material should be addressed prior to any renovation/demolition activities. OSHA regulations apply to workers or the public (City of Houston Hazard Category C-2).

Photo No. 3: L028002 - Black paint on pumps

Estimated one hundred fifty (150) square feet of the red paint and black paint located on the pump motor and associated piping were found to contain lead above allowable lead level (See Appendix A Figures and Photographs of the lead report). Abatement should be addressed prior to any renovation/demolition activities.

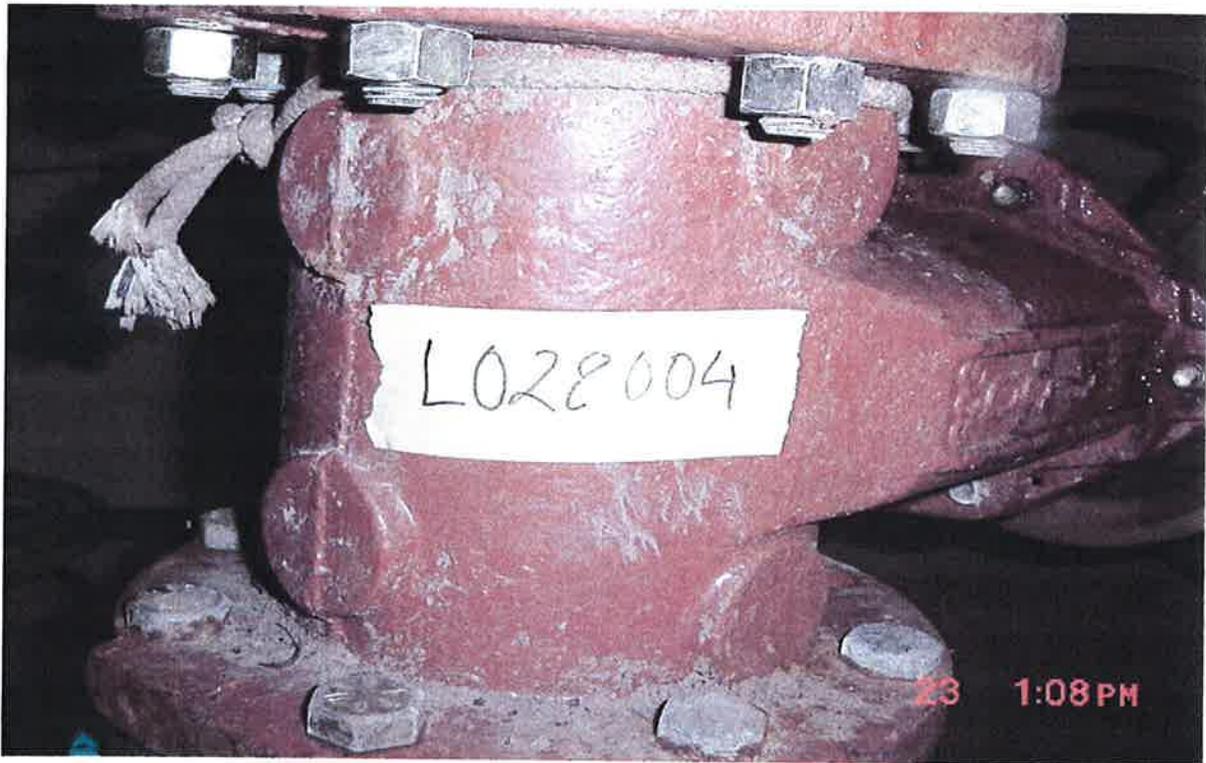
4. Analytical results of the red paint located on the piping indicated lead concentrations of 0.34% by weight. These materials appeared to be in good condition at the time of our facility visit. Approximately fifty (50) square feet of this paint exist. Abatement of this material should be addressed prior to any renovation/demolition activities. OSHA regulations apply to workers or the public (City of Houston Hazard Category C-2).

Photo No. 4: L028004 - Red paint on pipes
