**PHASE I ENVIRONMENTAL SITE ASSESSMENT
OF IMPERIAL VALLEY AREA PACKAGE II
HOUSTON, TEXAS**

FINAL REPORT

Prepared by
AVILES ENGINEERING CORPORATION
5790 Windfern
Houston, Texas 77041
Phone: 713-895-7645
Fax: 713-895-7943
AEC Project No. E107-13

December 31, 2013

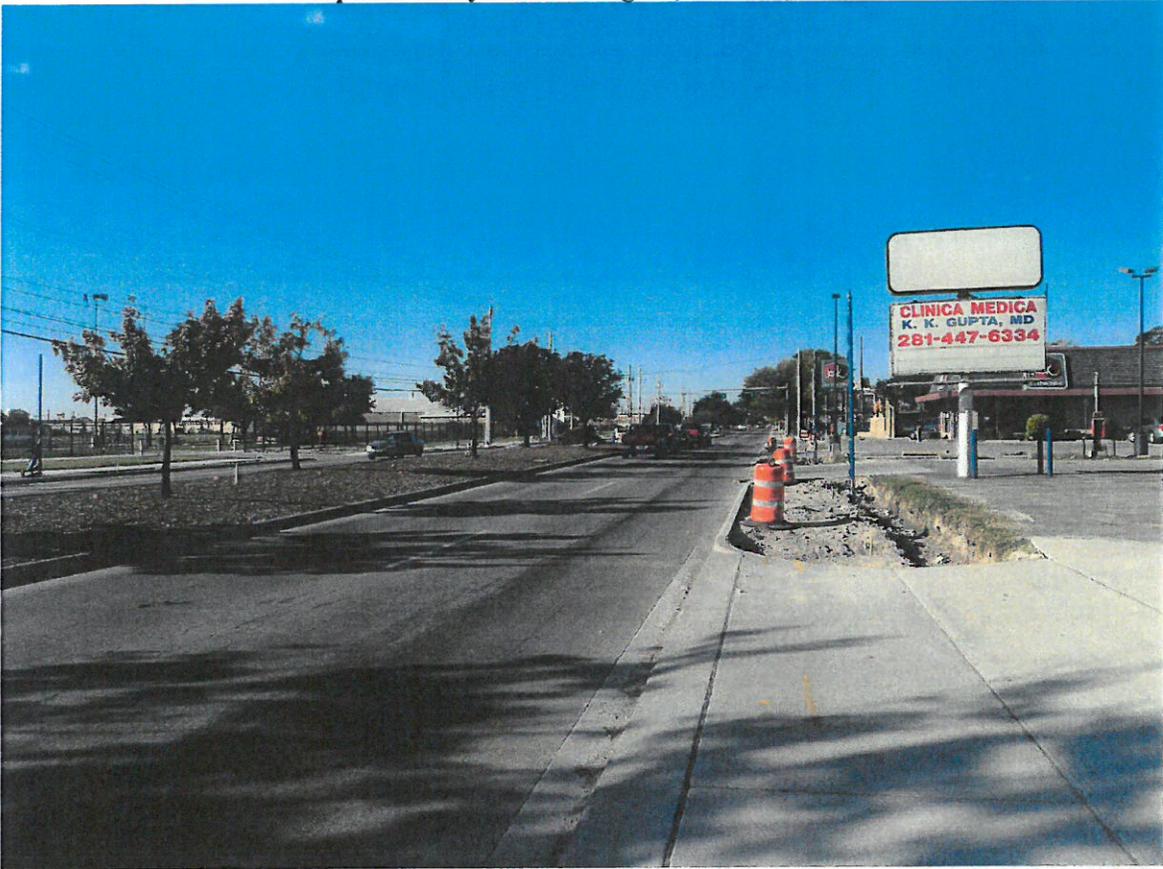
Photograph 1: View to the north along Airline Drive, a typical concrete street in the Subject Right-of-Way.

All of the roads in the Subject Right-of-Way are composed of concrete paved streets with curbs and storm sewer drains (refer to Photograph 1 in Appendix B). Power lines cross or parallel most of the roads and transformers are attached to some of the power poles. Transformers were in fair to good condition and no leaking electrical transformers were observed. All the roads are two lane except for Airline Drive which is four lane with landscaped medians and Hardwicke which is four lanes near Airline Drive. Drainage ditches extend along the northern boundary of the Subject Right-of-Way eastward from Imperial Valley Drive and southward at the eastern dead end of Casa Grande Drive and La Jolla Lane (refer to Photograph 2 in Appendix B). Outside but within 500 feet of the Subject Right-of-Way, Lillja Road, Hummingbird Lane and Gillespie (west of north end of Airline) are two lane asphalt roads with ditches.

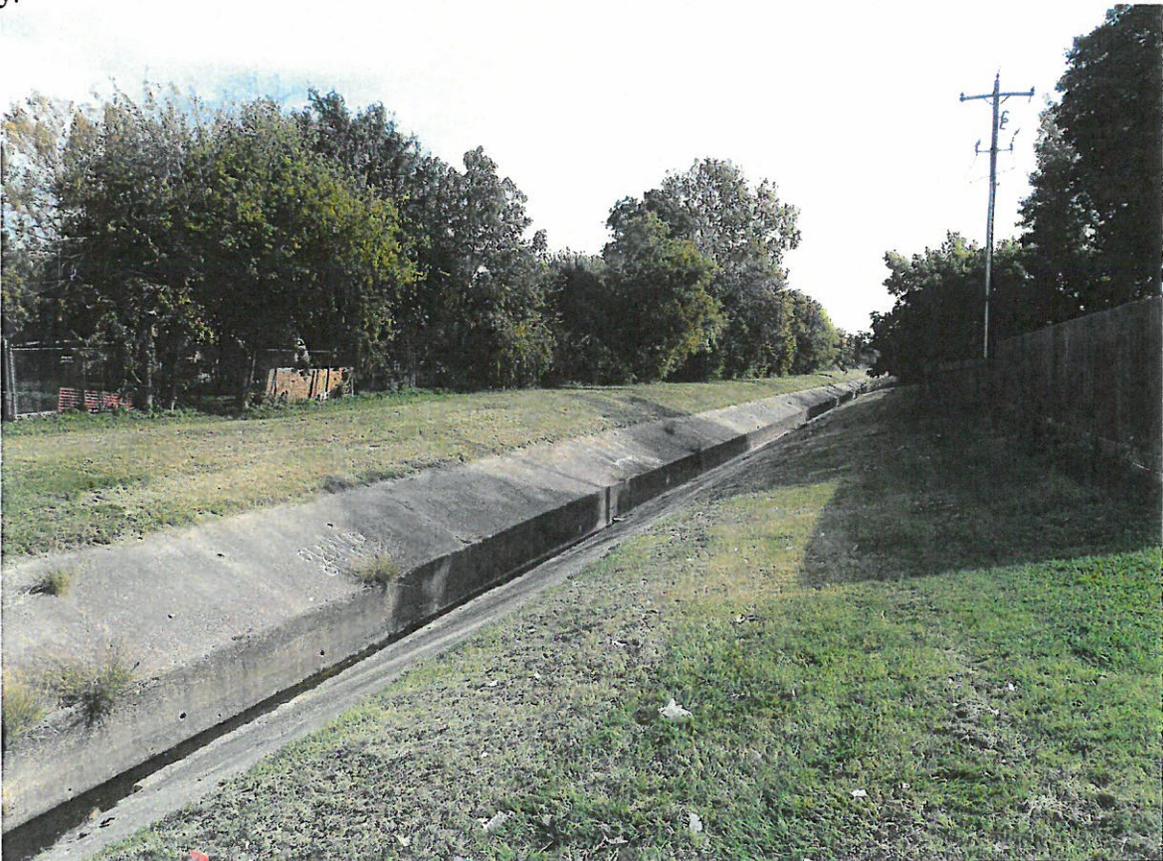
Photograph 2: View to the northeast of drainage ditch at the northern end of Imperial Valley Drive.

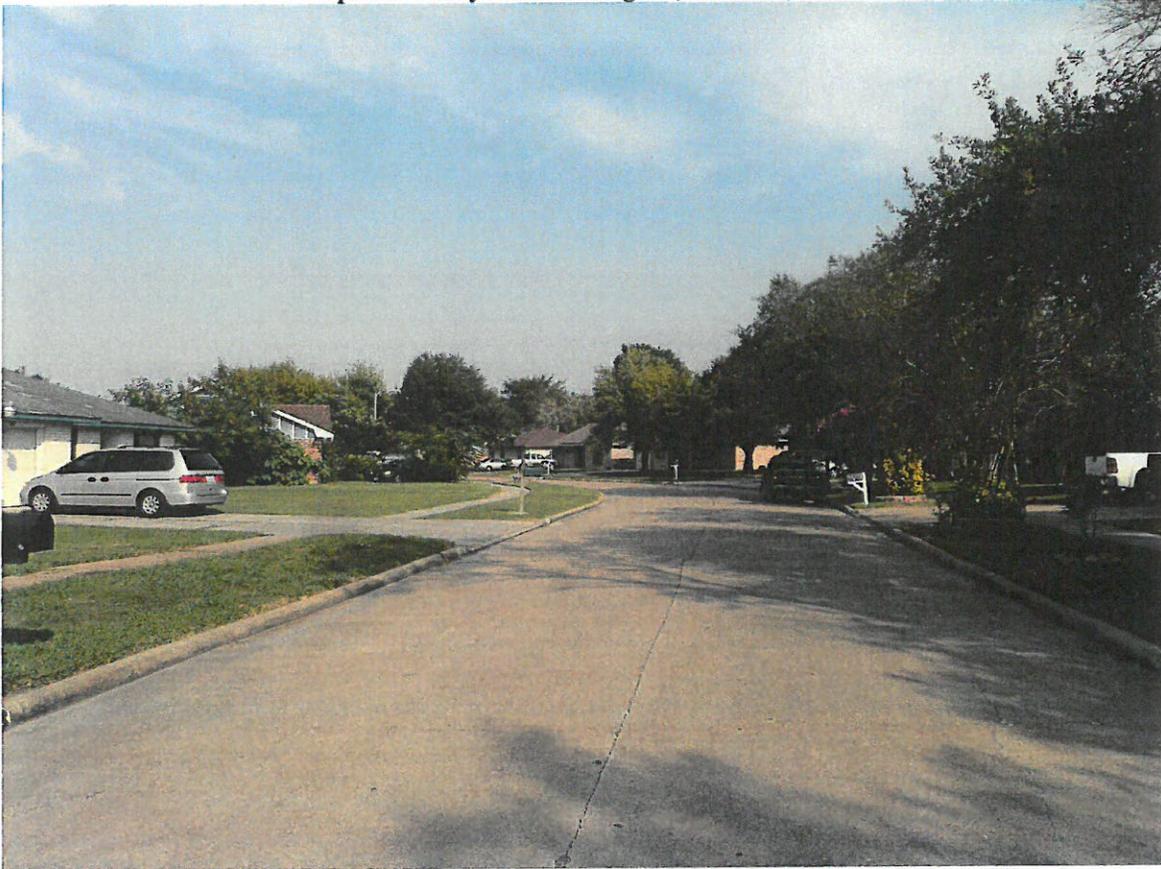
Photograph 3: View of typical residential area in the Subject Right-of-Way (location is along Merritt Lane).

Properties adjoining or surrounding the Subject Right-of-Way are primarily limited to residential land use with single- and multi-family dwellings, a few churches and a few undeveloped residential properties (refer to Photographs 3 and 4 in Appendix B), except for the following (the numbers correspond to the numbers on Figure 3 in Appendix A):

Properties adjoining or surrounding the Subject Right-of-Way are primarily limited to residential land use with single- and multi-family dwellings, a few churches and few undeveloped residential properties (refer to Photographs 3 and 4 in Appendix B), except for the following (the numbers correspond to the numbers on Figure 3 in Appendix A):

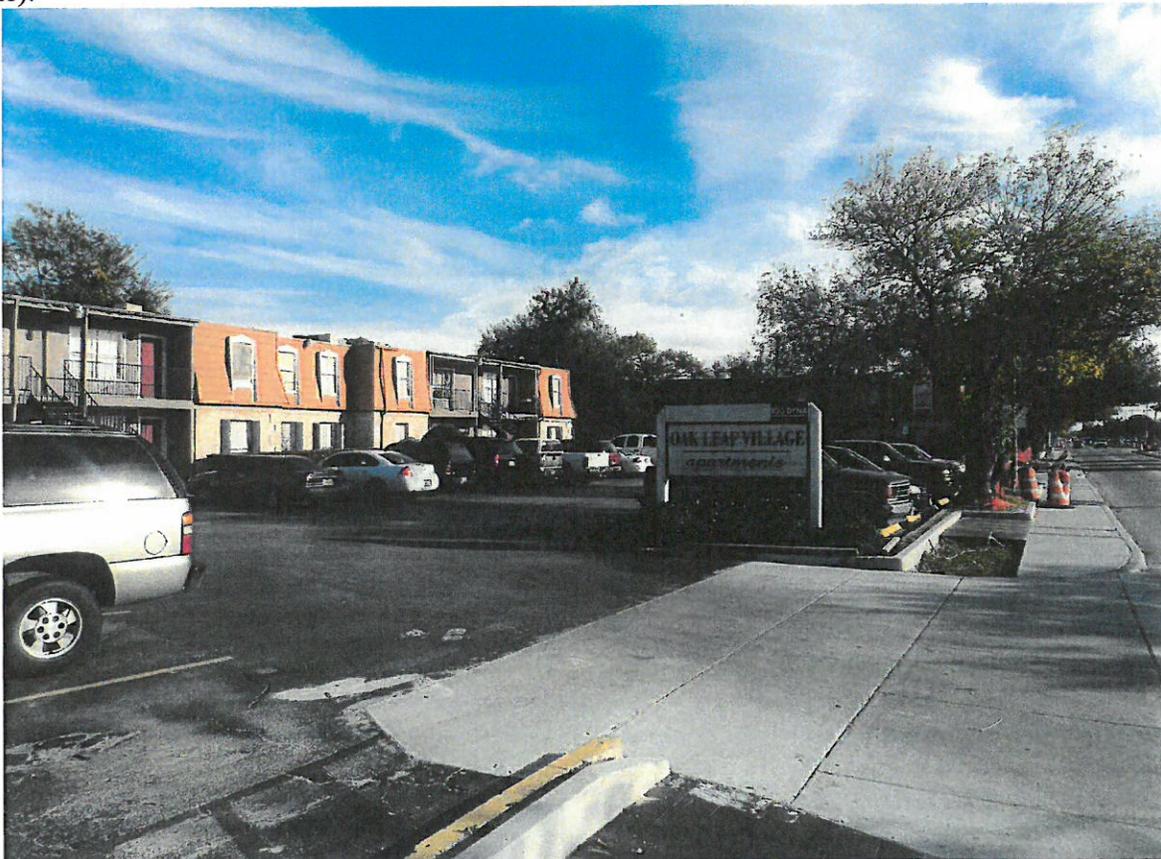
Photograph 4: View of a typical apartment complex along Subject Right-of-Way. Location is Oak Leave Village Apartments along Airline Drive.

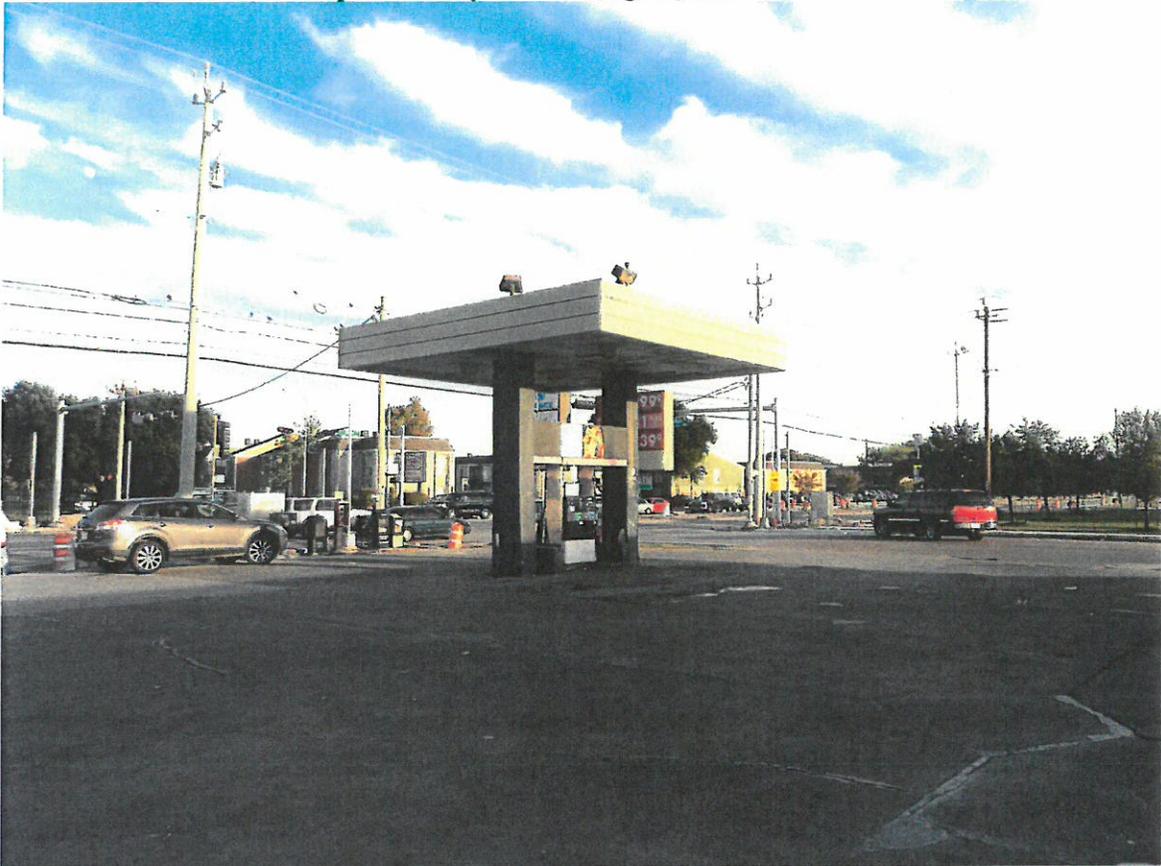
Photograph 5: View to the southeast of the dispenser island at N-1 Airline Food Store at 11703 Airline Drive. This is a closed leaking petroleum storage tank (LPST) site and a recognized environmental condition (refer to Property 19, Section 3.3).

This report was prepared to document the Phase I ESA investigation and results. The following recognized environmental condition was identified: **Leaking Petroleum Storage Tank and associated plugged monitor wells at the N-1 Airline Food Store at 11703 Airline Drive.** It is recommended that a Phase II ESA (ESA-II) be conducted in the Subject Right-of-Way with three soil borings drilled to 5 feet below the maximum depth of construction in front of the N-1 Airline Food Store at 11703 Airline Drive. A soil sample should be collected from each boring. If groundwater is encountered, a temporary well should be installed in one of the recommended borings and a groundwater sample should be collected. The soil samples and the groundwater

5. N 1 Airline Food Store 11703 Airline Dr.	NOV: failure to maintain Stage II vapor recovery system in proper operating condition. Petroleum Storage Tank (PST): Two 8,000 gallon gasoline steel tanks and piping installed in 1972 and one 10,000 gallon gasoline tank of unknown material and steel piping installed in 1972 are located at the site. Facility Registry System (FRSTX): Registry identifies facility as registered under TX-TCEQ ACR. Leaking Petroleum Storage Tank (LPST): A release reported in 1997 impacted groundwater.

Radius Report Map ID No. and Site Name & Location	Database Summary
	<p>The TCEQ closed the case. A closure letter was issued by the TCEQ on December 29, 1999. AEC performed an on line search of the TCEQ LPST Database and the resulting information is included in Appendix C. AEC also reviewed records for this site at the Texas Commissions on Environmental Quality (TCEQ) district office in Houston. Copies of the pertinent records reviewed are in Appendix C. A known environmental condition.</p>
<p>6. Beltway Printing 11832 Airline Dr. The facility is no longer at this address.</p>	<p>IHW: Inactive conditionally exempt small quantity generator. Registration inactivated because facility was registered prior to 1994 and no waste activity was reported in 1994 through 1996. Not a suspect or known environmental condition.</p>
<p>7. Houston Facility/W T Byler 15203 Lillja Road.</p>	<p>PST: Two unknown sized diesel steel tanks and piping, one unknown sized gasoline fiberglass reinforced plastic tank with steel piping installed in 1978 and one unknown sized diesel steel tank and piping installed in 1980 were removed from the ground in 1992. One unknown sized aviation gasoline and one unknown sized diesel above-ground storage tanks were installed in 1999. IHW: Company is a waste transporter. No other useful information reported.</p> <p>A suspect or known environmental condition due to the above ground storage tanks at the site.</p>

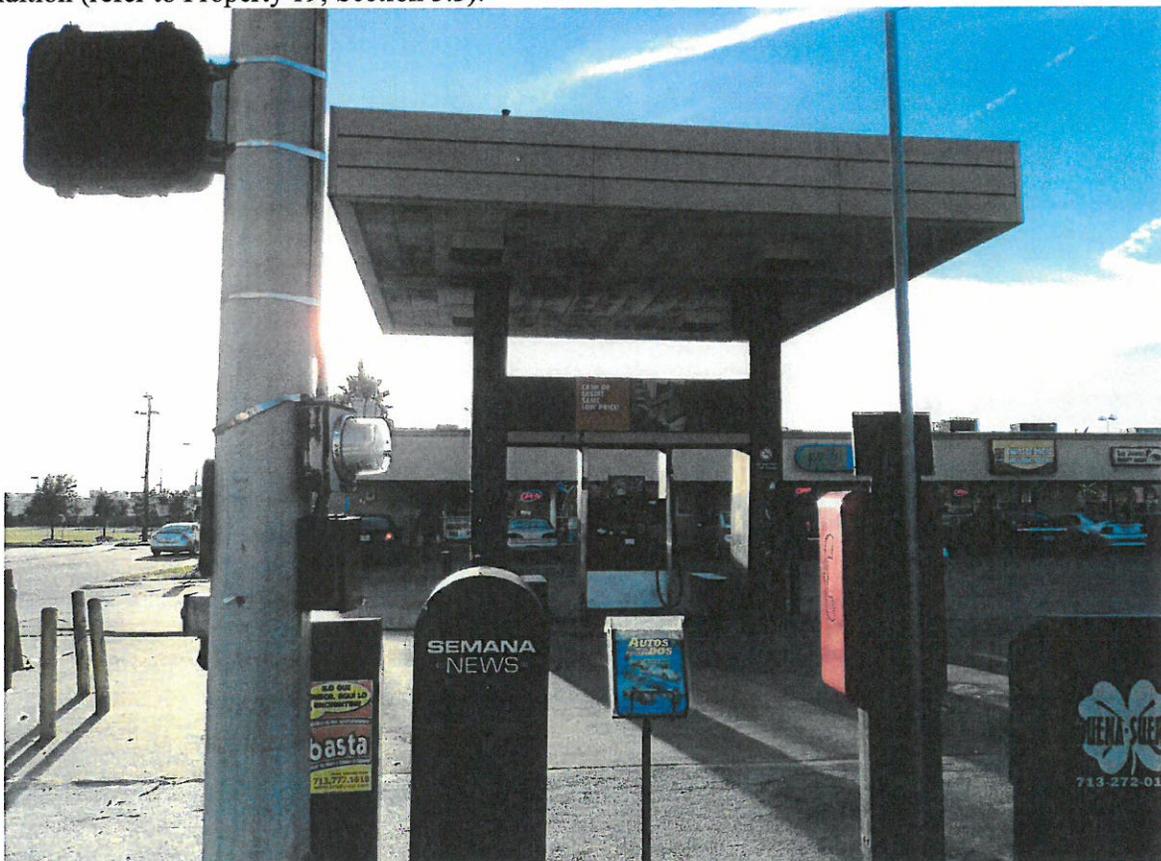
Photograph 6: View to west of the N-1 Airline Food Store facility at 11703 Airline Drive.

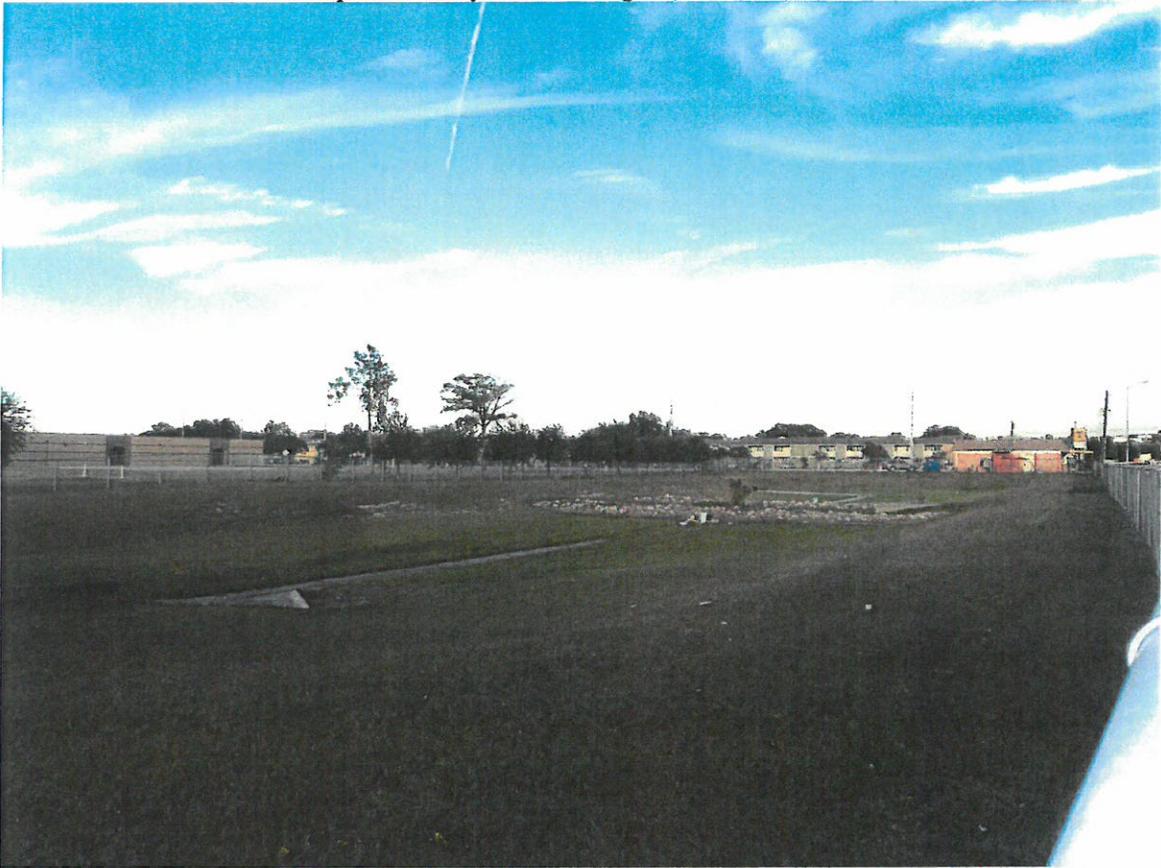
Photograph 7: View to the northeast from West Dyna Drive of detention pond site (refer to Property 22, Section 3.3).

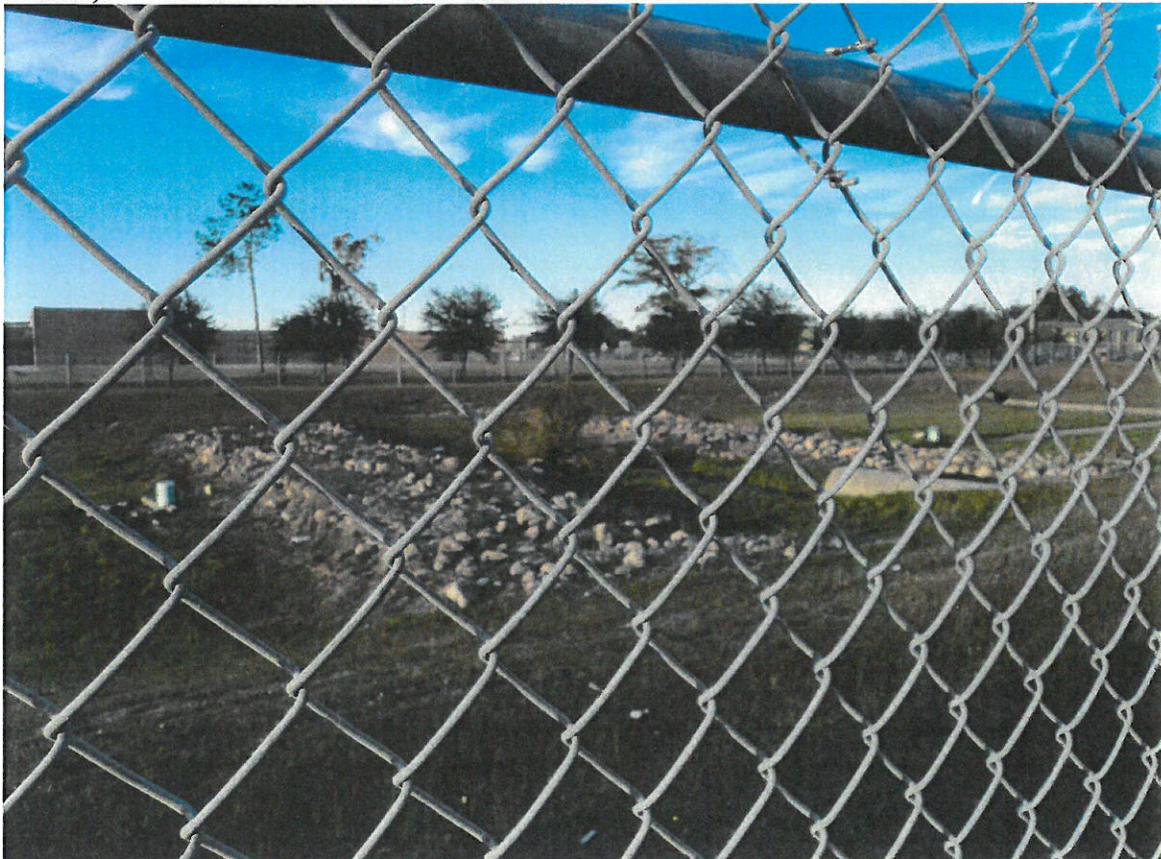
Photograph 8: Close-up view to the northeast of the stone "platforms" in the detention pond.

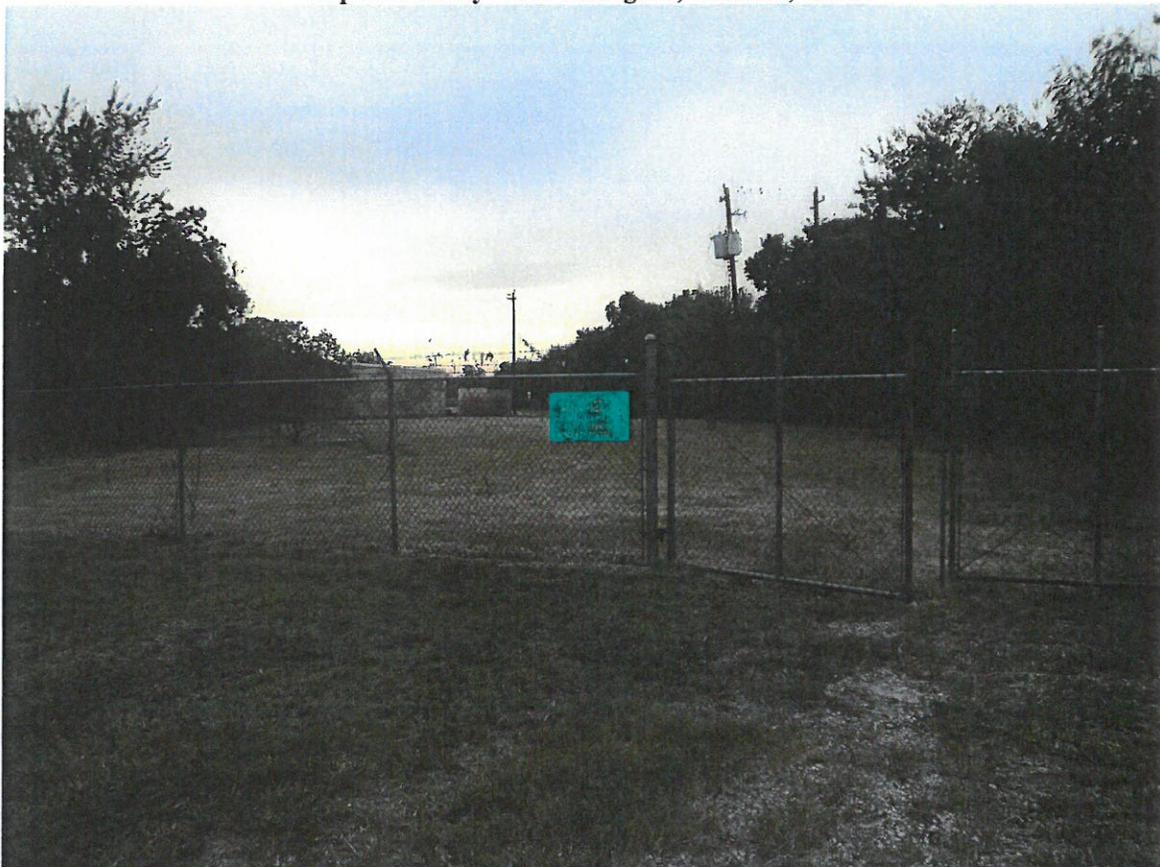
Photograph 9: View to the northwest of the City of Houston property at 239 Glazebrook Drive where two water wells and a water plant were once located (refer to Property 28, Section 3.3).

Radius Report Map ID No. and Site Name & Location	Database Summary
1. City of Houston PWE Water Plant Groundwater West Road Plant 239 Glazebrook. The plant and associated wells have been removed from this site.	Tier II Chemical Reporting Program Facilities (Tier II): 900 pounds of chlorine located at this plant. This facility passes all validation checks. Not a suspect or known environmental condition.

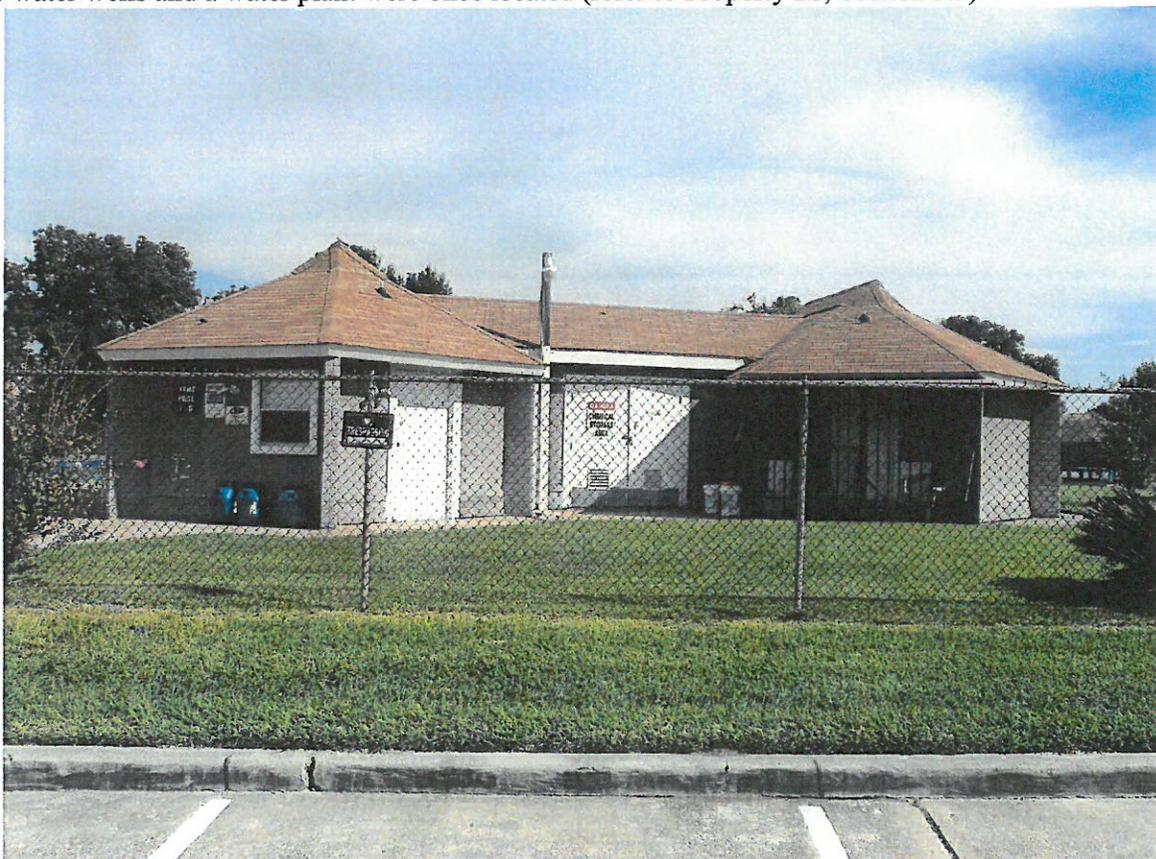
Photograph 10: View to the northeast of building with chemical storage area at unnamed park at 15500 Old Creek Road (refer to Property 30, Section 3.3).

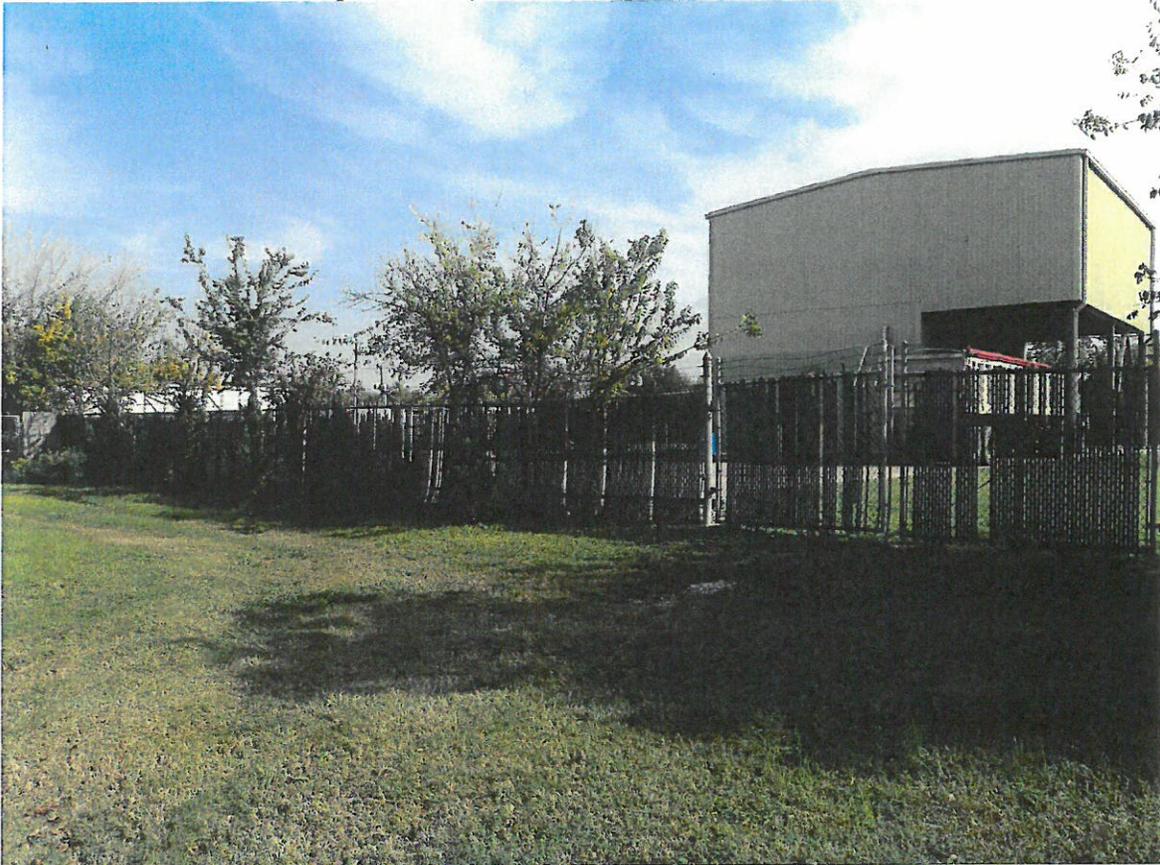
Photograph 11: View to the east northeast from La Fonda Drive of sludge loading area of the Imperial Valley Waste Water Treatment Plant at 15500 Cotillion Road (refer to Property 31, Section 3.3).

2. City of Houston PWE WW OPS Waste Water Treatment Plant Imperial Valley 15500 Cotillion.	Tier II: Sodium bisulfite solution and sodium hypochlorite solution used at this site. This facility passed all validation. Emergency Response Notification System (ERNSTX): 5,000 gallons of sodium hypochlorite was released from four leaks in a bleach containment structure. Release went into secondary containment area and the material was put back into the original tank once the tank was repaired. Facility Registry System (FRSTX): Registry indicates Standard Industrial Classification (SIC) as 4952-Sewerage Systems and identifies facility as registered under Integrated Compliance Information System (ICIS). This is a suspect environmental condition due to the sodium bisulfite solution and sodium hypochlorite solution used at this site.

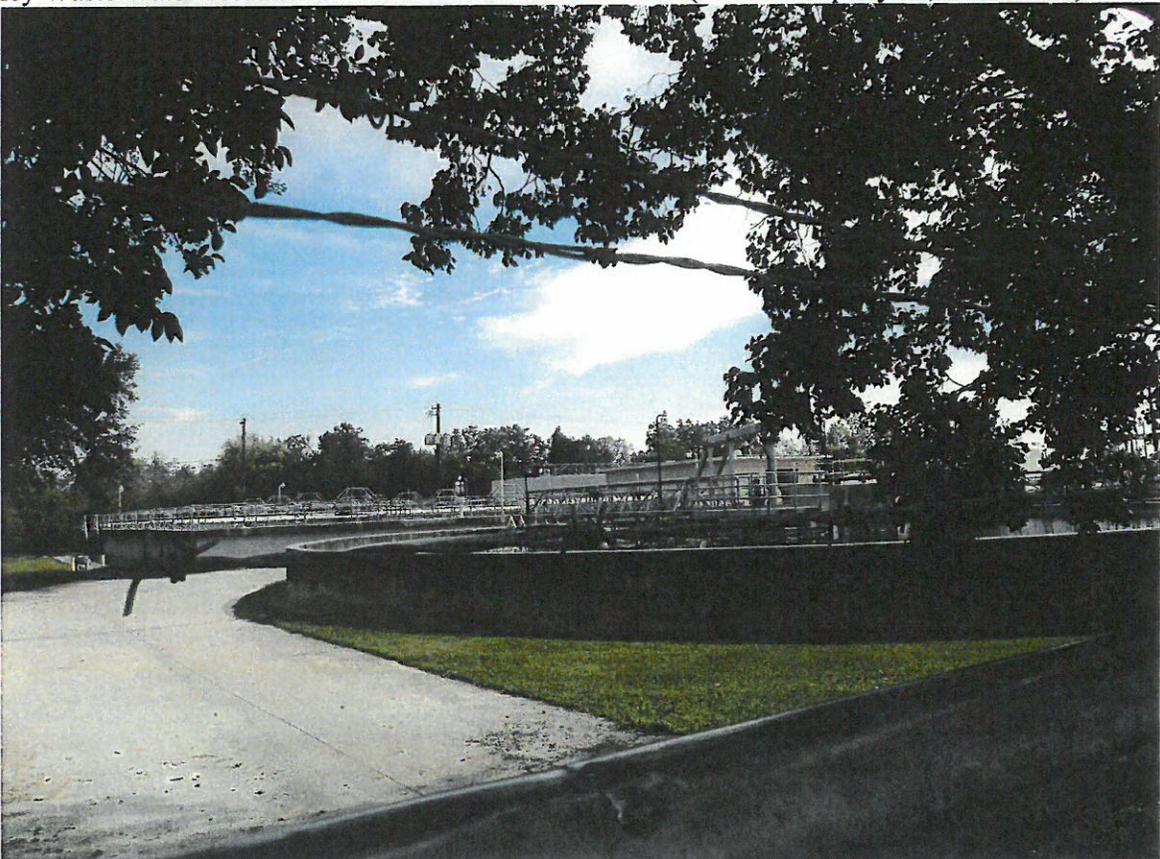
Photograph 12: View to the southeast from the entrance of the Imperial Valley Waste Water Treatment Plant at 15500 Cotillion Road.

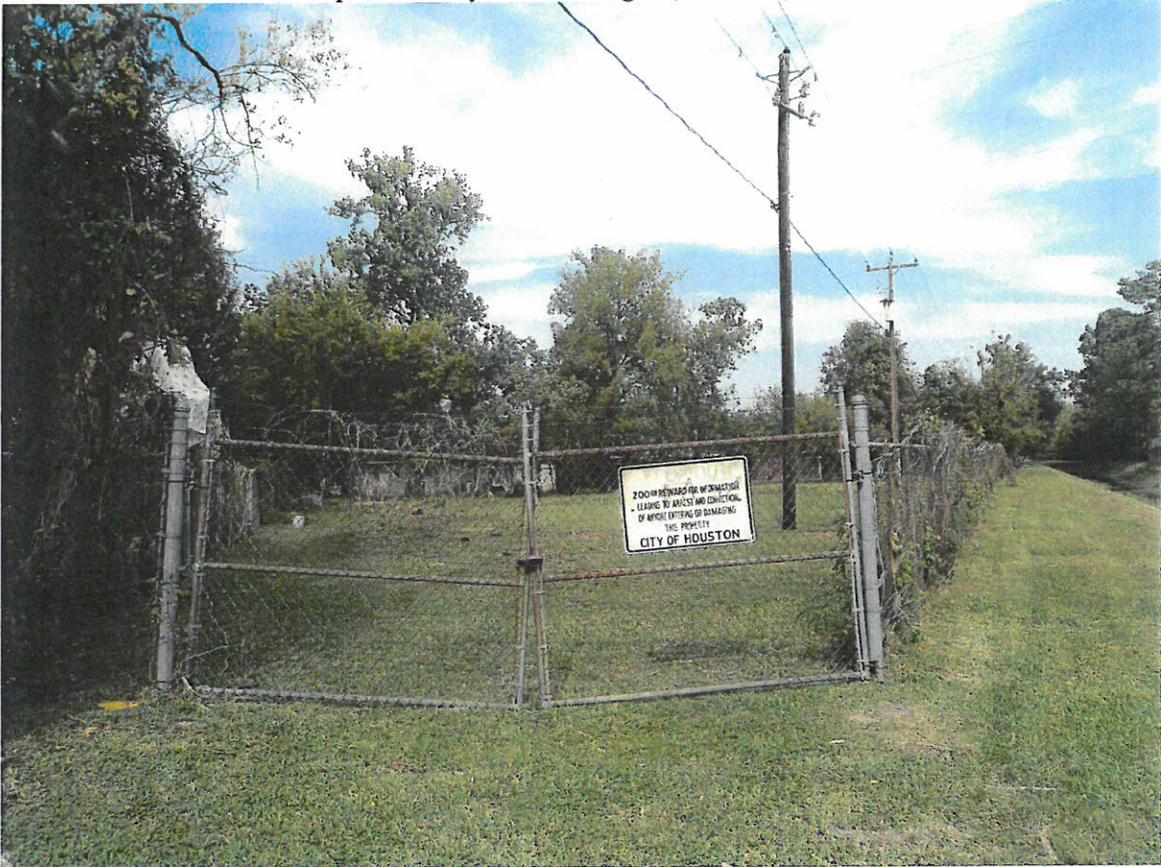
Photograph 13: View to the north of the vacant City of Houston property located just north of the eastern dead end of La Jolla Lane (refer to Property 32, Section 3.3).

property (refer to Photograph 13 in Appendix B). The transformer was in good condition and did not appear to be leaking.

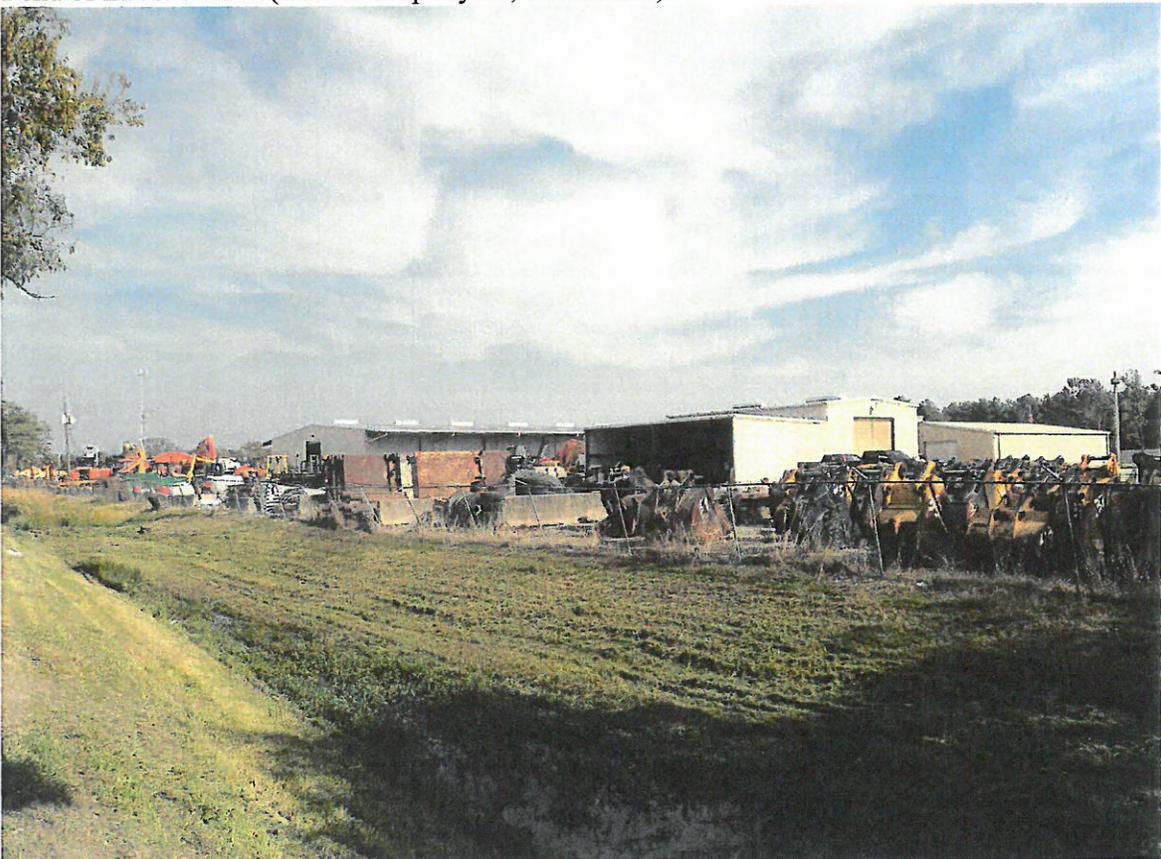
Photograph 14: View to the northeast from the dead end of La Jolla Lane of a portion of the WT Byler facility at 15203 Lillja Road (refer to Property 32, Section 3.3).

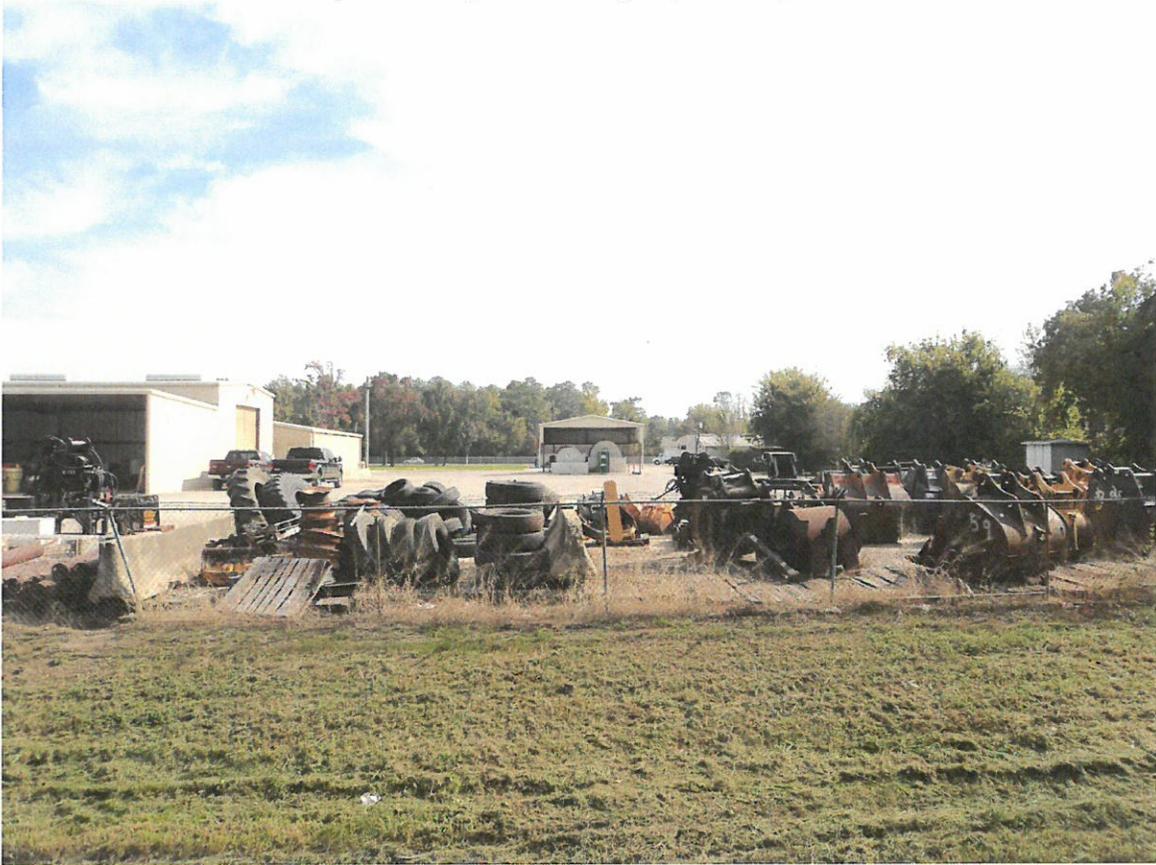
Photograph 15: View to the east of part of the WT Byler facility. Note the large above ground storage tanks (ASTs) in the center of the background of the photograph.

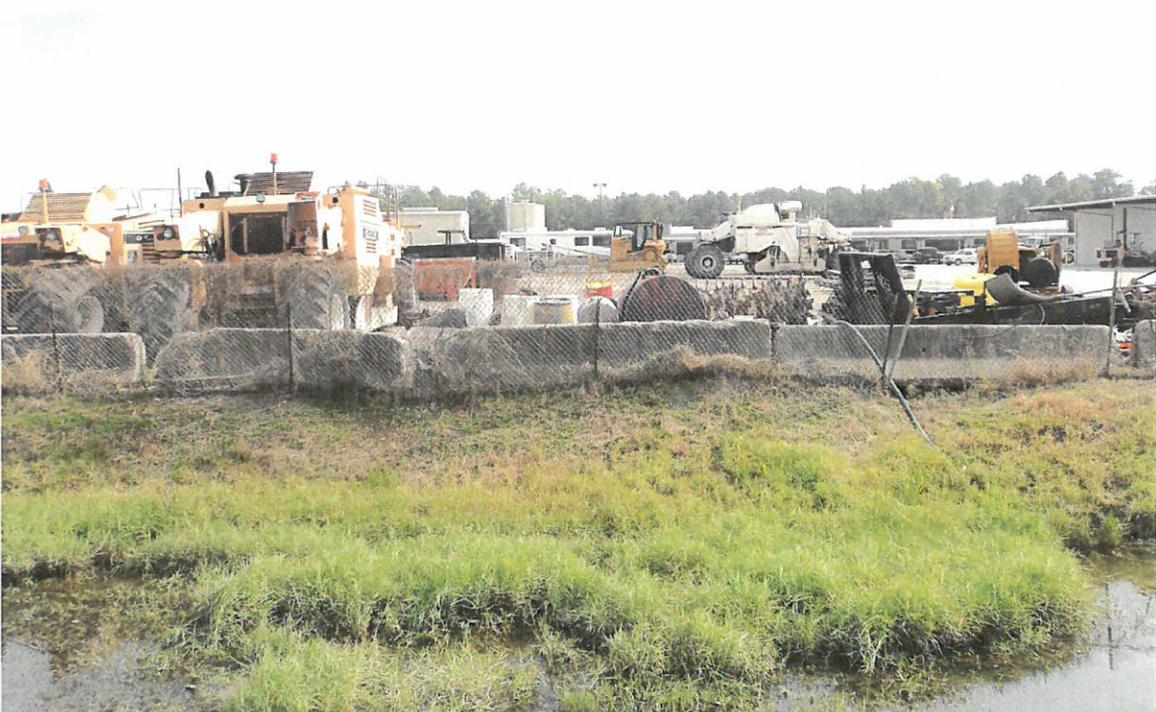
Photograph 16: View to the east of an AST with fuel pump and 55-gallon drums against the concrete barrier at the WT Byler facility.

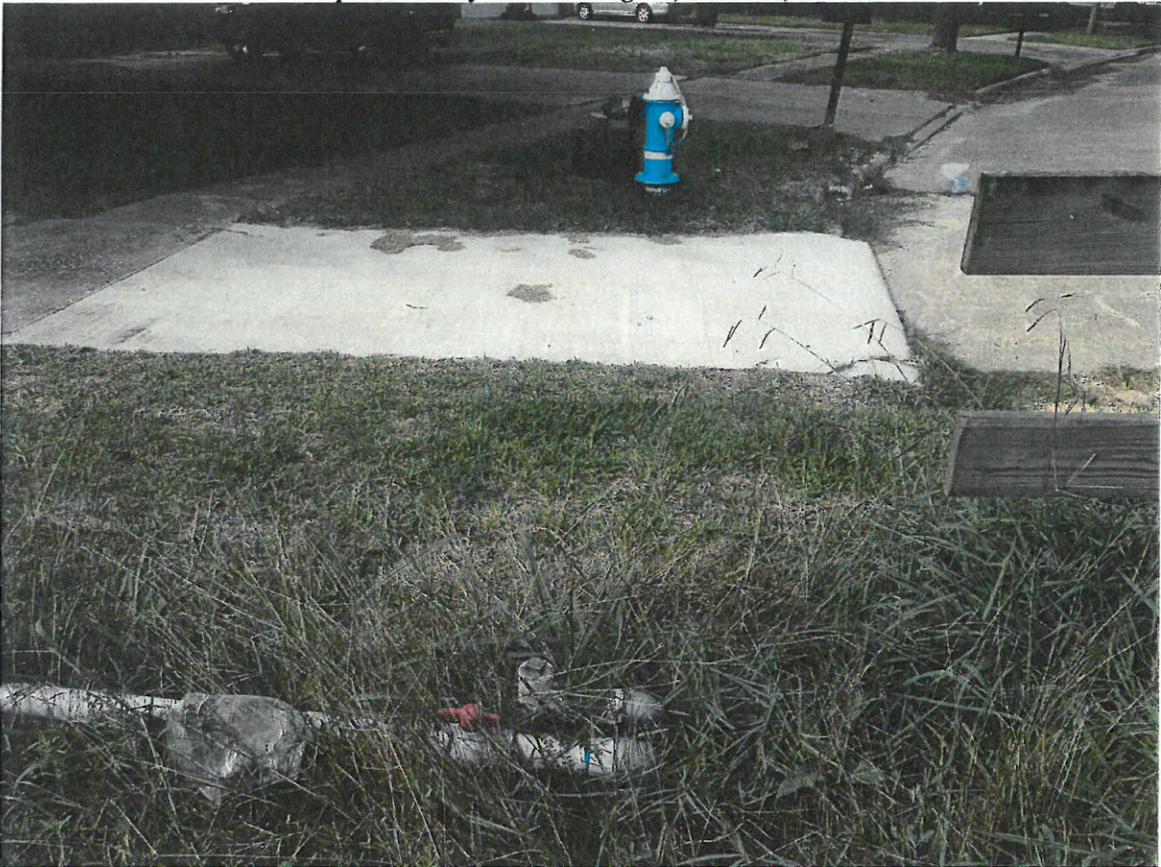
Photograph 17: View to the northwest of an above ground pipeline at the eastern dead end of La Jolla Lane (refer to Property 36, Section 3.3). The function of this pipeline is unknown.

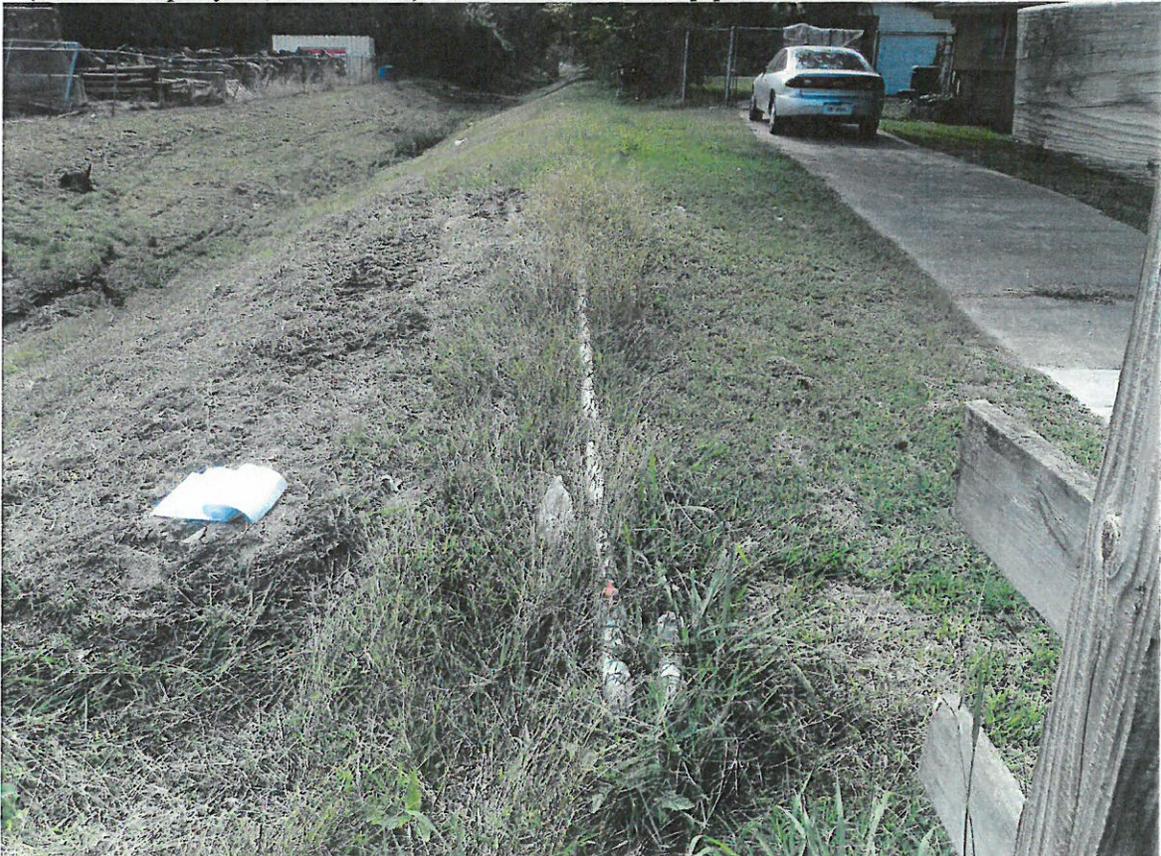
Photograph 18: View to the south of the ditch and above ground pipeline at the eastern dead end of La Jolla Lane.
