**PHASE II ENVIRONMENTAL SITE ASSESSMENT
MINNETEX AREA
AND ALMEDA GENOA PLACE
DRAINAGE AND PAVING IMPROVEMENTS
WBS NO. M-000289-0002-3
HOUSTON, TEXAS**

REPORT NO. 1130019801

**Reference: Phase II Environmental Site Assessment (ESA)
Minnetex Area and Almeda Genoa Place
Drainage and Paving Improvements
WBS No. M-000289-0002-3
Houston, Texas**

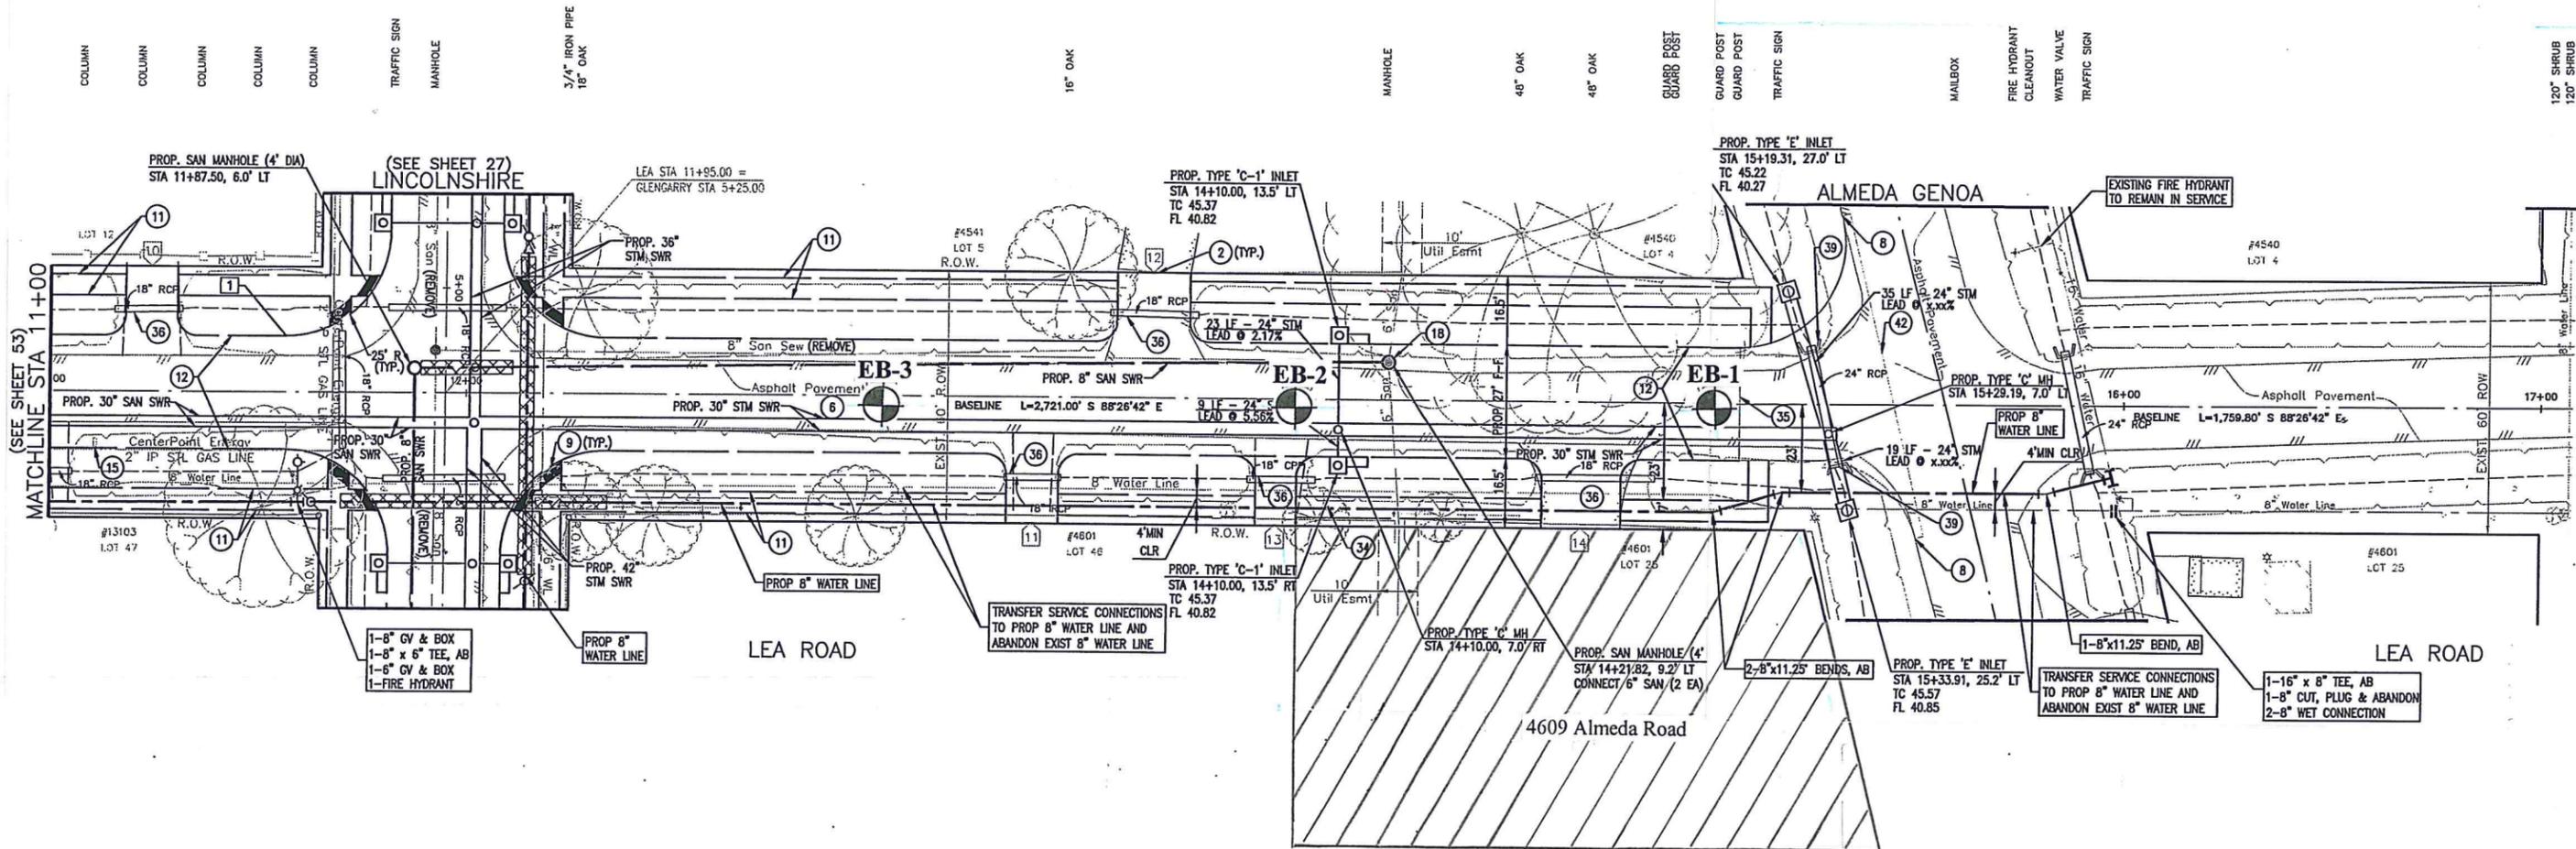
FIGURE 2

Legend	Geotest Engineering, Inc	1130019801
Boring REC	PHASE II ENVIRONMENTAL SITE ASSESSMENT MINNETEX AREA AND ALMEDA GENOA PLACE DRAINAGE AND PAVING IMPROVEMENTS WBS NO. M-000289-0002-3 HOUSTON, TEXAS PLAN OF BORINGS 0 20 40 60 80 SCALE IN FEET

The field investigation included drilling and continuously sampling of three (3) environmental borings (designated as EB-1 through EB-3) along the proposed Minnetex Area and Almeda Genoa Place Drainage and Paving Improvements alignment at the Historic Auto Station site for this study. All the boring locations including the Historic Auto Station site are shown in Plan of Borings, Figure 2.
