**PHASE II ENVIRONMENTAL SITE ASSESSMENT
LIFT STATION RENEWAL/ REPLACEMENT
GALLERIA AREA LIFT STATIONS
WBS NO. S-000267-0109-3
HOUSTON, TEXAS**

REPORT NO. 1130018301, dated July 23, 2014

**Reference: Phase II Environmental Site Assessment (ESA)
Lift Station Renewal/Replacement
Galleria Area Lift Stations
WBS NO. S-000267-0109-3
Houston, Texas**

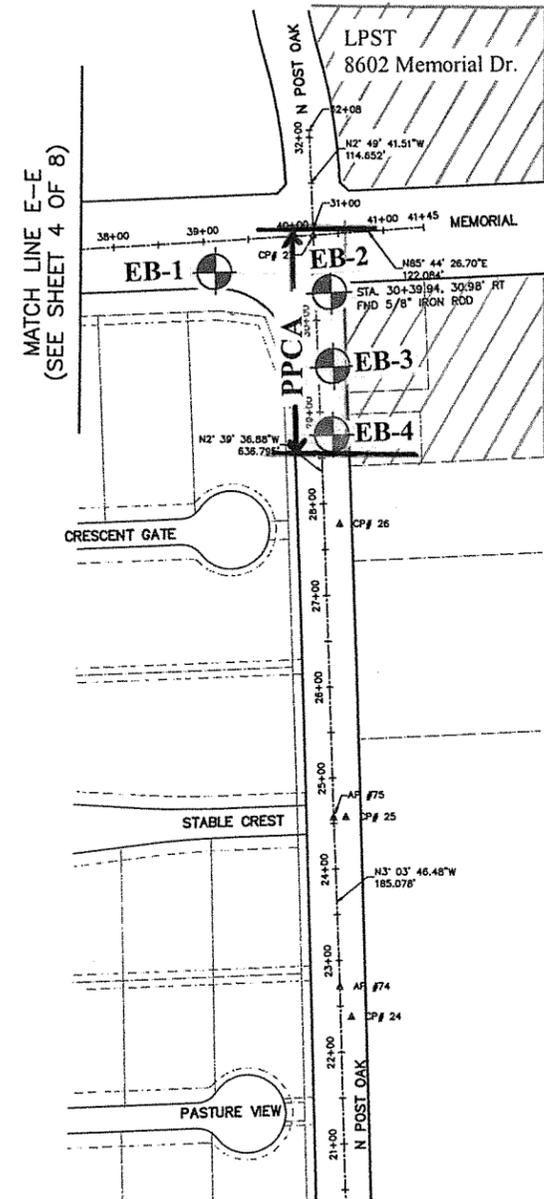
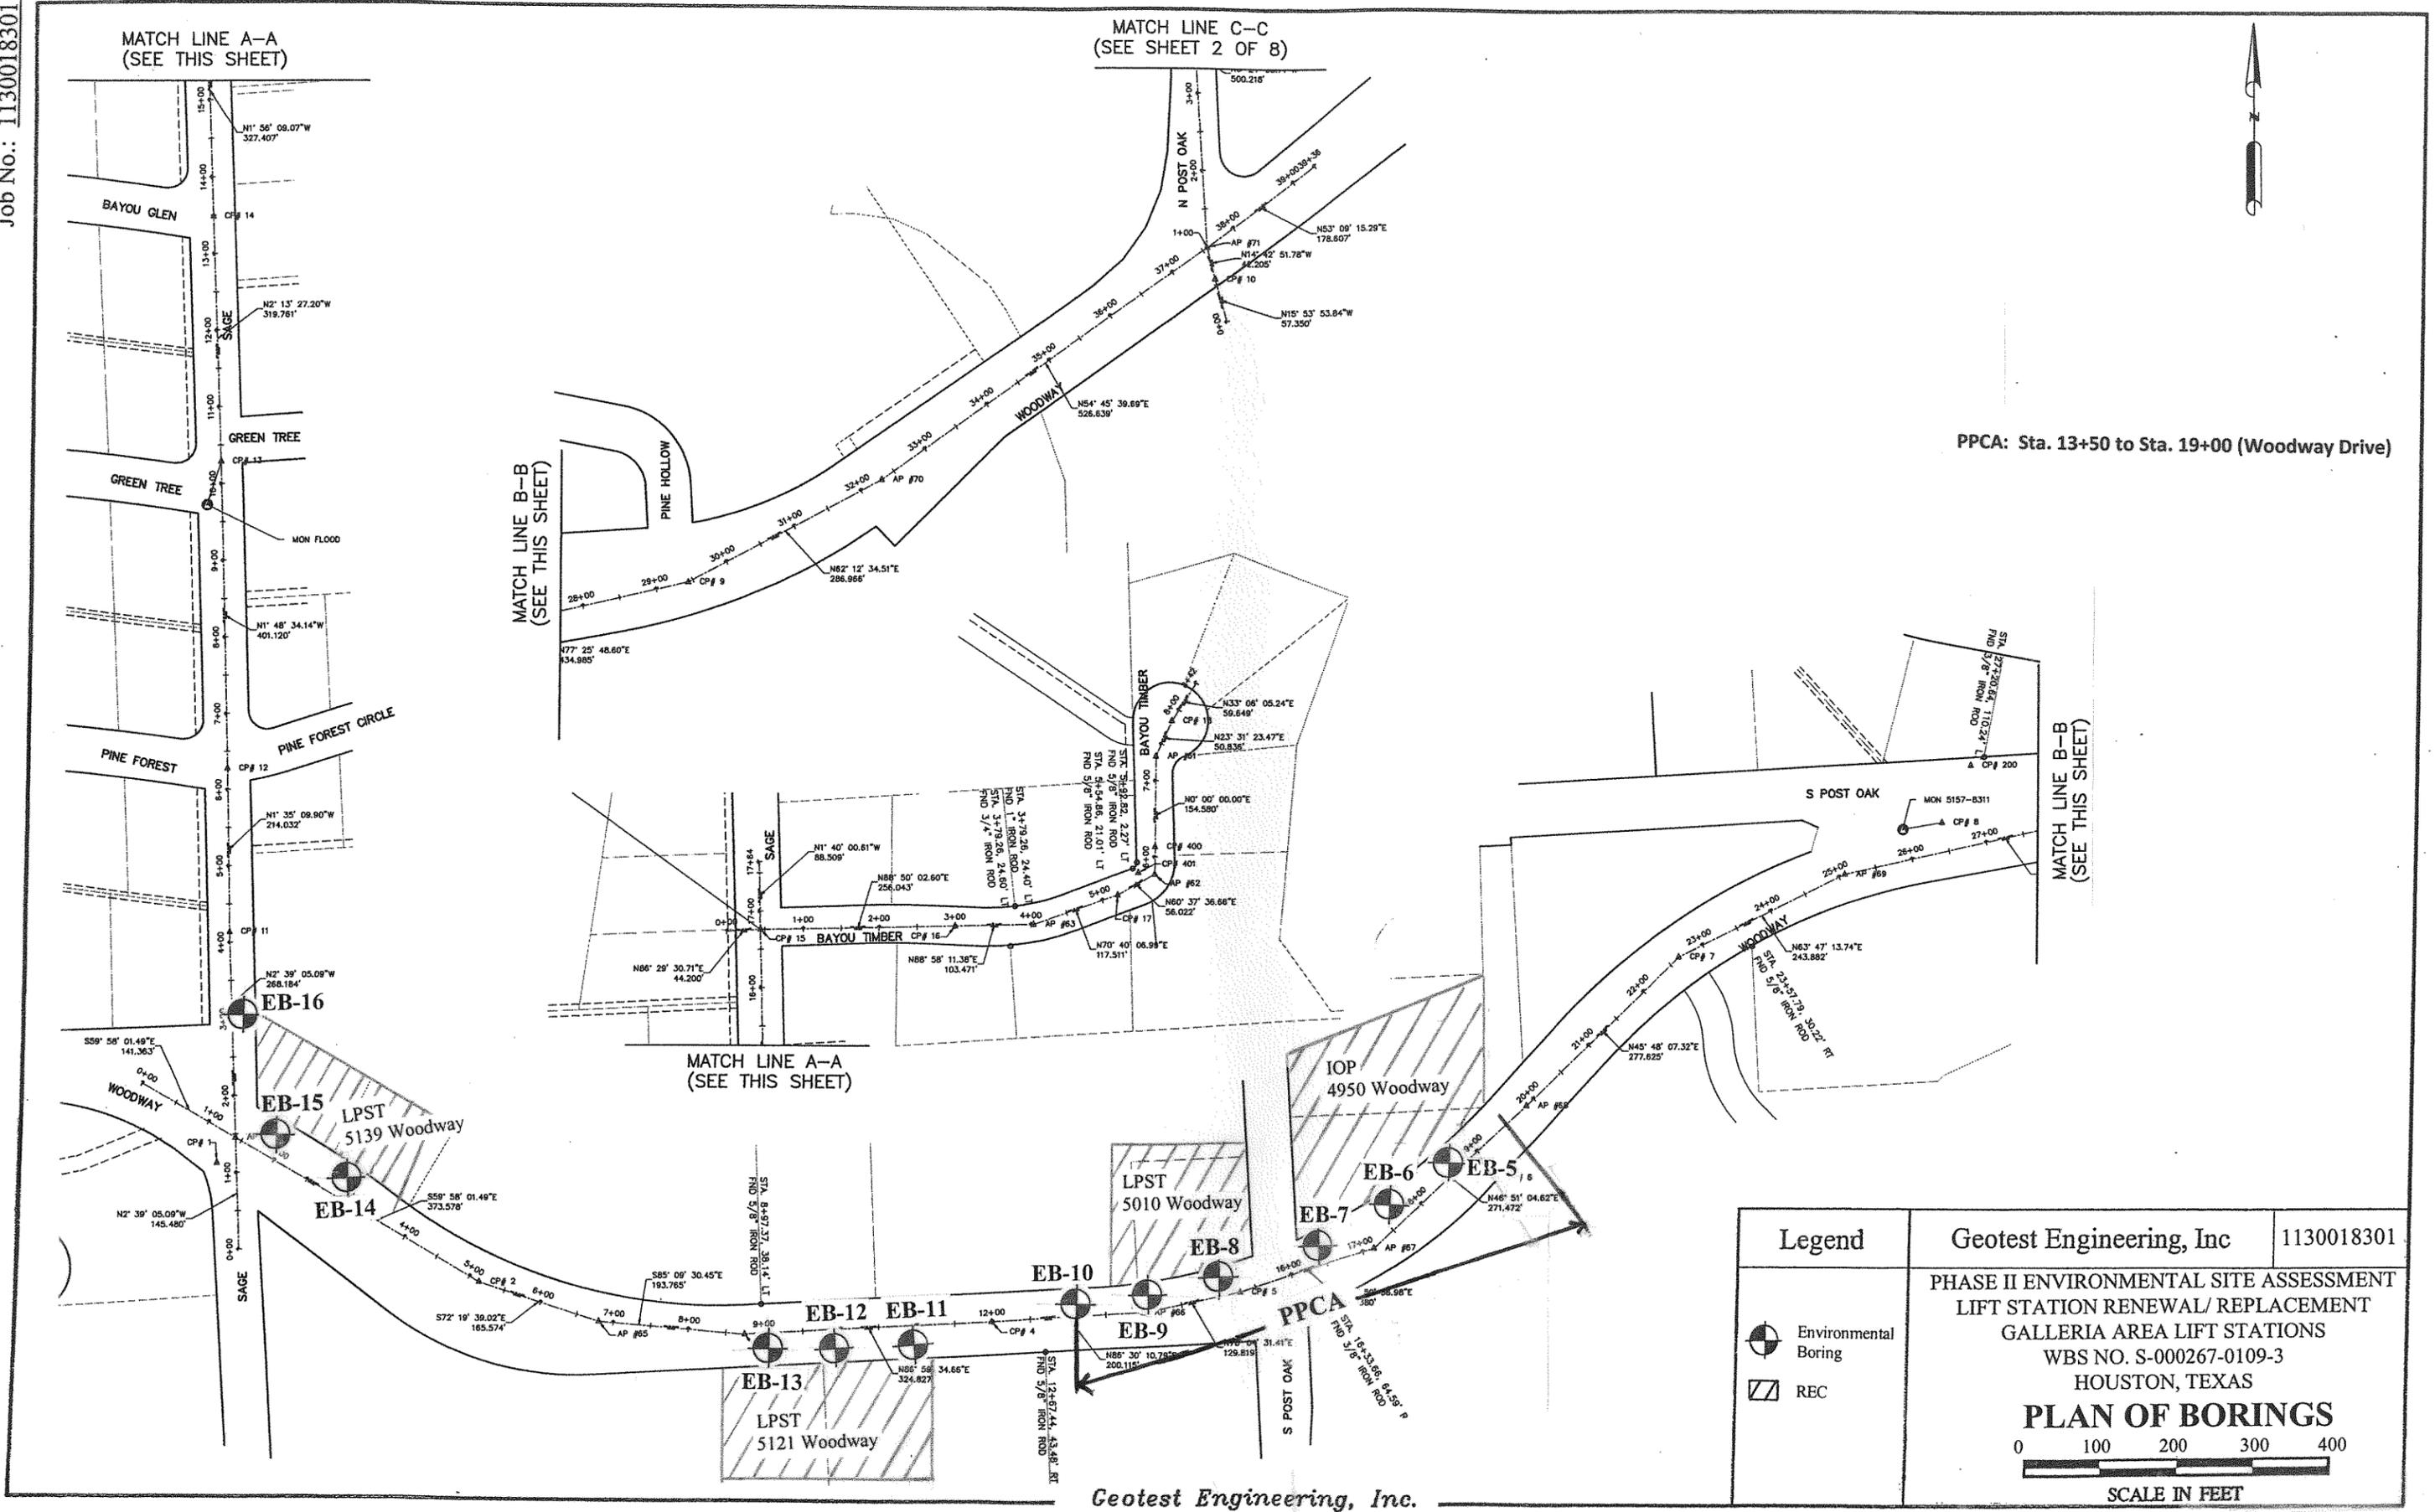
FIGURE 2.1

Legend Environmental Boring REC	Geotest Engineering, Inc 1130018301
	PHASE II ENVIRONMENTAL SITE ASSESSMENT LIFT STATION RENEWAL/ REPLACEMENT GALLERIA AREA LIFT STATIONS WBS NO. S-000267-0109-3 HOUSTON, TEXAS PLAN OF BORINGS 0 100 200 300 400 SCALE IN FEET
