**FINAL REPORT
LIMITED PHASE II
ENVIRONMENTAL SITE ASSESSMENT
FOR WATER LINE REPLACEMENT IN
GESSNER AREA PROJECT, HOUSTON, TEXAS
CITY OF HOUSTON WBS No. S-000035-0154-04**

**Prepared by
AVILES ENGINEERING CORPORATION
5790 Windfern
Houston, Texas 77041
Phone: 713-895-7645
Fax: 713-895-7943**

AEC Project No. E102-14

April 08, 2014

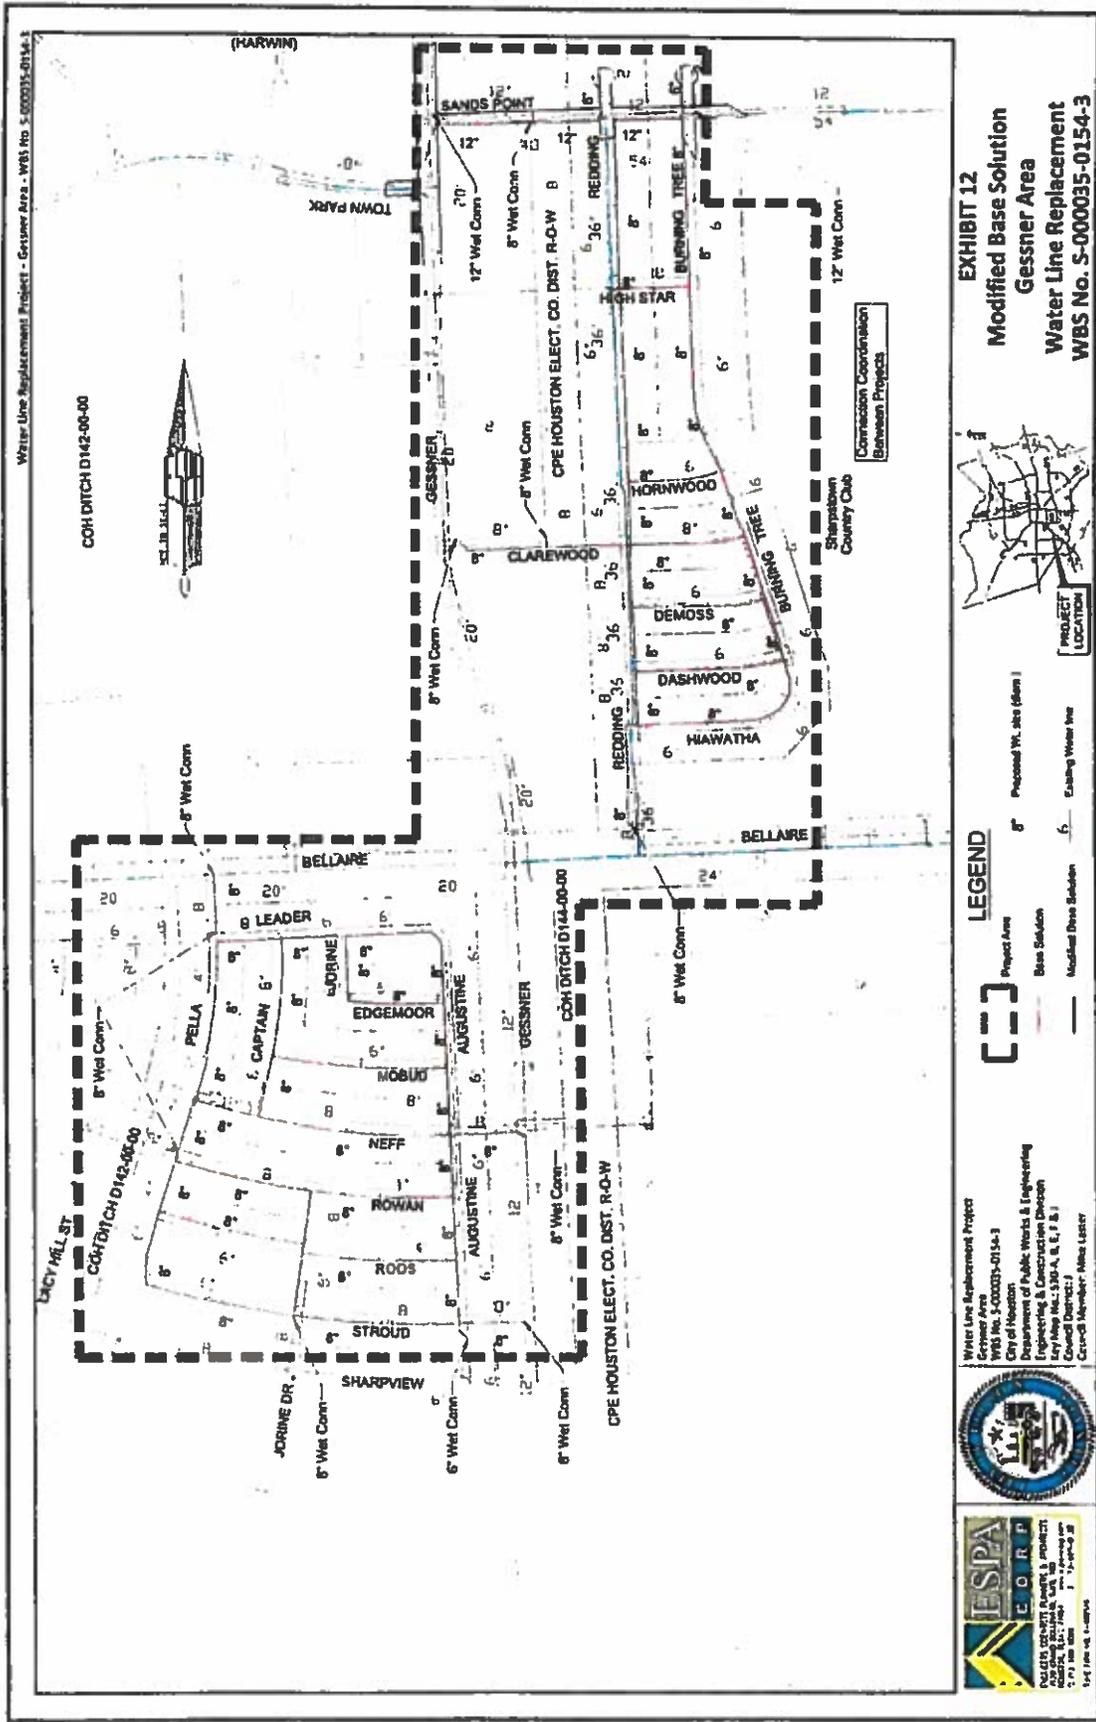
FIGURE 1

The City of Houston plans to replace approximately 27,780 feet of water lines in existing City of Houston street rights-of-way (referred to herein as the Subject Right-of-Way). The Subject Right-of-Way (refer to Figure 1 in Appendix A) is located in a general Project Area bounded by Sands Point Drive on the north, Stroud Drive on the south, Burning Tree Drive on the east, and the City of Houston Ditch 142-00-00 just west of Pella Street on the west. The general Project Area adjoins to the northeast and southwest of the Gessner Road and Bellaire Boulevard intersection in southwest Houston, Texas. Aviles Engineering Corporation (AEC) performed a Phase I Environmental Site Assessment (refer to ESA I report dated March 20, 2012) that identified the following recognized environmental conditions (RECs) in connection with the Subject Right-of-Way (refer to attached Figures 2 and 3 in Appendix A):

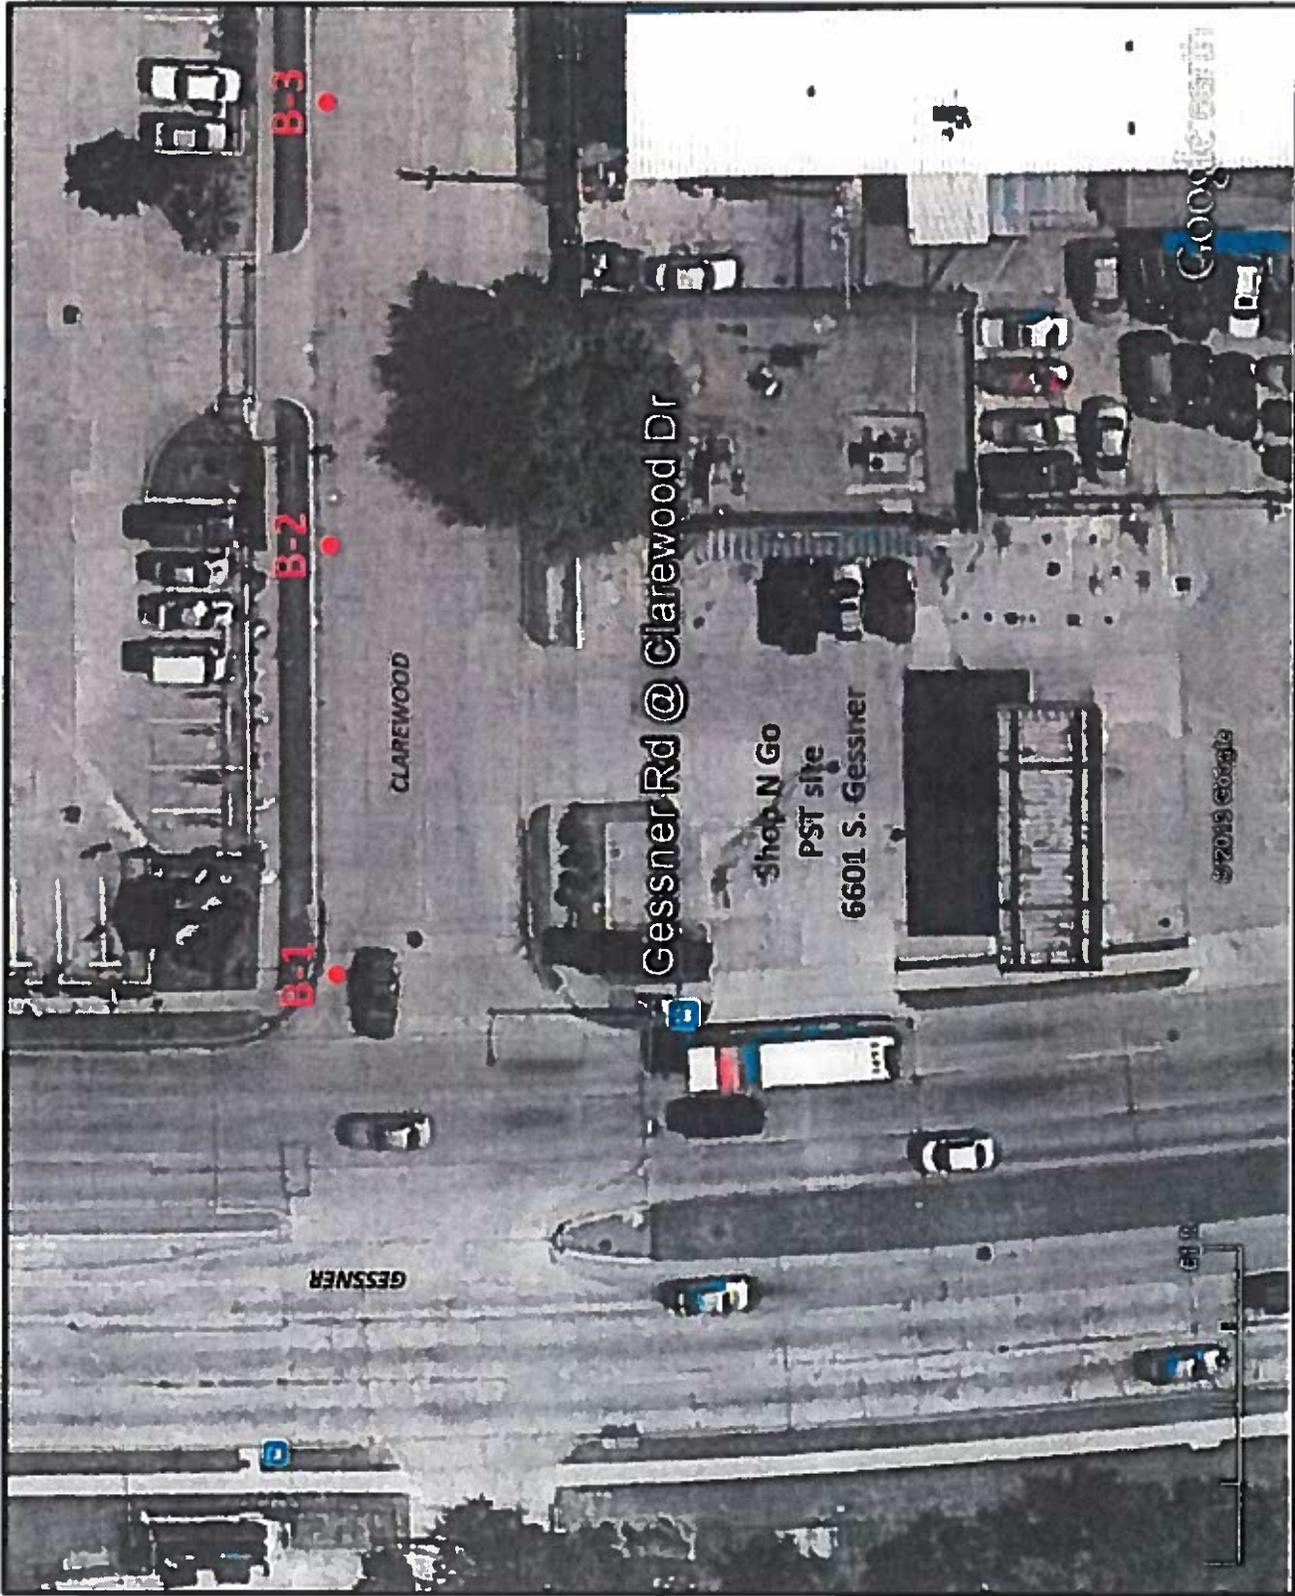
FIGURE 2

- Shop N Go operating gasoline filling station (petroleum storage tank, PST site) adjoining the Subject Right-of-Way at 6601 South Gessner (refer to Figure 2).
- Shell leaking petroleum storage tank (LPST) site and Shop N Go 2 PST site adjoining the Subject Right-of-Way at 8540 Bellaire Boulevard (refer to Figure 3).

- **B-1** was installed near the western boundary of the Shop N Go property (approximately Station 2+14, refer to Figure 2 in Appendix A and Photograph 1 in Appendix B).
- **B-2** was installed near the eastern side of the Shop N Go property, approximately 85 feet east of B-1 (approximately Station 3+00, refer to Figure 2 in Appendix A and Photograph 2 in Appendix B).
- **B-3** was installed approximately 80 feet east of B-2 (approximately Station 3+79, refer to Figure 2 in Appendix A and Photograph 3 in Appendix B).

Approximate Soil Boring Location: ●

REC 1: Three soil borings (B-1 through B-3) were installed in the Subject Right-of-Way to investigate contamination in the area of the Shop N Go gasoline filling station located at 6601 South Gessner. Each boring was extended to a depth of 15 feet below the pavement surface and a soil sample was collected from each boring. Groundwater was not encountered during drilling of these soil borings so a temporary well casing was not installed. No petroleum product odors were detected in the soil cores.

REC 1: The three soil samples collected from B-1 through B-3 were analyzed to determine the concentrations of benzene, toluene, ethylbenzene and total xylenes (collectively known as BTEX), methyl tertiary butyl ether (MTBE), and total petroleum hydrocarbons (TPH). The BTEX, MTBE, and TPH concentrations in each of the collected soil samples were less than their respective laboratory sample detection limits.

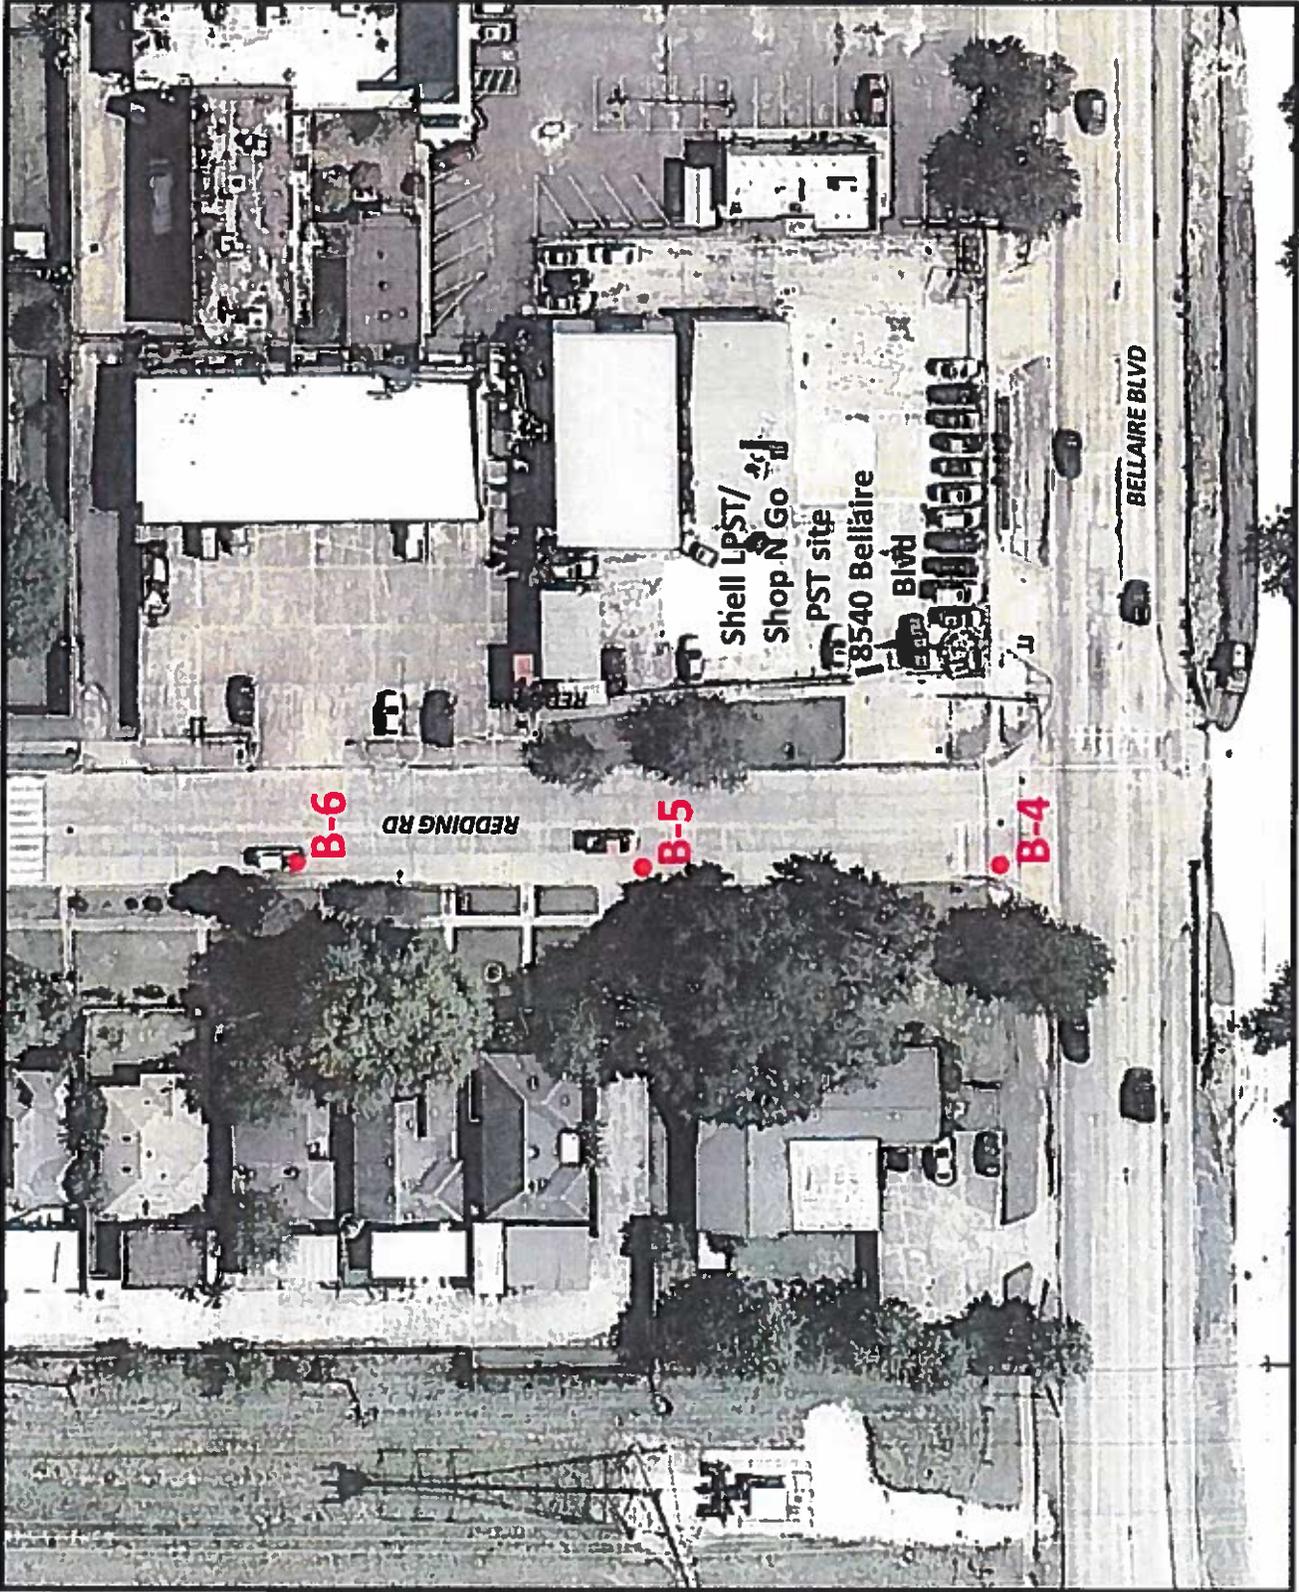
- **B-4** was installed near the southern boundary of the Shell property (approximately Station 2+65, refer to Figure 3 in Appendix A and Photograph 4 in Appendix B).
- **B-5** was installed near the northern boundary of the Shell property, approximately 105 feet north of B-4 (approximately Station 3+71, refer to Figure 3 in Appendix A and Photograph 5 in Appendix B). A temporary well casing was installed in B-5.
- **B-6** was installed approximately 100 feet north of B-5 (approximately Station 4+74, refer to Figure 3 in Appendix A and Photograph 6 in Appendix B).

Approximate Soil Boring Location: ●

REC 2: Three soil borings (B-4 through B-6) were installed in the Subject Right-of-Way to investigate contamination in the area of the Shell leaking petroleum storage tank (LPST) site and Shop N Go 2 petroleum storage tank (PST) site. Each boring was extended to a depth of 15 feet below the pavement surface and a soil sample was collected from each of the three borings for analysis. Damp zones indicating the possible presence of groundwater was present in borings B-4 and B-6, however, no groundwater had collected in either borehole at the end of drilling. Groundwater was encountered during the drilling of boring B-5. A temporary well casing was installed in B-5. A groundwater sample was collected for analysis however; the laboratory

REC 2: The three soil samples collected from B-4 through B-6 and the groundwater sample from B-5 were analyzed to determine the concentrations of BTEX, MTBE, and TPH. The BTEX, MTBE, and TPH concentrations in each of the soil samples were less than their respective laboratory sample detection limits. The BTEX and MTBE concentrations in the groundwater sample were also below respective laboratory sample detection limits. TPH testing was performed but the accuracy was not low enough to compare to the Texas Commission on Environmental Quality (TCEQ) Texas Risk Reduction Program (TRRP) Tier 1 soil ^{GW}Soil_{ing} residential protective concentration levels (PCLs) (regulatory action levels) due to the small volume of groundwater collected because of very slow well recharge.

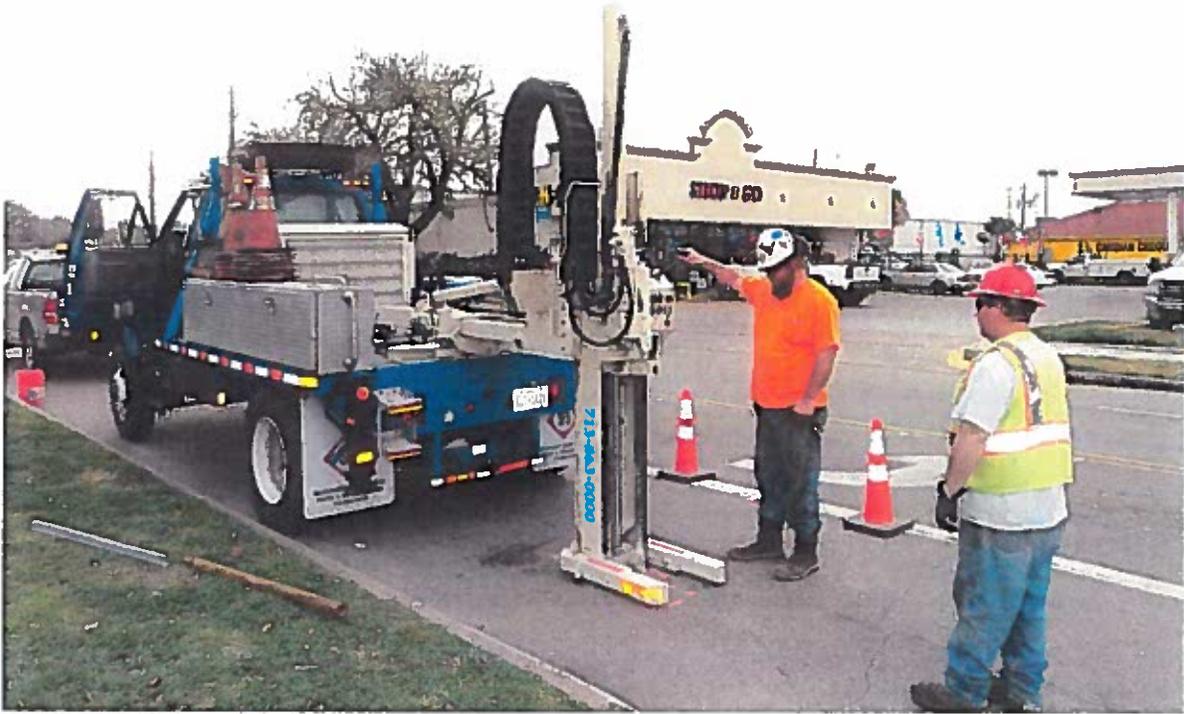
Photograph 1: View to the southeast of drilling B-1, Clarewood near Gessner.

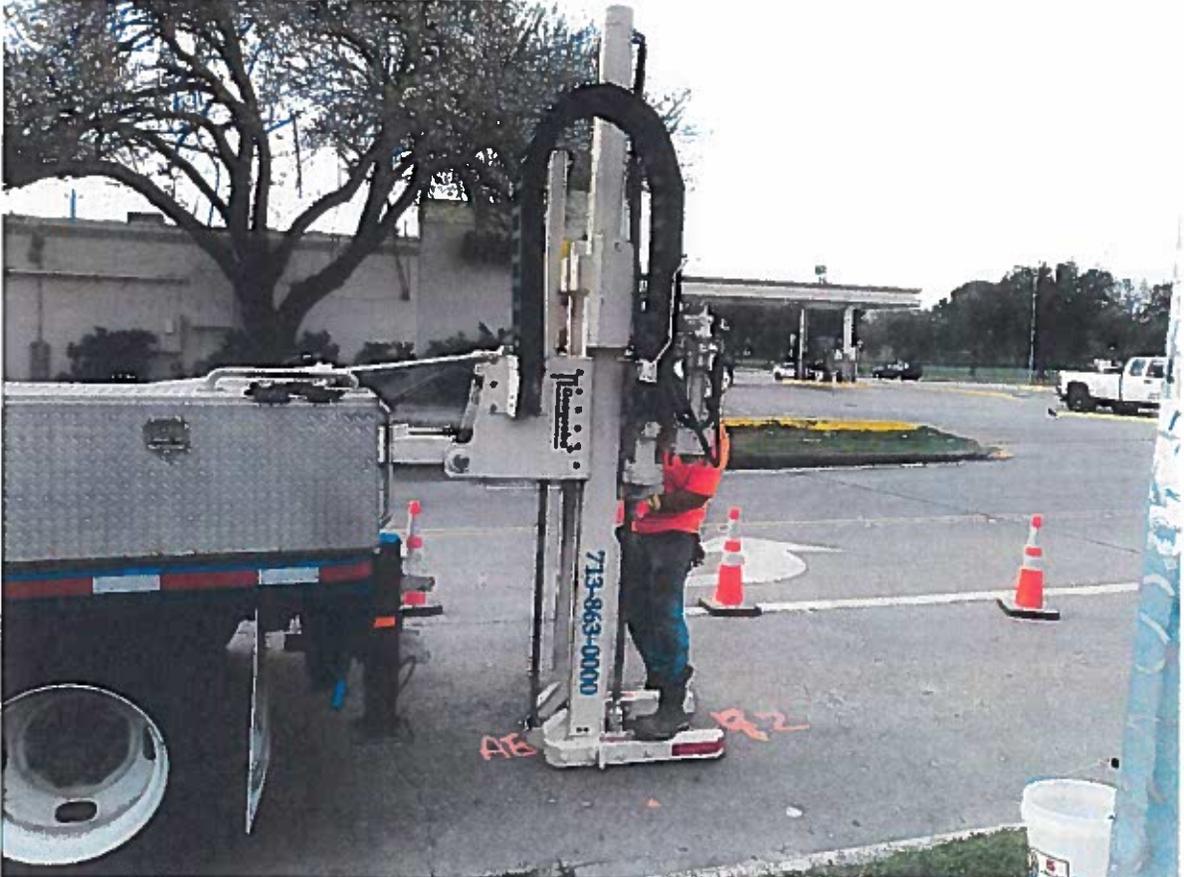
Photograph 2: View to the south southwest of drilling of B-2, Clarewood near Gessner.

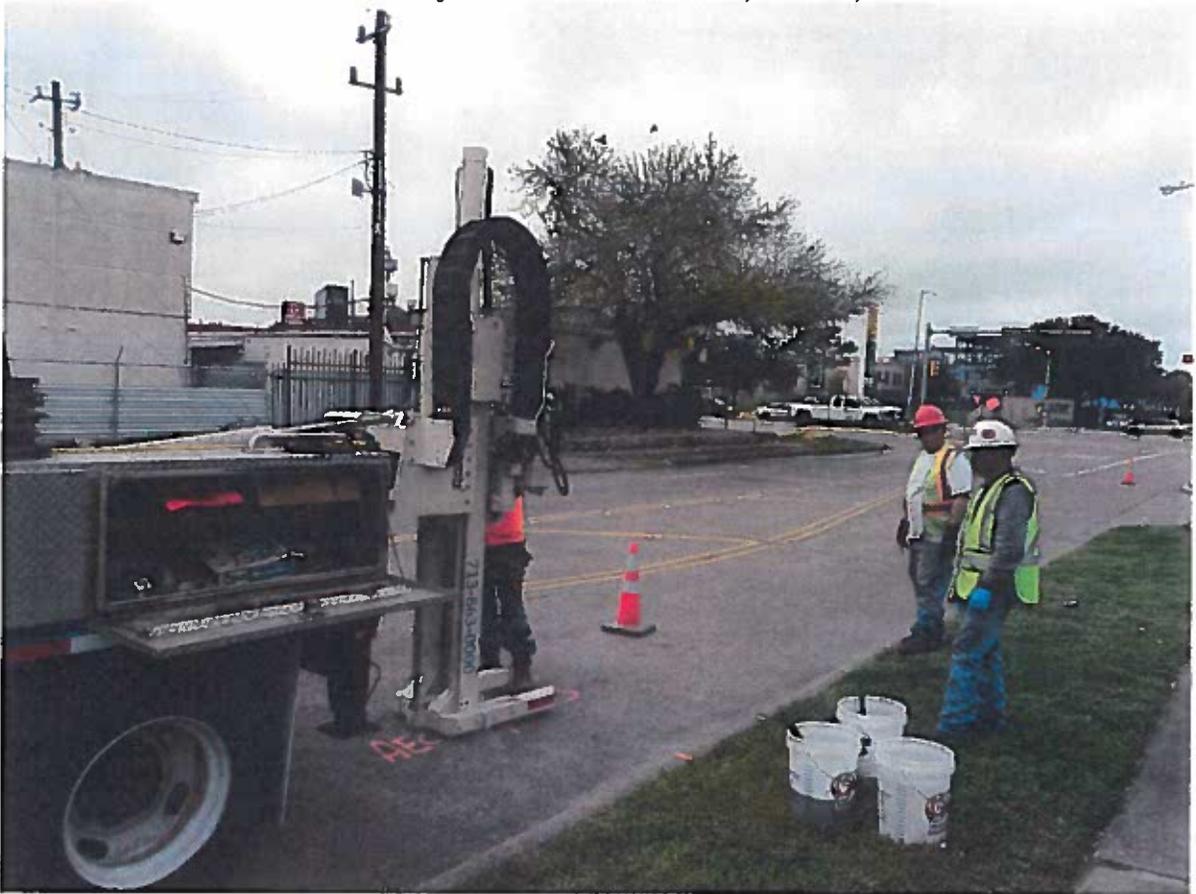
Photograph 3: View to the southwest of drilling of B-3, Clarewood near Gessner.

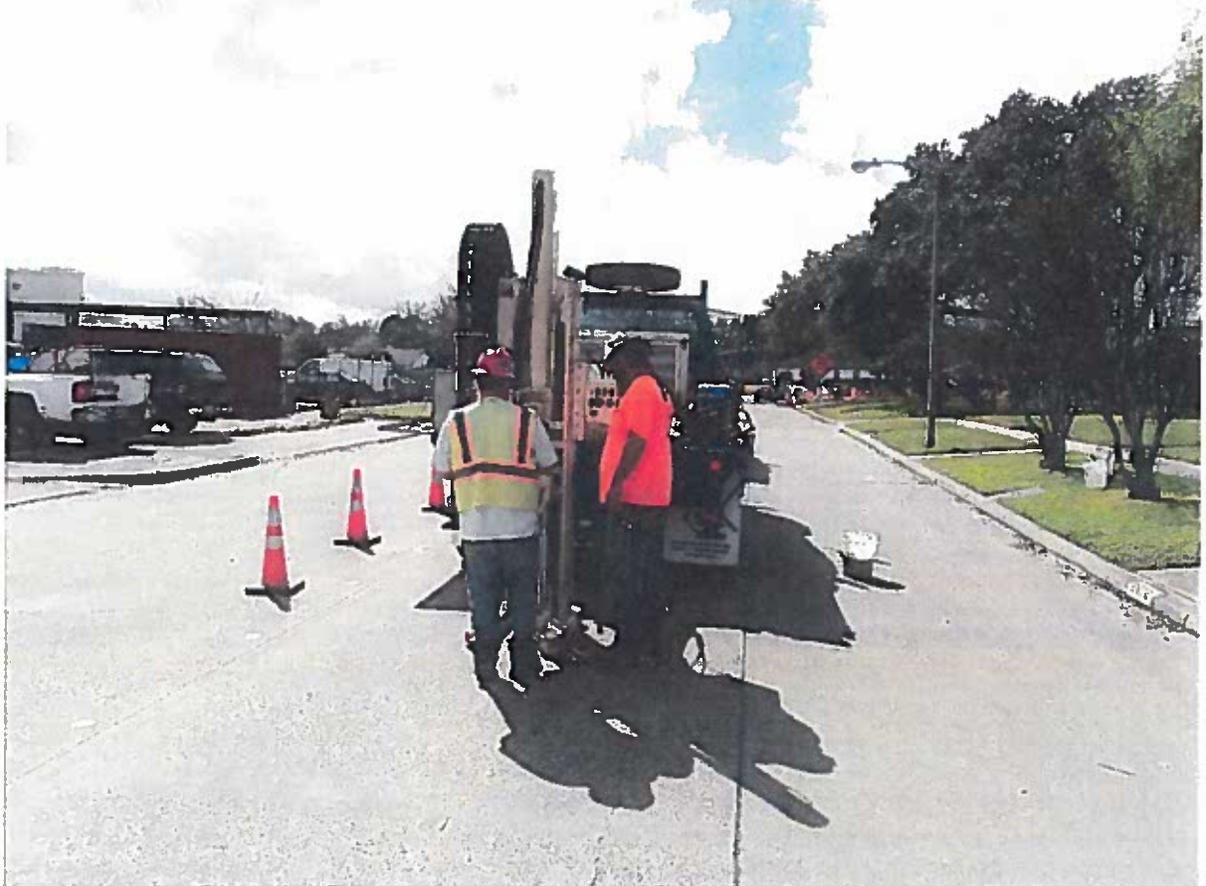
Photograph 4: View to the south of drilling of B-4, Redding near Bellaire Boulevard.

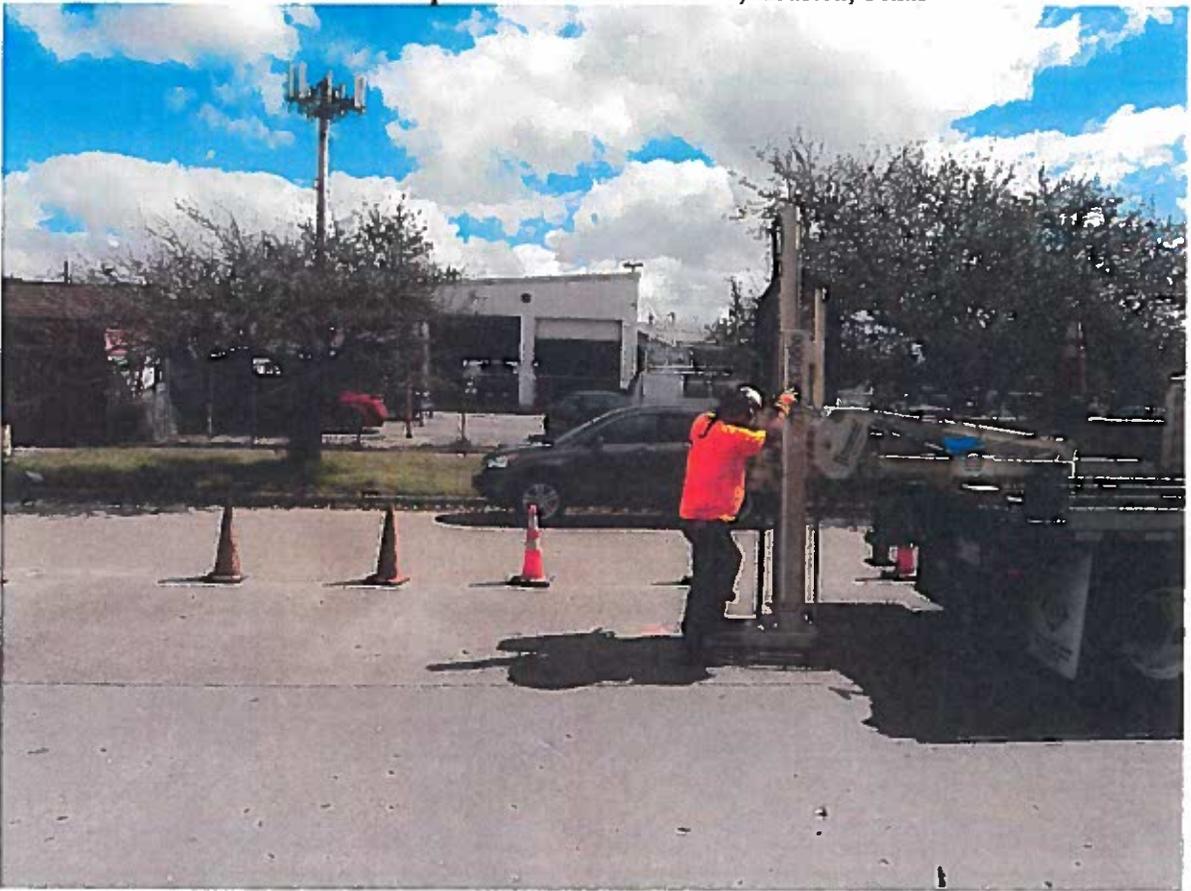
Damp zones indicating the possible presence of groundwater was encountered in borings B-4 and B-6 (refer to Table 1). However at the end of drilling, no groundwater was present in either borehole. Groundwater was encountered during drilling of B-5 at 10.6 feet below pavement

surface. The depth to groundwater was measured at 14.2 feet below pavement surface in the borehole of boring B-5 after completion of the borehole and so the boring was converted into a temporary groundwater monitor well. The well consisted of 10 feet of new 1-inch diameter polyvinyl chloride (PVC) casing and 5 feet of new 1-inch diameter PVC screen that was inserted into the boring (refer to Photograph 8 in Appendix B). The groundwater in the temporary groundwater monitor well was purged prior to sampling but the well went dry after only approximately 4 ounces of water was retrieved from the temporary well. The well was allowed to recharge and then a groundwater sample was collected from the temporary well for analysis however, only enough water to fill one 40 milliliter vial (compared to the usual three vials) and about 10 milliliters of an 80 milliliter vial (compared to the usual three vials) could be collected due to the presence of insufficient volume of water in the temporary well. The groundwater sample did not exhibit any petroleum product odor. The groundwater sample was placed into clean, laboratory-provided sample containers, labeled with the date and time of sample collection, the well number, the requested analyses, and the initials of the sample collector. Each soil sample and groundwater sample were preserved on ice and transported to A&B Environmental Services, Inc. commercial analytical laboratory with a completed chain-of-custody form (refer to the analytical laboratory report in Appendix E).

Photograph 5: View to the east of drilling of B-5, Redding near Bellaire Boulevard.

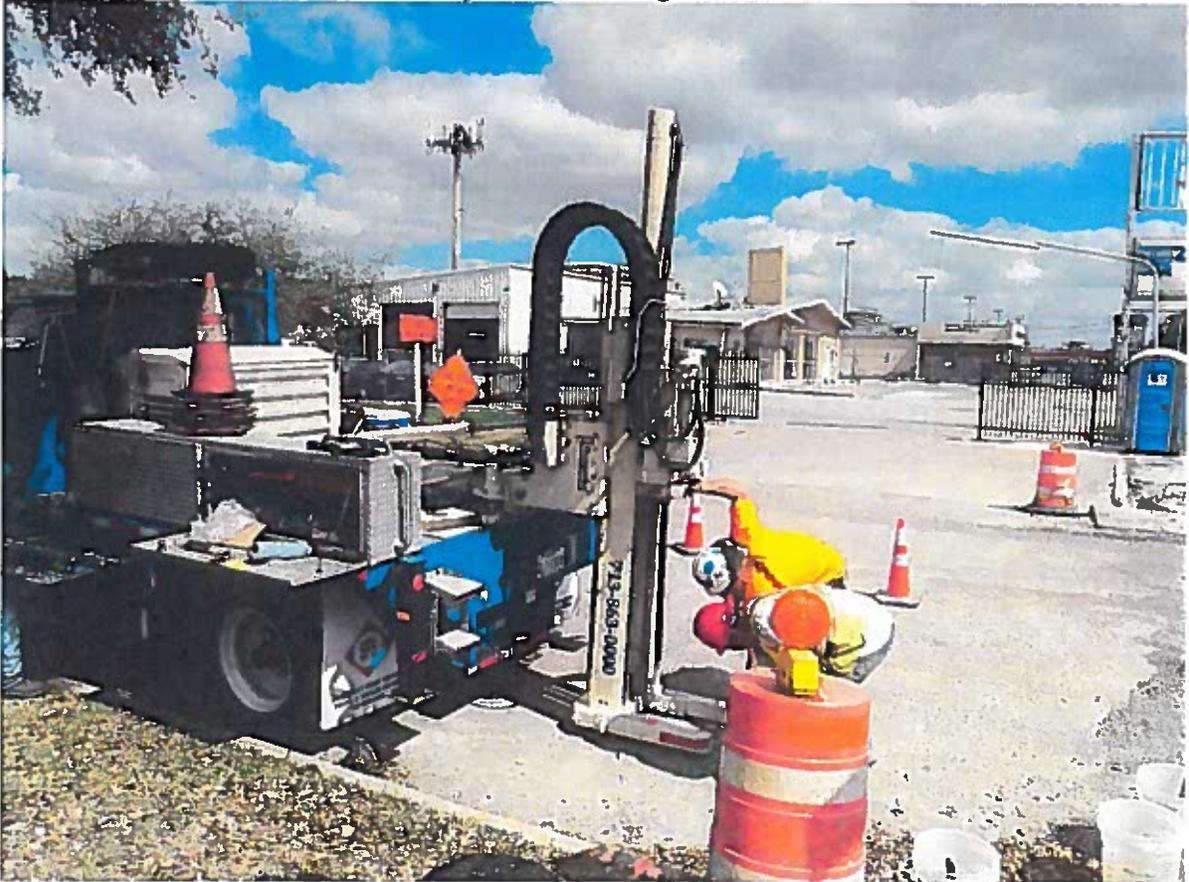
Photograph 6: View to the east northeast of drilling of B-6, Redding near Bellaire Boulevard.

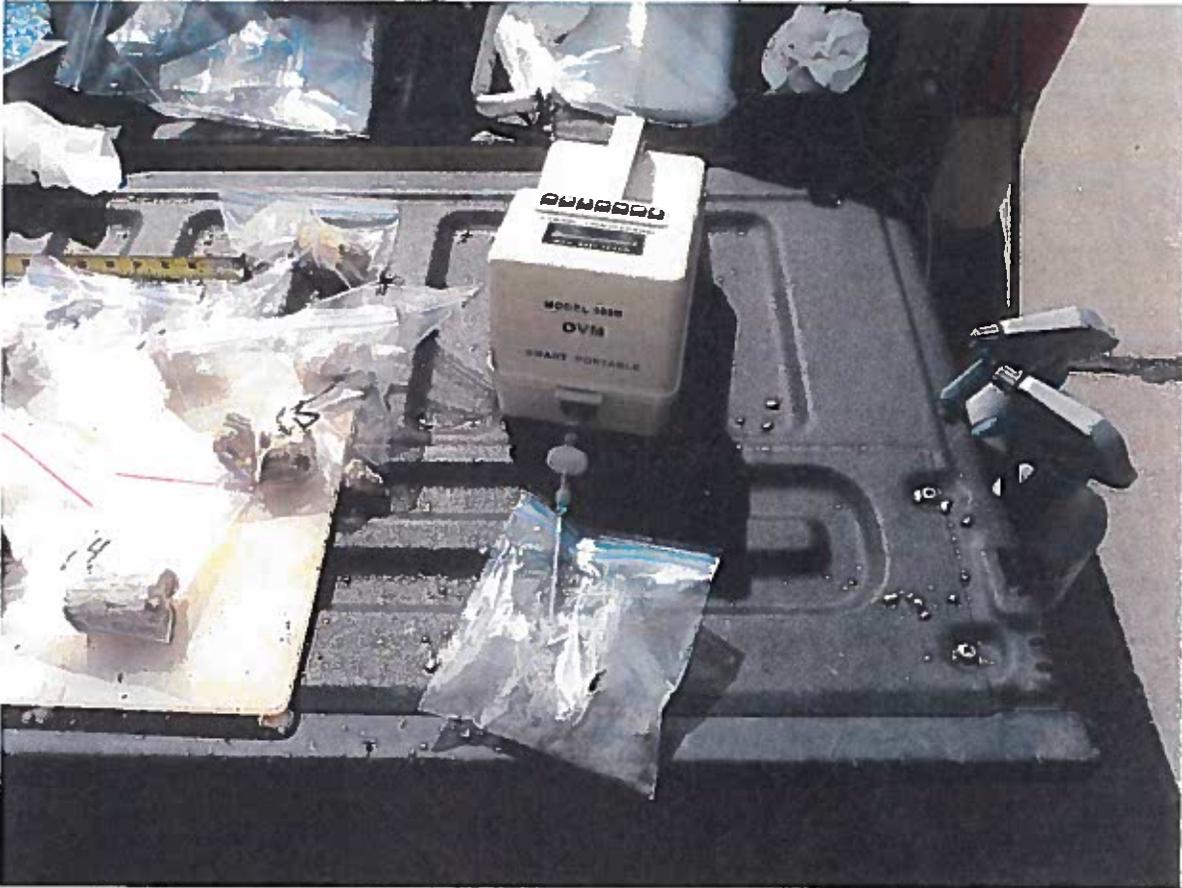
At each soil boring location a continuous direct-push soil boring machine was used first to vibrate through the concrete pavement. The pavement ranged in thickness from 6 inches in B-6 to 9 inches in B-5 (refer to Table 1 on the next page). Below the pavement, crushed limestone, gravel and/or sand fill or base material was encountered and ranged in thickness from 0.5 inch in B-2 to 5 inches in B-3 (refer to Table 1). The direct-push soil boring machine was then used to obtain a soil core from the ground surface to the total depth of the boring (refer to Table 1). Soil cores were collected in 4-foot long acetate liners within the 2-inch diameter direct push sampler. The majority of the soil encountered during drilling was sandy clay (refer to the soil borings in Appendix C and Table 1). The recovered core was logged and screened on-site for volatile organic vapors using a calibrated photoionization detector (PID) (refer to the boring logs in Appendix C). The on-site screening was conducted by cutting a sub-sample from each 1-foot interval of core with a decontaminated knife. Each subsample was sealed in a zip-lock-type sandwich bag for a minimum of 10 minutes. The headspace concentration of volatile organic vapors from the sample was then analyzed by inserting the probe tip of the calibrated PID into a narrow opening of the bag seal (refer to Photograph 7 in Appendix B). The volatile organic vapor concentrations detected by the PID meter of each subsample except the 0 to 1 foot sample from boring B-1 was equal to the background air PID readings of 0.0 to 0.2 parts per million (ppm). The PID reading of the soil in the 0 to 1 foot interval of boring B-1 was 0.3 ppm, just slightly above background concentrations (refer to the boring logs in Appendix C for the specific PID readings). No petroleum product odors were detected in the soil cores during the limited ESA II investigations.

Photograph 7: Set up to measure PID readings.

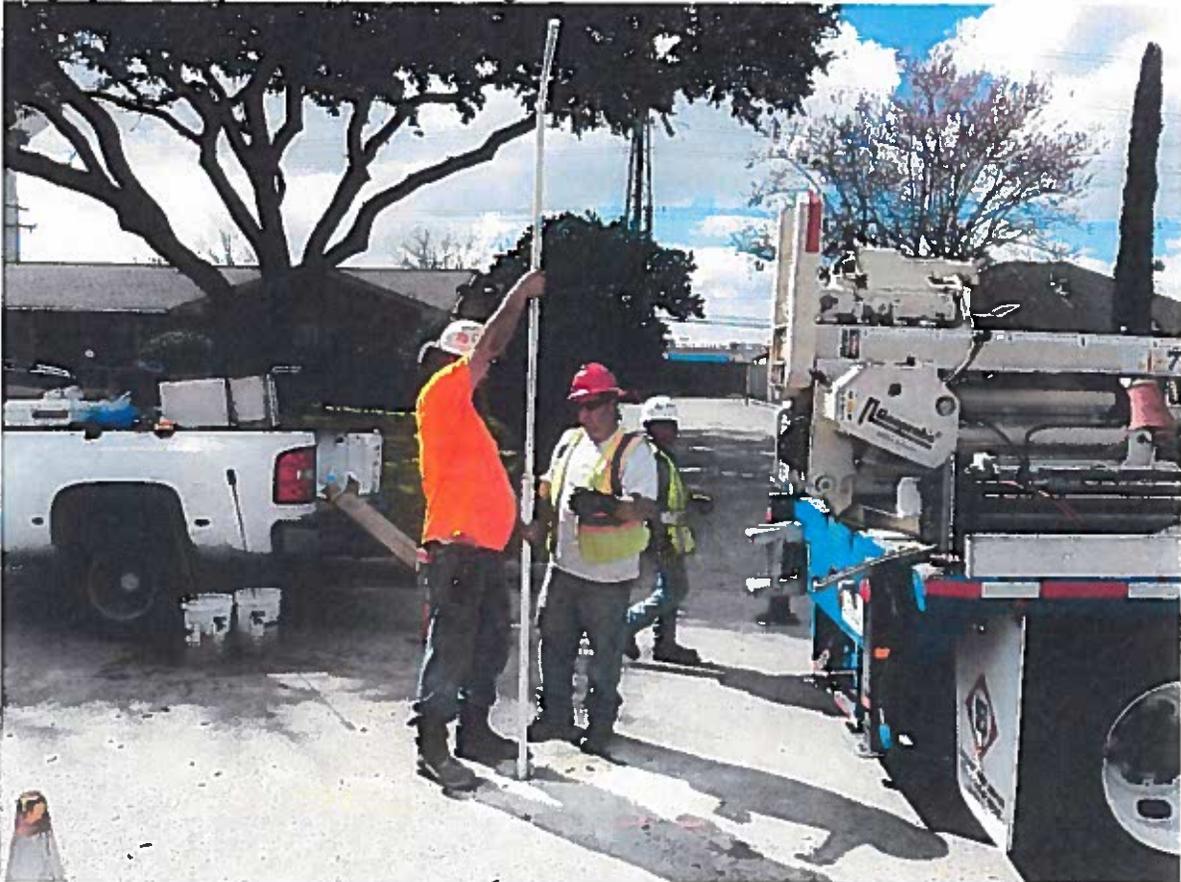
Photograph 8: Installing temporary water well at B-5. View to the west.

Following groundwater sampling, the temporary well casing was removed from B-5 and each of the six boreholes was grouted from the total depth to the base of the street pavement. The pavement at each soil boring location was patched with concrete.
