JONES & CARTER, INC.

Subject: **Phase II Environmental Site Assessment**
Water Line Replacement in Kickerillo Area
City of Houston, Texas
WBS No.: S-000035-0185-3
Kenall Report No. 1757

EXECUTIVE SUMMARY

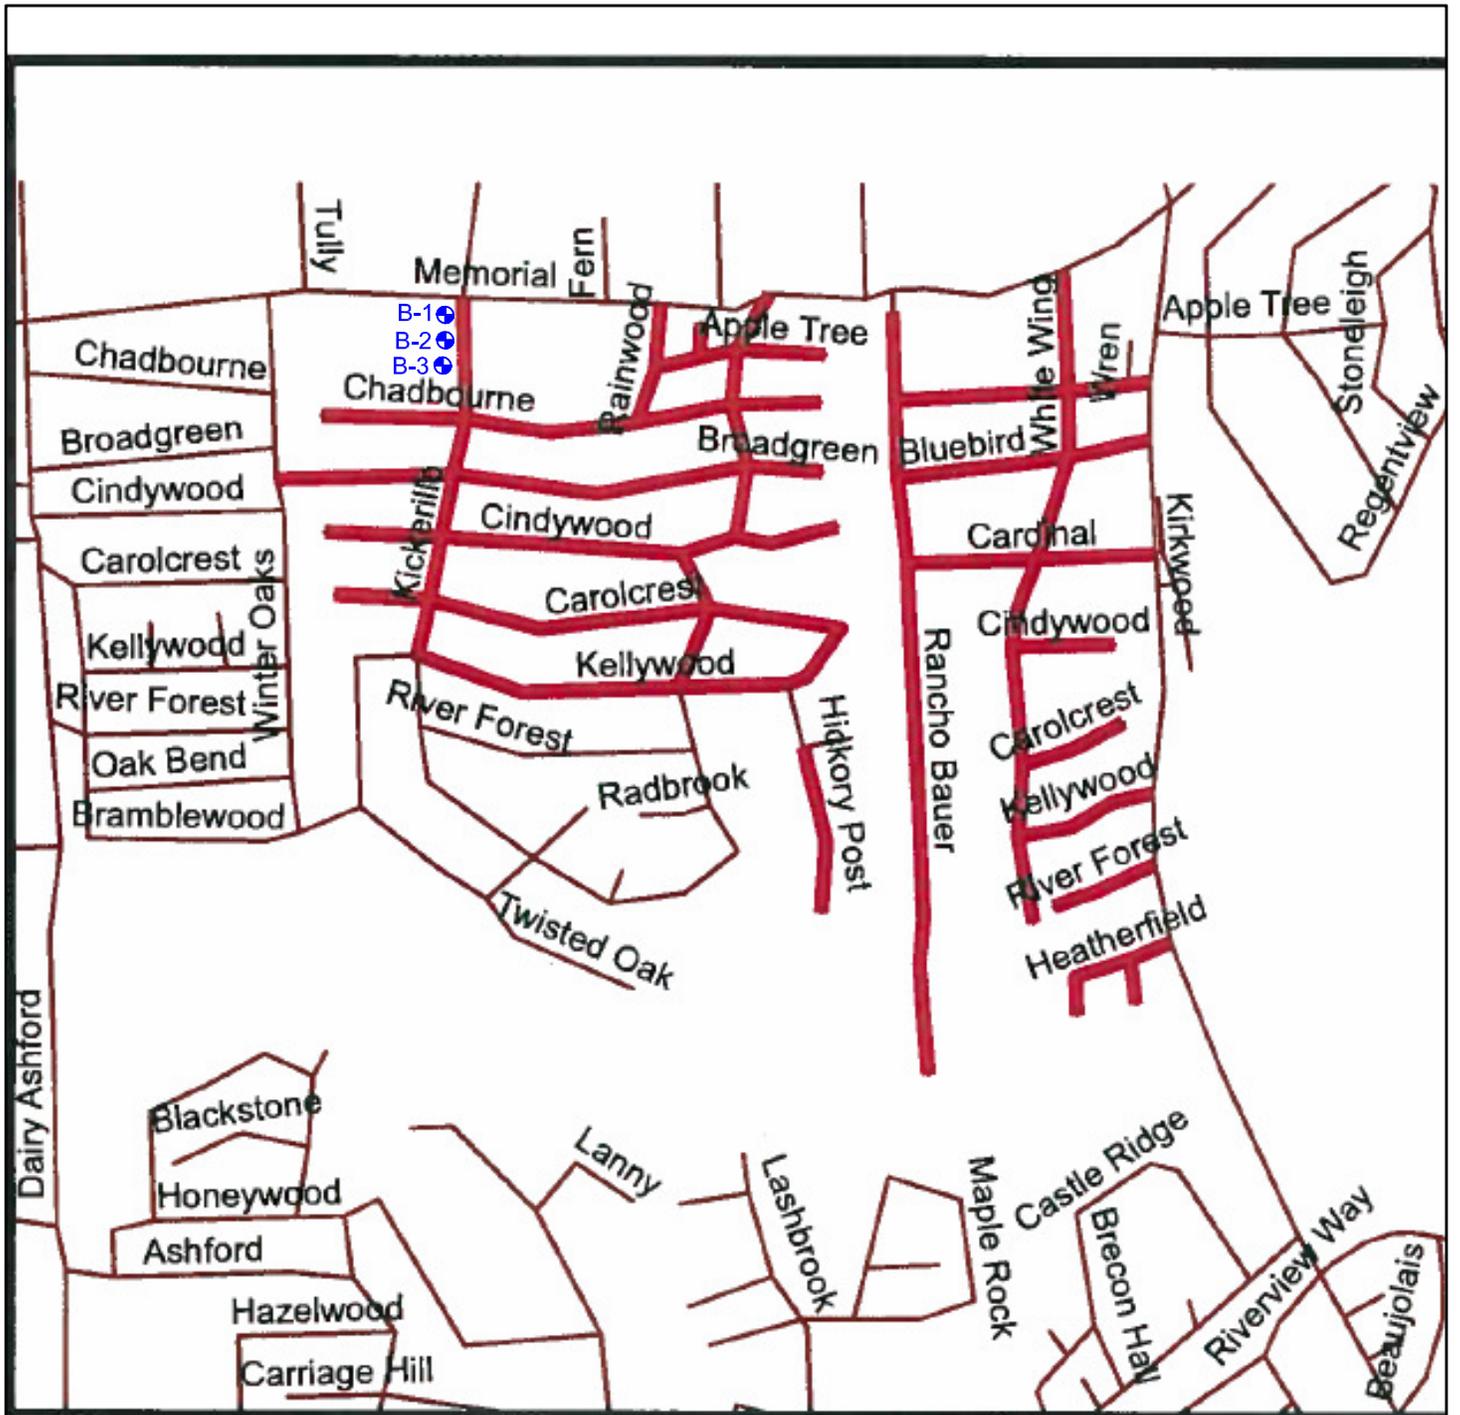
Appendix B- Plan of Borings

The location of the soil borings/probes is shown on the Plan of Borings (Appendix B). At the start of drilling, all sampling tools were decontaminated with a phosphate-free Liquid-Nox detergent, followed by a Freon rinse and a final deionized water rinse to reduce possible sample cross-contamination. The sampling tools were once again decontaminated after sample recovery. All the soil borings were advanced to 12 ft. Soil samples obtained were continuously examined for impact using visual and olfactory methods. Samples were also screened for organic vapors with a properly calibrated Photo Ionization Detectors (PID) Meter. Descriptions of the materials encountered are presented on the Boring Logs (Appendix C).

Kenall Inc. Geotechnical, Environmental & Material Engineers		
Scale: Not to Scale	Approved By: KP	Prepared By: RT
PLAN OF BORINGS Water Line Replacement in Kickerillo Area City of Houston, Texas		
WBS No. S-000035-0185-3	Appendix B
