**FINAL REPORT  
LIMITED PHASE II  
ENVIRONMENTAL SITE ASSESSMENT  
FOR WATER LINE REPLACEMENT IN  
IMPERIAL VALLEY AREA PACKAGE II,  
HOUSTON, TEXAS  
CITY OF HOUSTON WBS No. S-000035-0197-3**

**AEC Project No. E111-14**

**December 15, 2014**

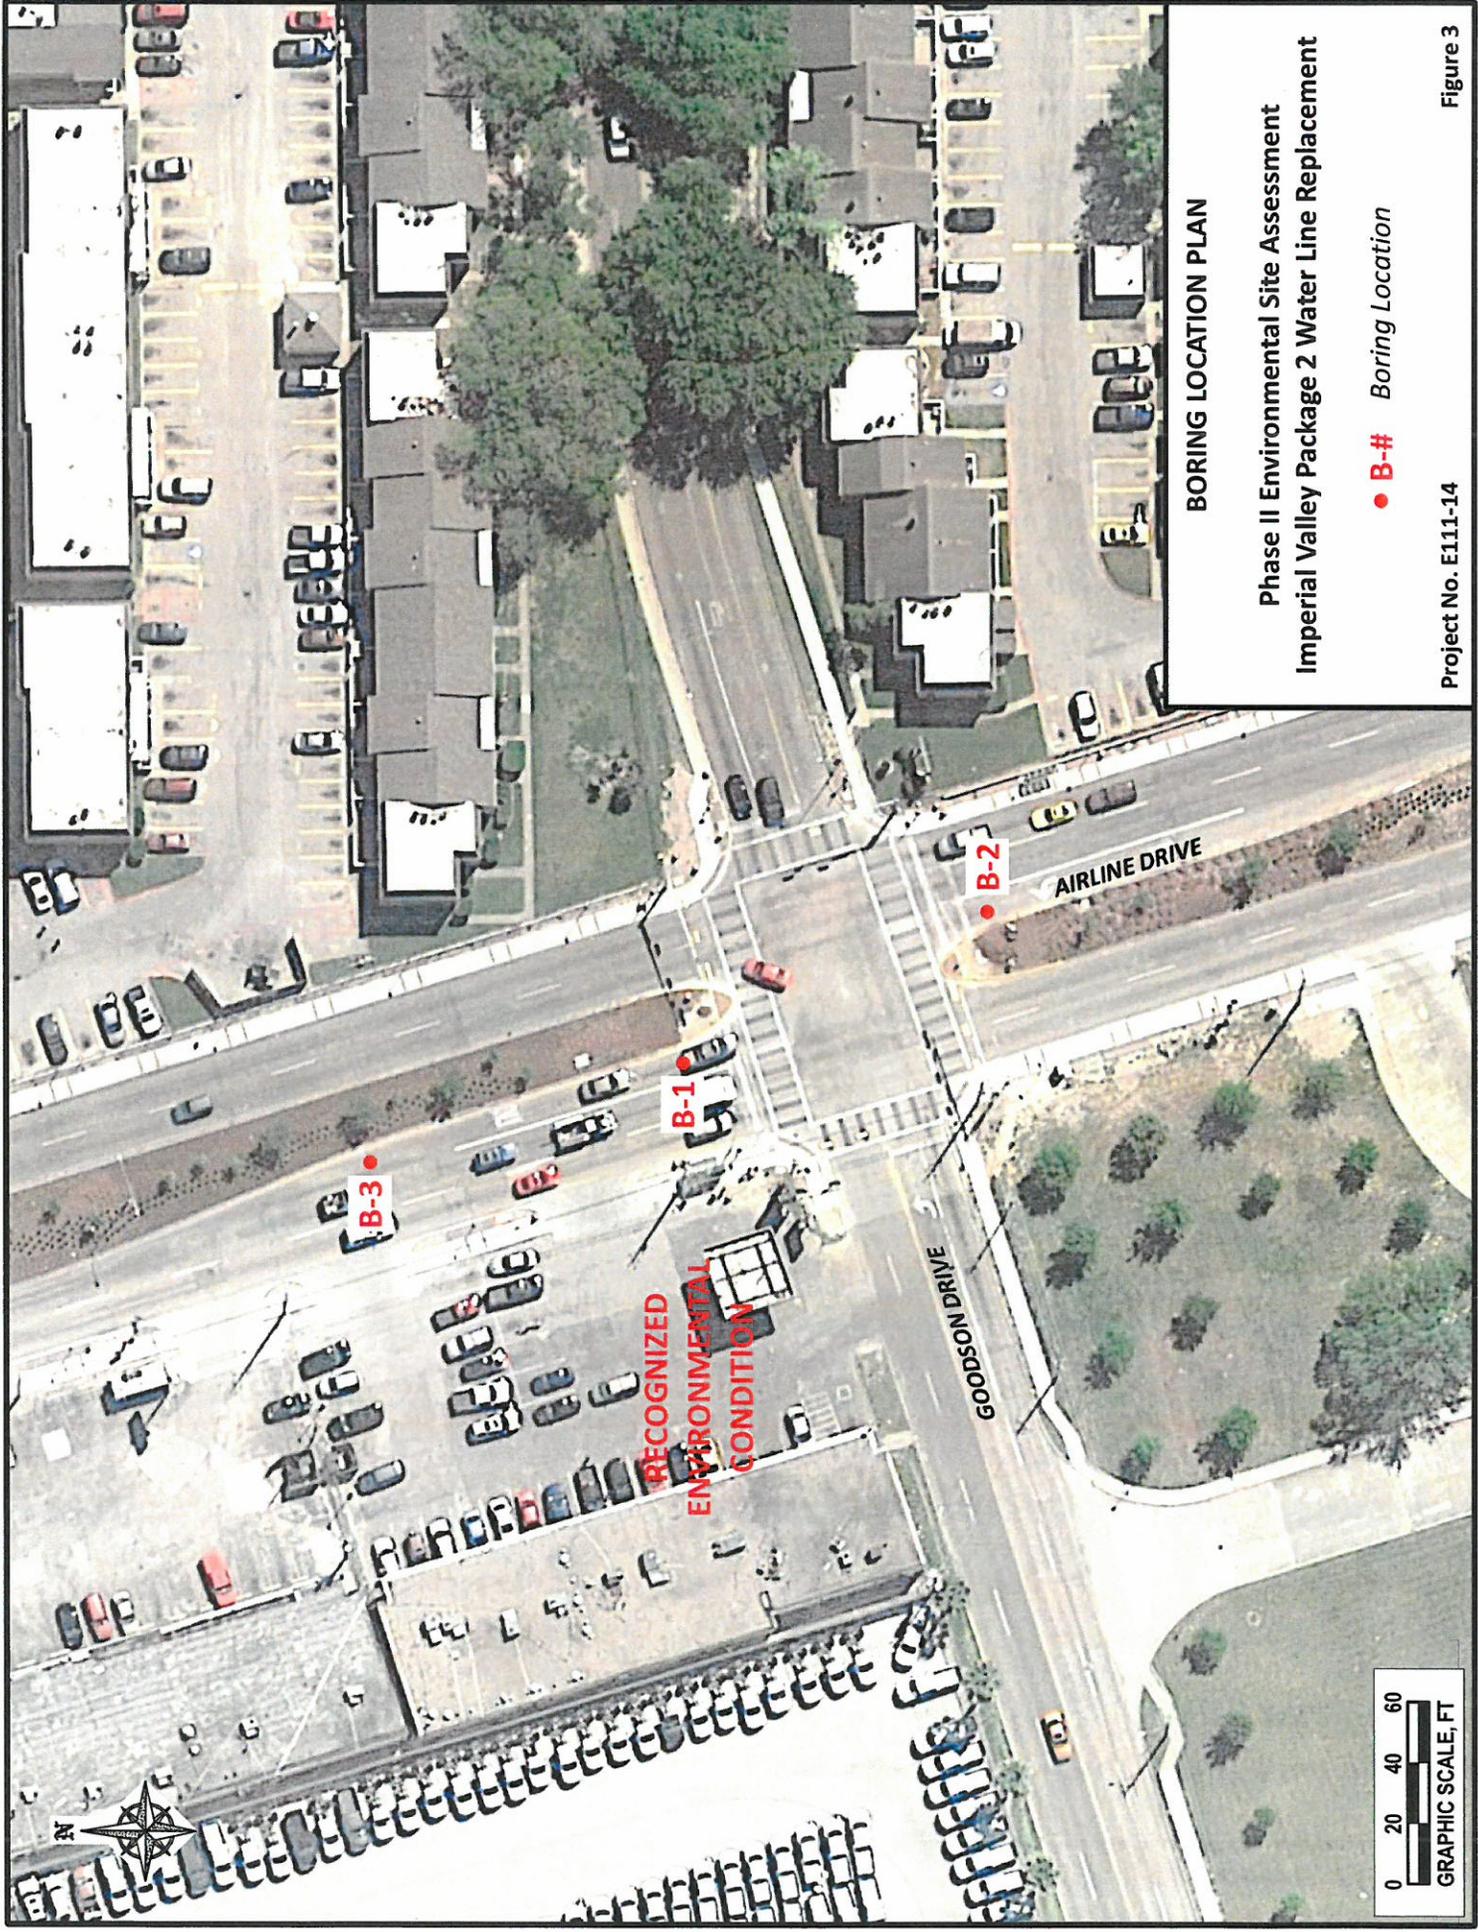
Figure 3

**BORING LOCATION PLAN**

Phase II Environmental Site Assessment  
Imperial Valley Package 2 Water Line Replacement

● B-# Boring Location

Following site preparation activities, three soil borings (B-1 through B-3) were drilled and one temporary monitor well at B-1 was installed on October 20, 2014. Each soil boring was placed in the best practicable location, considering the location of utilities and other site-specific conditions. Figures 2 and 3 show the locations of the soil borings. Boring B-1 was drilled to 24 feet below pavement surface (bps) and B-2 and B-3 were each drilled to 14 feet bps. B-1 was drilled directly across from the pump island and tankfield of the REC.

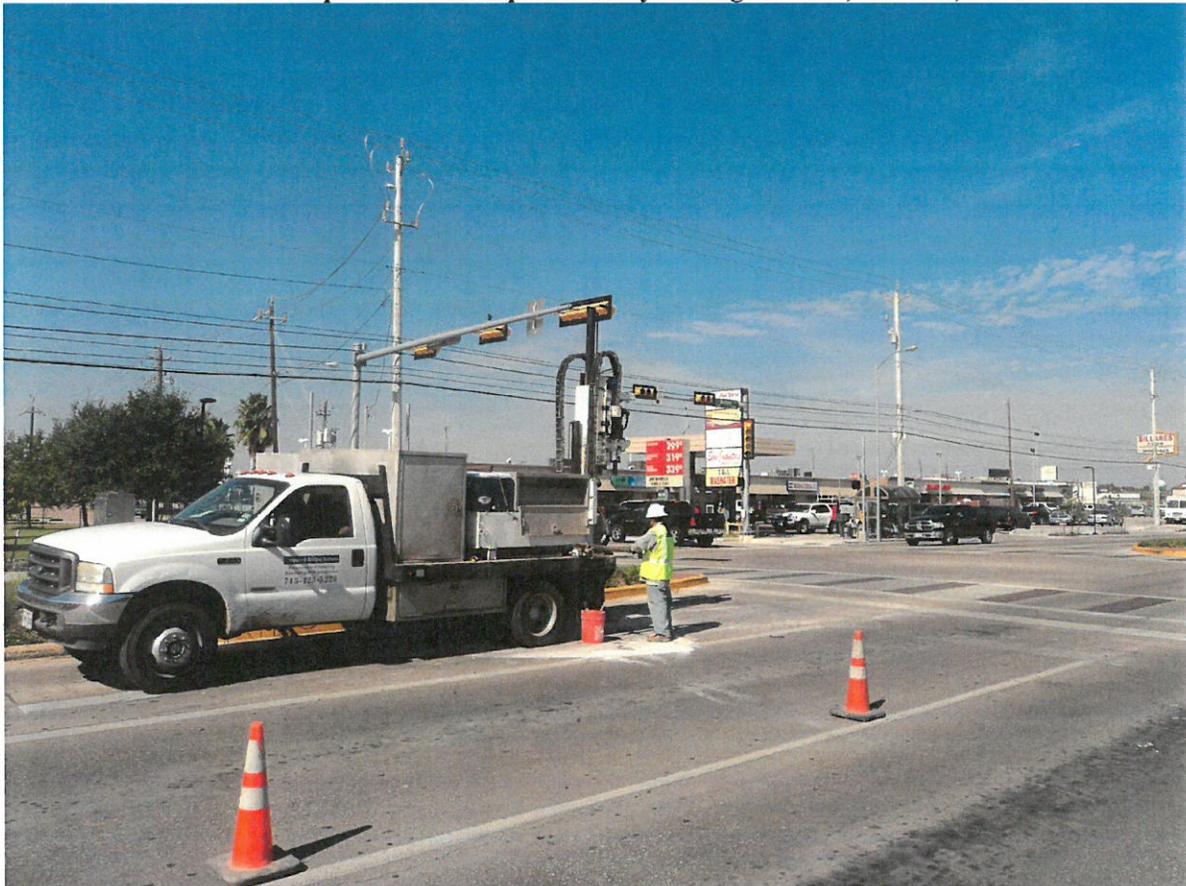
**Photograph 1:** View to the west of coring the pavement at the B-2 location.

The concrete pavement at each boring location was cored prior to drilling (refer to Photograph 1 in Appendix B). The pavement thickness ranged from 8.5 inches in B-3 to 9.5 inches in B-2. Cement stabilized base material consisting of crushed limestone, sand and in some cases gravel were encountered beneath the concrete pavement. The base material thickness at the boring locations ranged from 5.5 inches in B-2 to 12 inches in B-1 (refer to Table 1 below for specifics concerning the concrete and base thicknesses).

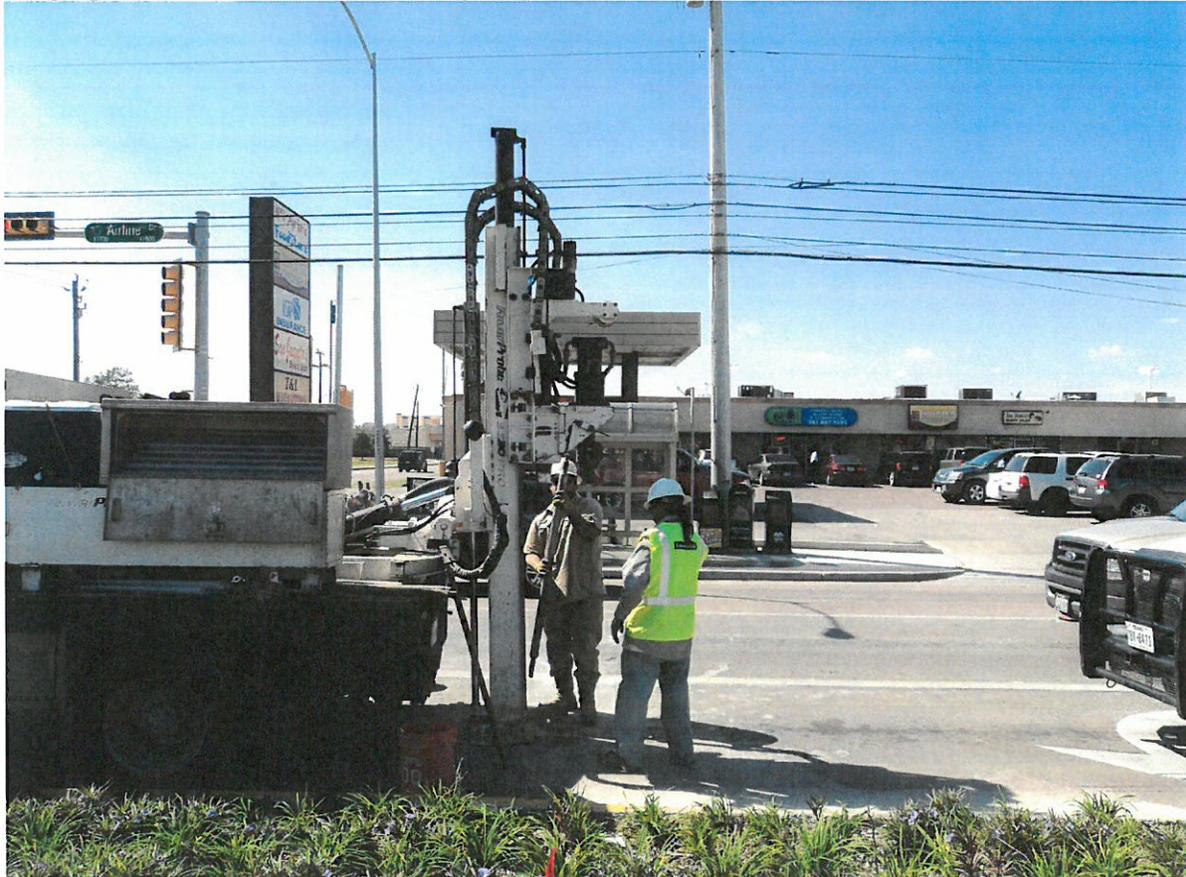
**Photograph 2:** View to the southwest of drilling of B-1. The REC is in the background.

After pavement coring, a continuous direct-push soil boring machine was used to obtain a soil core from the base of the base material to the total depth of the boring (refer to Photographs 2 and 3 in Appendix B). Soil cores were collected in 4-foot long acetate liners within the 2-inch diameter direct push corer. The recovered core was logged. All of the soil encountered during drilling was either clay or sandy clay (refer to the soil borings in Appendix C and summary of the borings in Table 1). A representative section of soil was cut from each one-foot section of core and placed in a zip-lock type sandwich bag for 10 minutes. After that time period, the

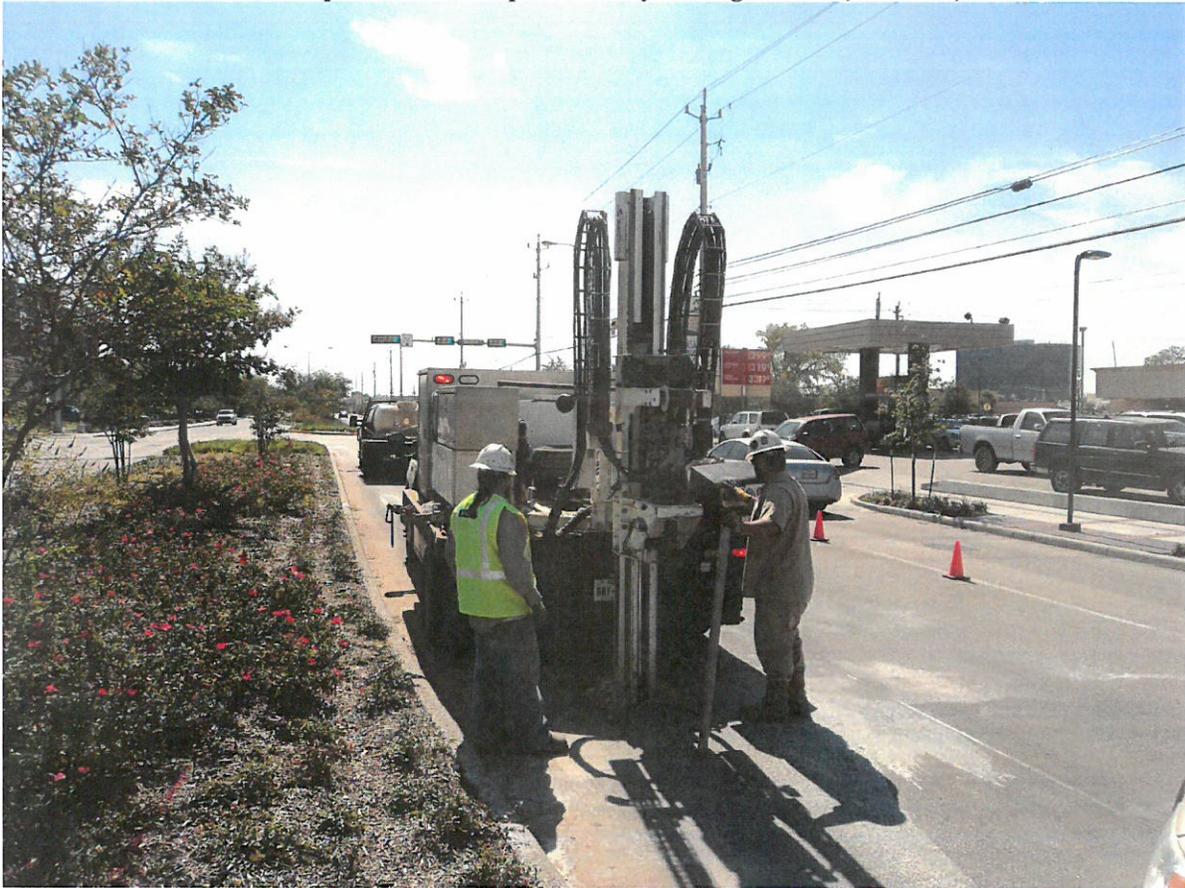
**Photograph 3:** View to the southeast of drilling of B-3.

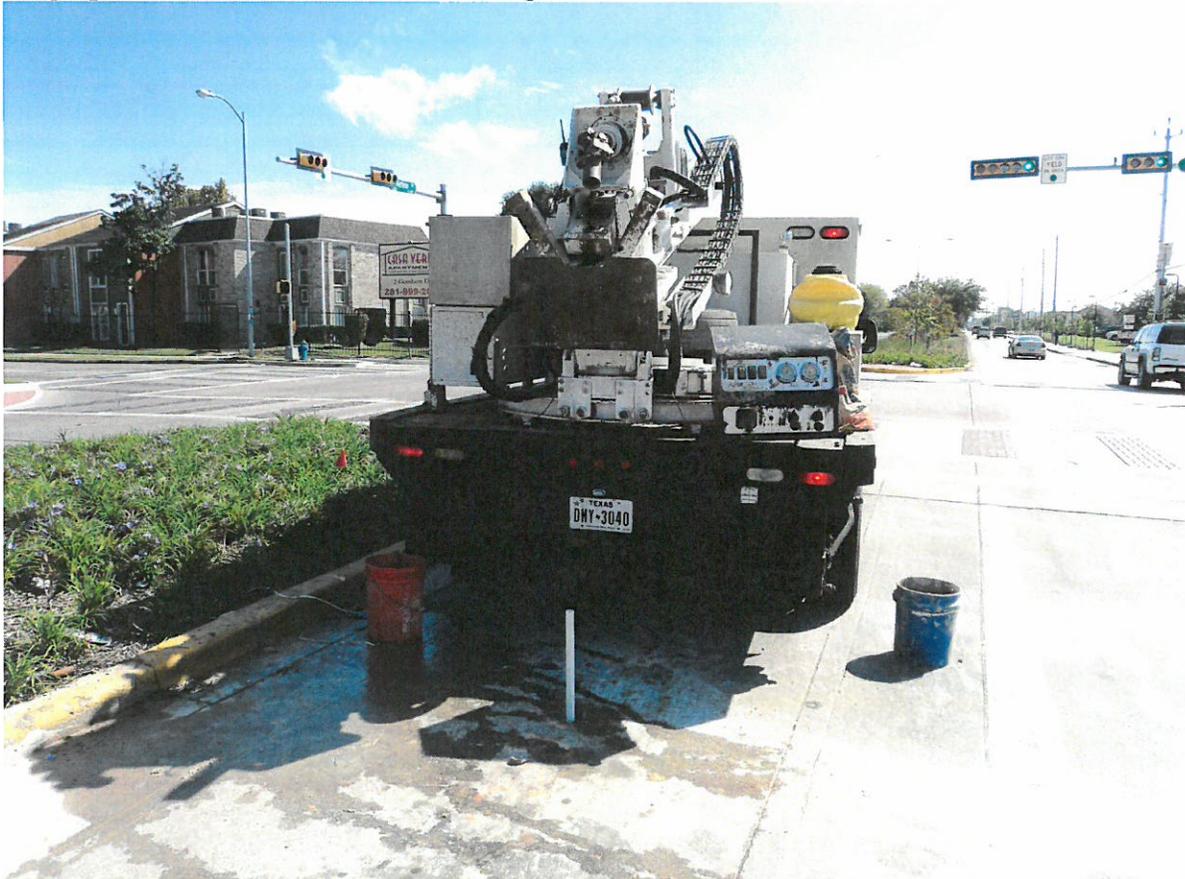
**Photograph 4:** View to the east-southeast of installed temporary monitor well at the B-1 location.

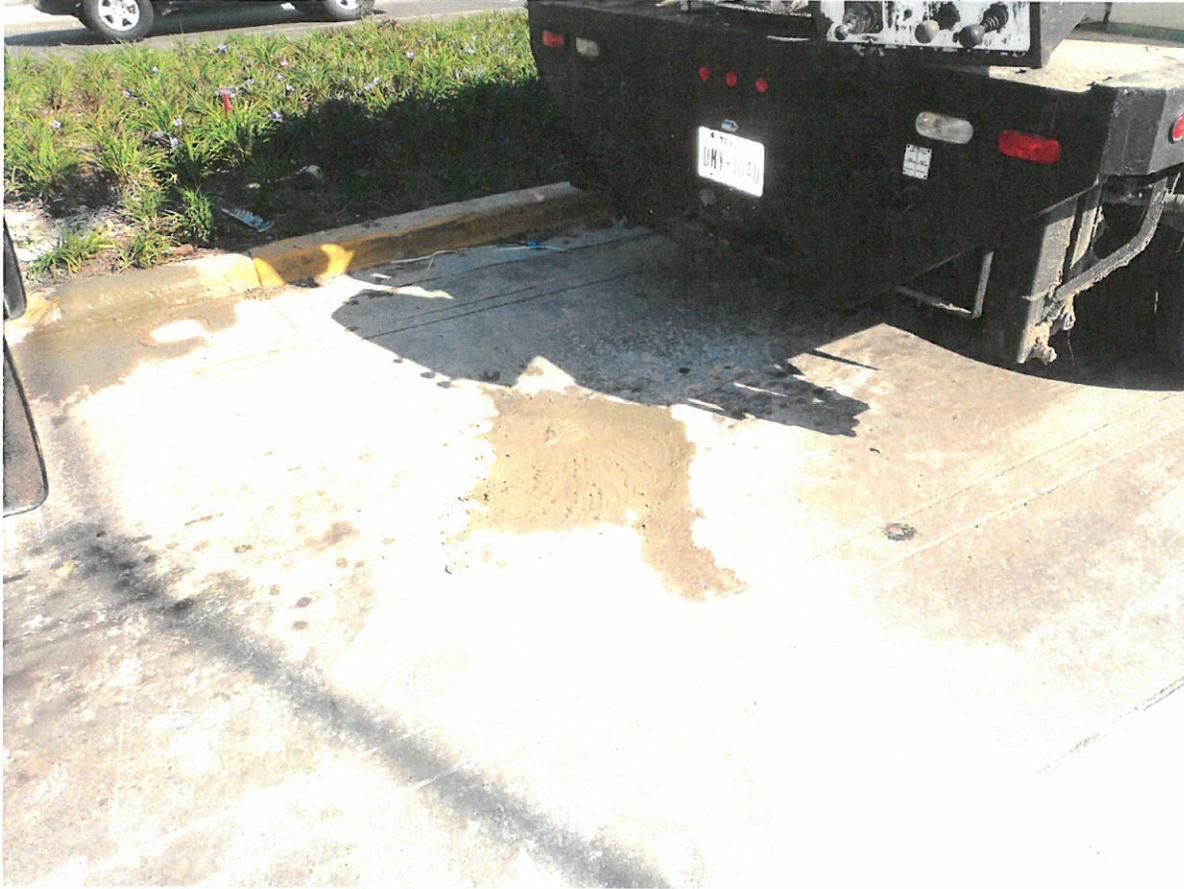
**Photograph 5:** View of plugged boring B-1.

Following groundwater sampling, the temporary monitor well was removed from B-1 and each of the three boreholes was grouted from the total depth to the base of the street pavement (refer to Photograph 5 in Appendix B). The pavement at each soil boring location was patched with concrete.
