WETLAND DELINEATION REPORT

HOLLISTER ROAD PAVING AND DRAINAGE

FROM NORTH OF WHITE OAK BAYOU
TO WEST GULF BANK ROAD

APRIL 2015
(REVISED APRIL 27, 2015)

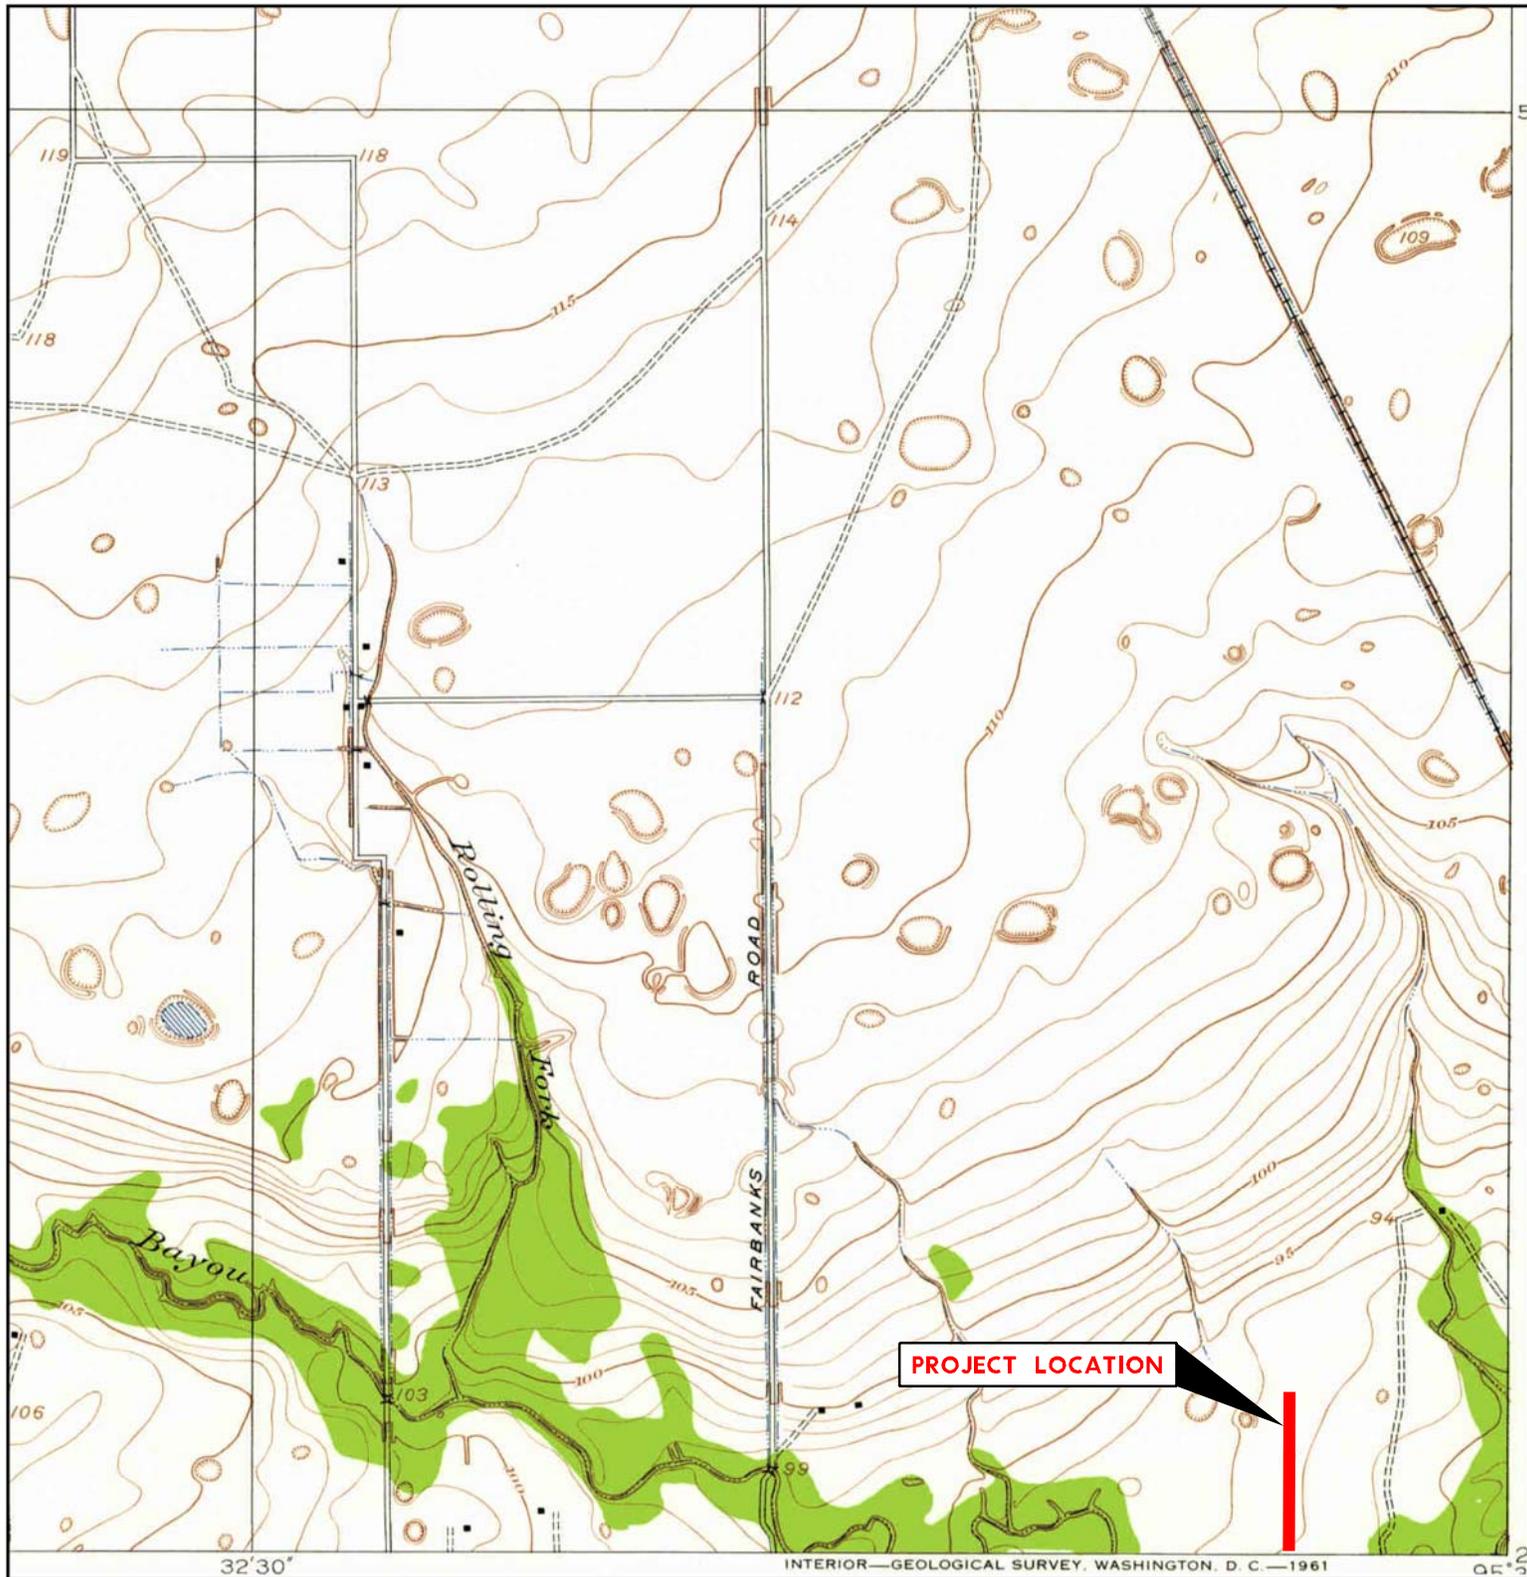
The 1916 topographic map depicts the area as a rural/undeveloped area. The general slope of the land is from the northwest to the southeast. The highest elevations (119 ft. above sea level) are seen in the northwest and the lowest elevations (90 ft. above sea level) are seen in the southeast portion of the area. Fairbanks Road is noted as a paved facility west of the project alignment. Minimal development is noted west of Fairbanks Road. Rolling Fork and White Oak Bayou are easily observed west and south of the proposed project alignment with riparian areas present. A railroad can be seen northeast of the project area. An unpaved road can be seen near the present day Hollister Road alignment. The historical topographic maps are included in Appendix G.

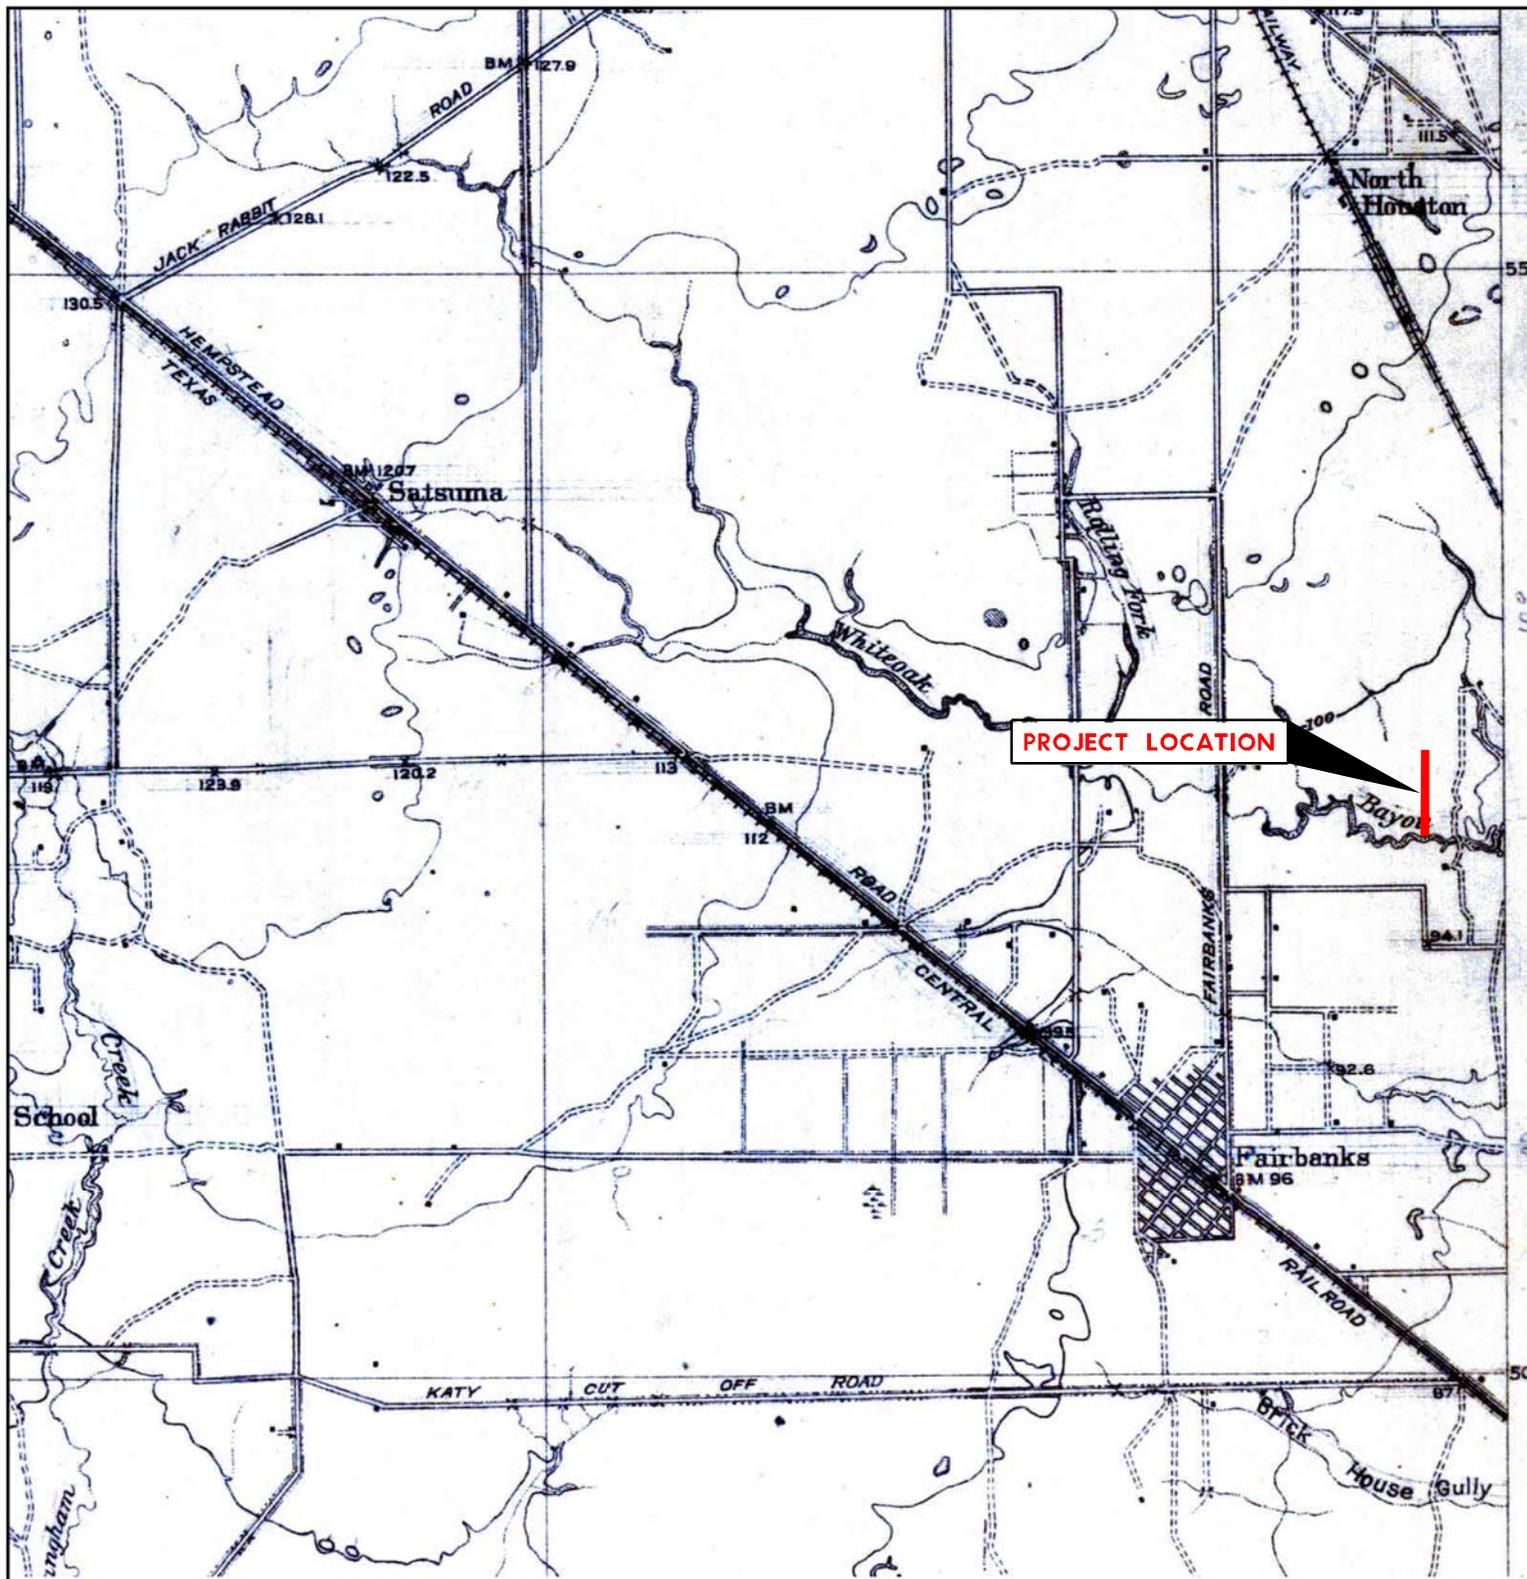
The 1919 topographic map shows development southwest of the project alignment (Fairbanks). White Oak Bayou is visible bordering the southern portion of the project alignment. Development is also seen north of the project area (North Houston). Hempstead Road is visible southwest of the project alignment as a major thoroughfare. The Central Railroad is seen along side of Hempstead Road. Unpaved roads can be seen near the project alignment. Development is seen northwest of the project alignment along Hempstead Road (Satsuma).

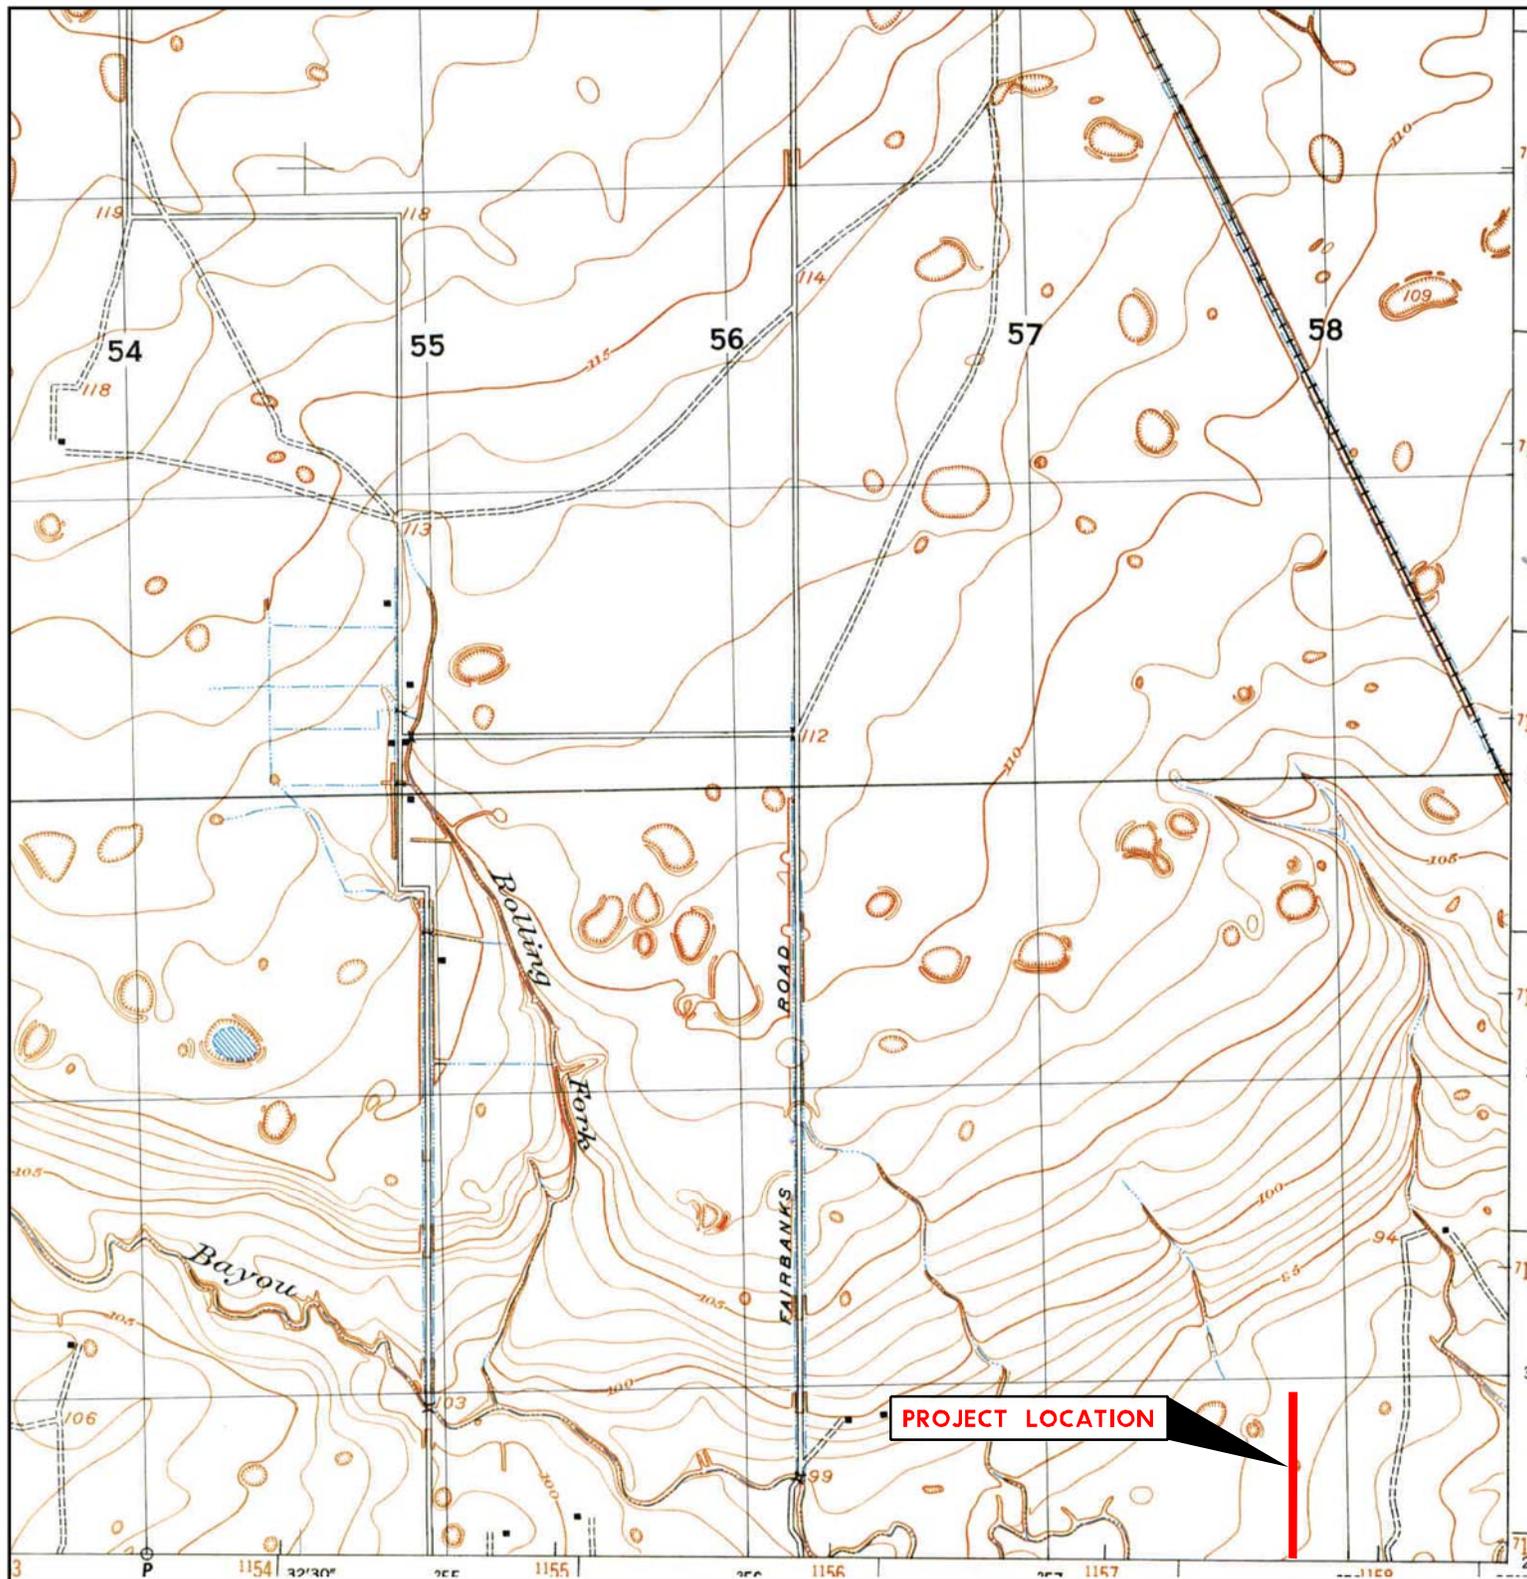
The 1920 topographic map is similar to the 1916 topographic map. Unpaved roads can be seen southwest of the project alignment. The elevation is now in the ranges from 120 to 86 feet above sea level. The unpaved road near the present day Hollister Road alignment is still present. No other significant changes are noted on the map.

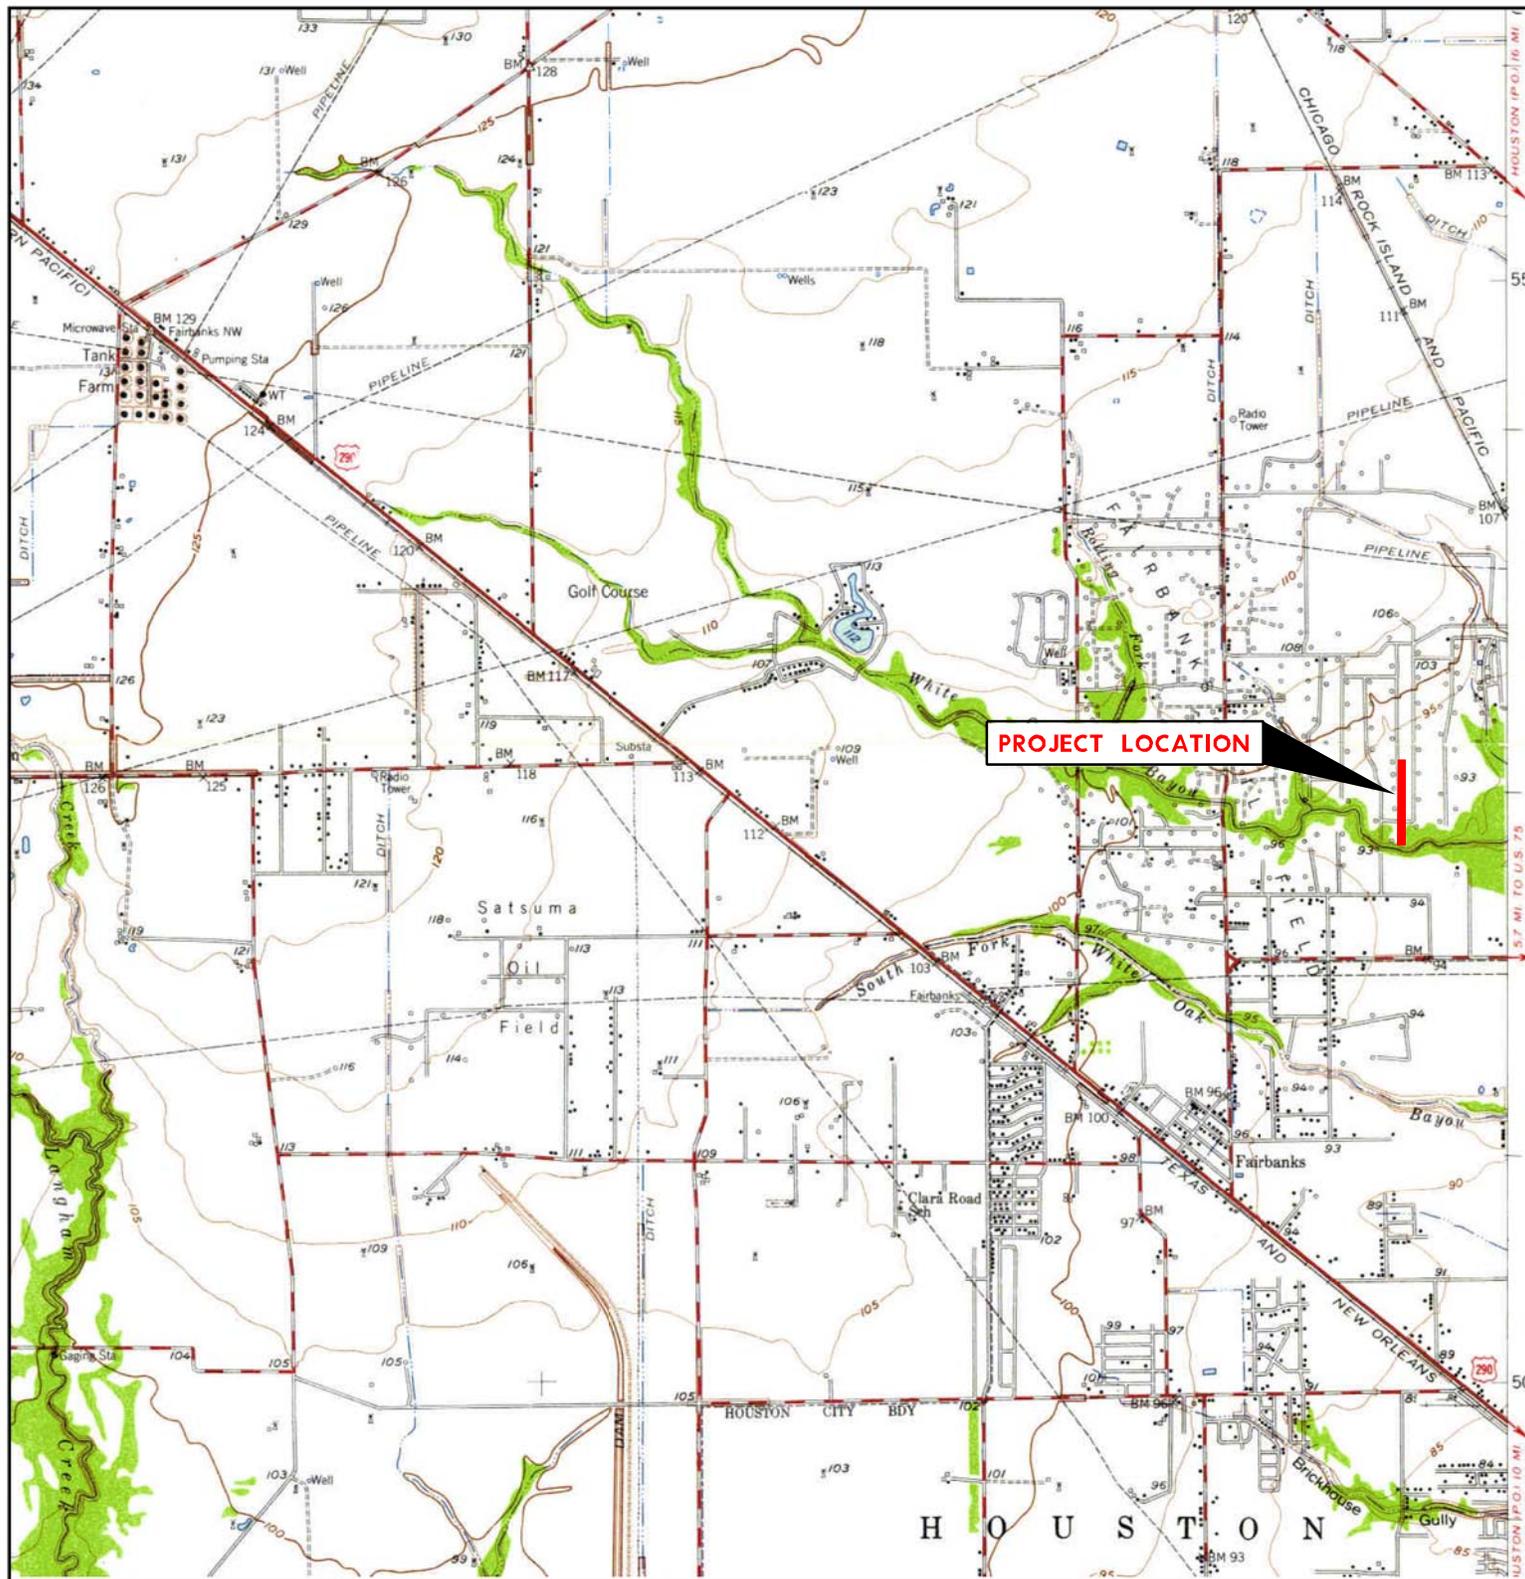
The 1955 topographic map depicts several changes. Development can now be seen in the project area. Several paved arterial streets are near and around the project areas. Satsuma and Fairbanks continue to grow. Pipelines can be seen southwest and north of the project area. White Oak Bayou is present with riparian areas. Drainage ditches can be seen north of White Oak Bayou. South Fork White Oak Bayou can be seen south of White Oak Bayou. Residential and commercial development is present along Hempstead Road.

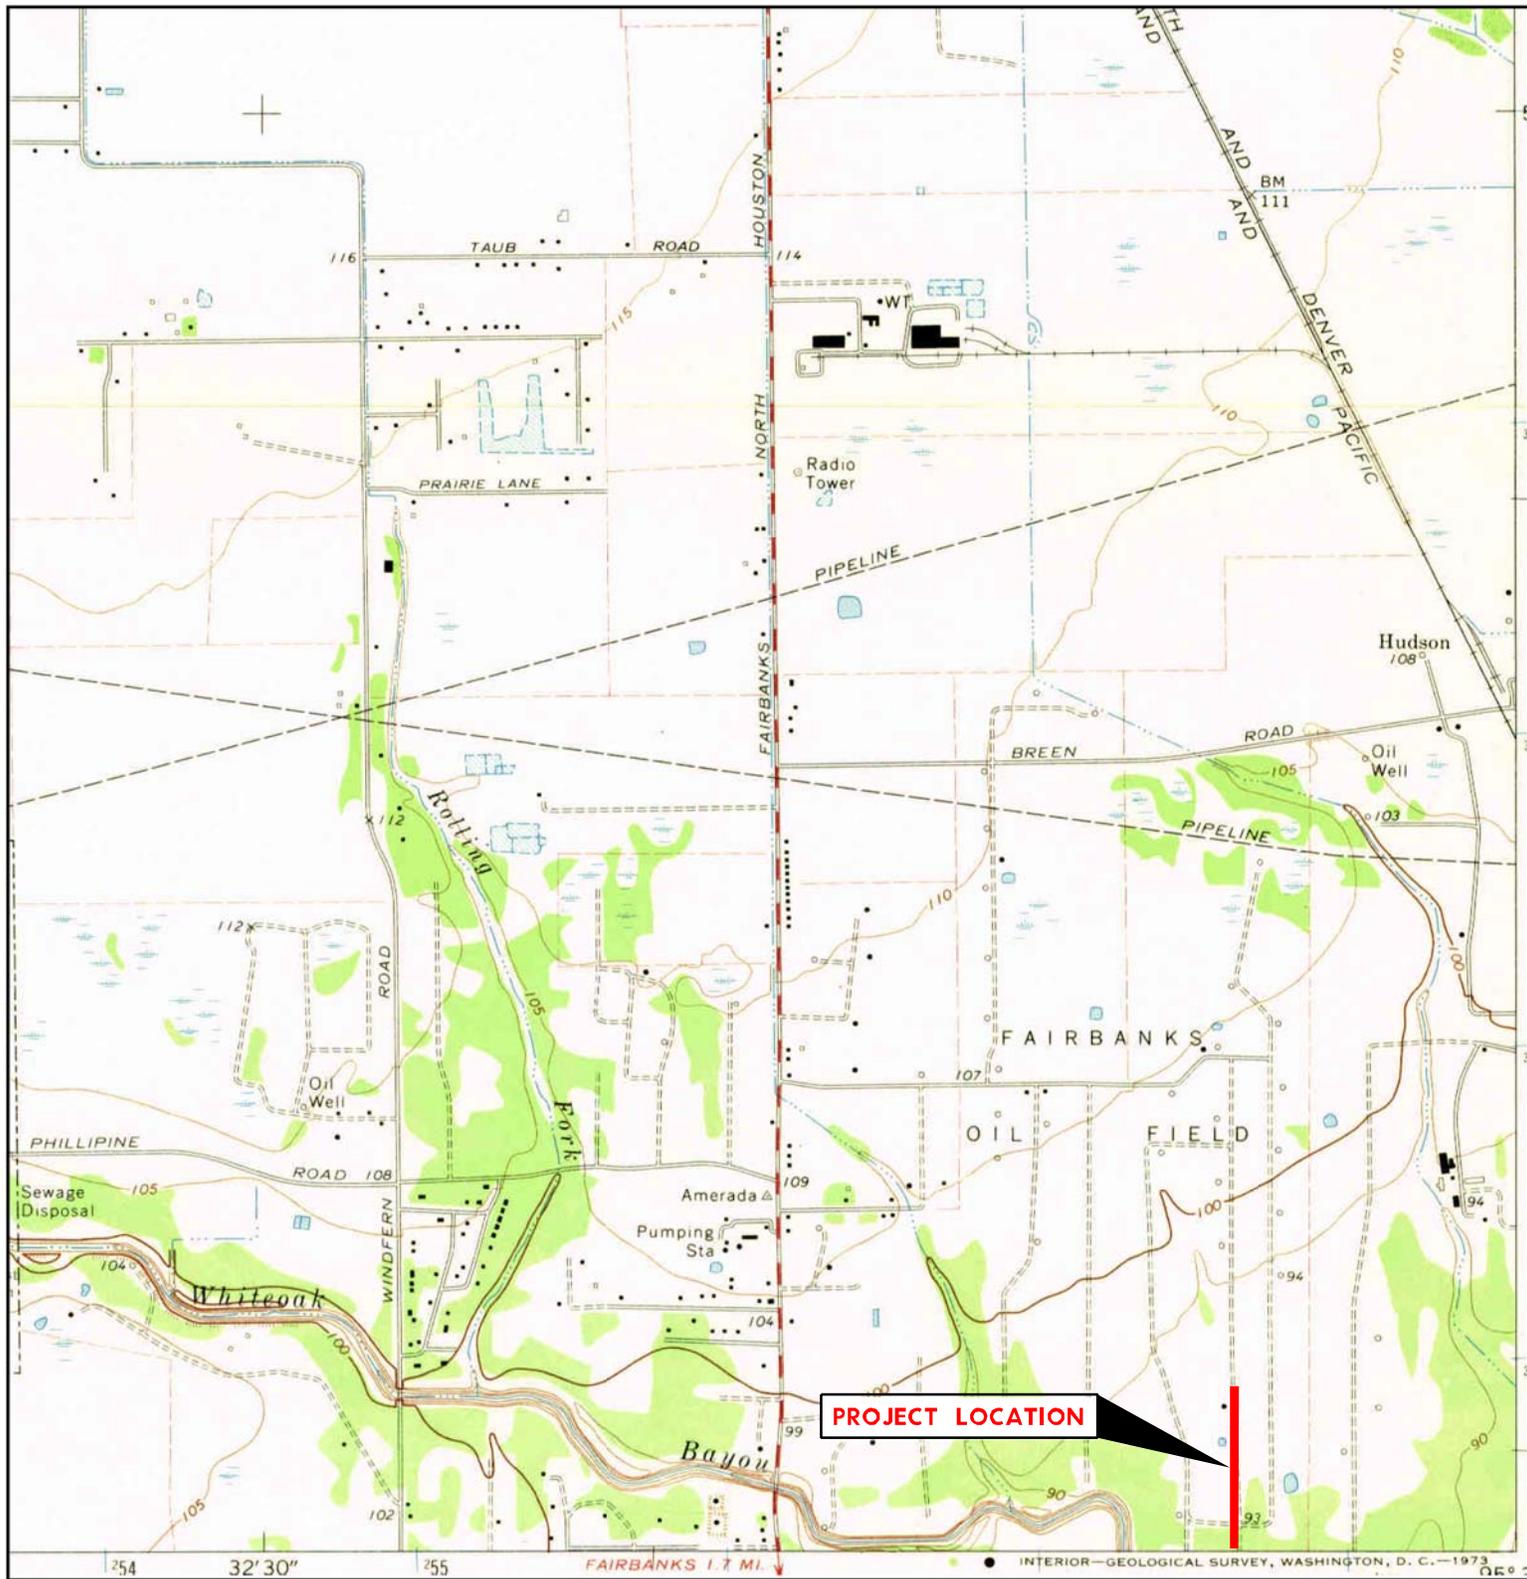
The 1970 topographic map depicts several changes. The riparian areas along White Oak Bayou are now smaller. Wetlands can be seen north and west of the project area. A pipeline is now visible north of the project alignment. Several paved streets are north and west of the project area such as Breen Road, Windfern Road, Taub Road and Philippine Road. The proposed project alignment is southeast of the Fairbanks Oil Fields. The unpaved road that was near the present day Hollister Road alignment has shifted to the west slightly and is now more defined. The elevation is now in the ranges from 115 to 90 feet above sea level.

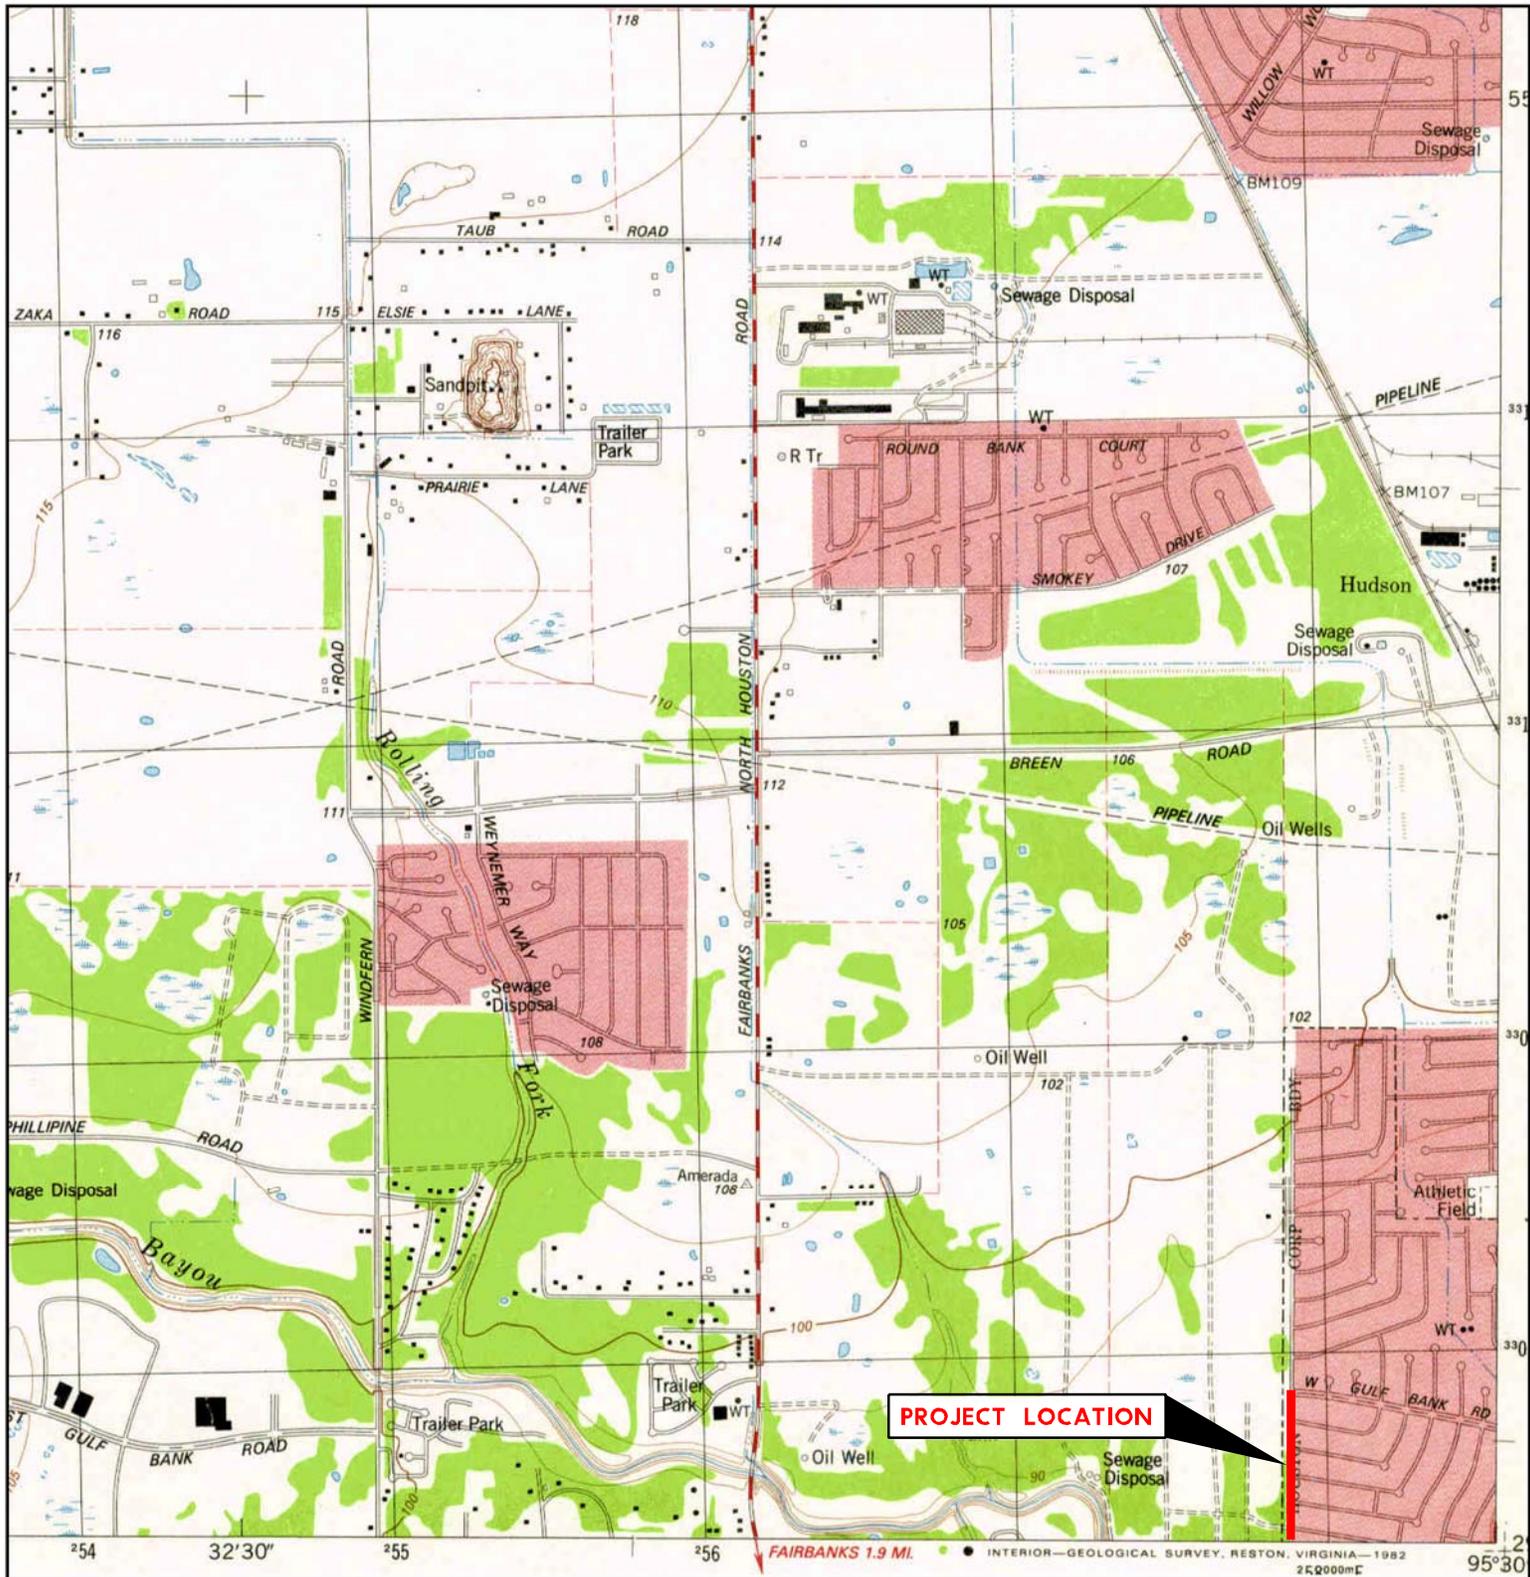
The 1982 topographic map depicts several changes from the 1970 map. A larger residential development is now located at the eastern border of the project alignment with several side streets and cul-de-sacs east of the project area. The City of Houston corporate limits are now visible along the project alignment at Hollister Road. Hollister Road is now a paved road at its present day location. West Gulf Bank Road is now visible. Oil Wells and pipelines are visible north of the project alignment. Several unpaved roads are now present along the western portion of the project alignment. The riparian areas along White Oak Bayou have now shrunk. The topography has continued to level off in the area with the elevation now ranging from 115 feet northwest of the project area to 95 feet in the southwest portion of the quadrangle map. Wetland are still present north and west of the project area, but they are becoming smaller and less numerous. A sewage disposal plant is now present west of the project alignment along with a water tank.

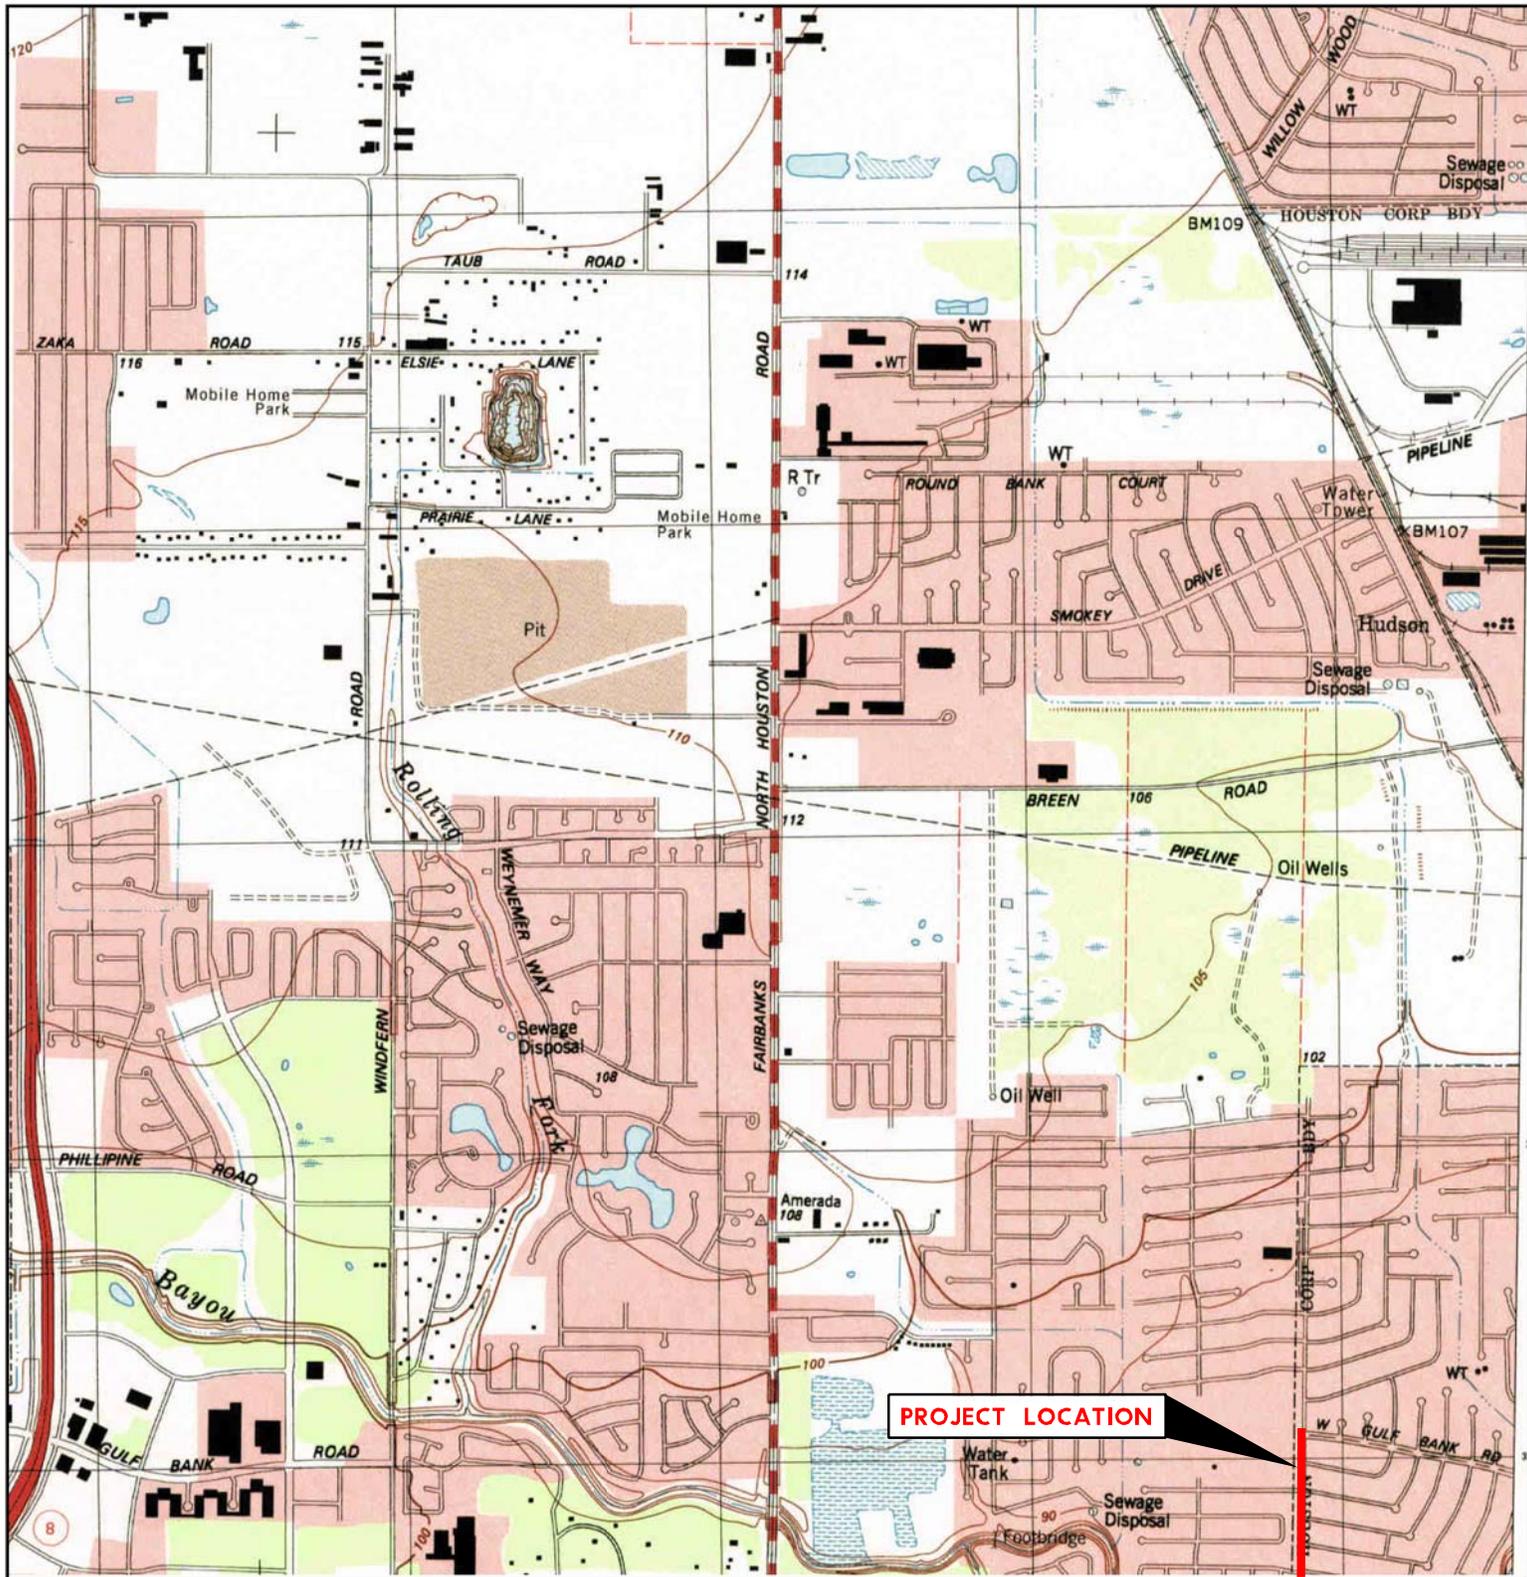
The 1995 topographic map depicts several changes from the 1982 map. Residential development can now be seen along the western border of the project alignment with side streets and cul-de-sacs. The residential areas have expanded in the region and most the surrounding area is developed. Small areas of wetlands are still present to the north, but they are become smaller and less numerous. The wetlands to the west are no longer present (with the exception of one isolated area). The riparian areas of White Oak Bayou are now almost non-existent. A man-made detention facility can be seen west of the project area. Beltway 8 is now present in the western portion of the quadrangle map.

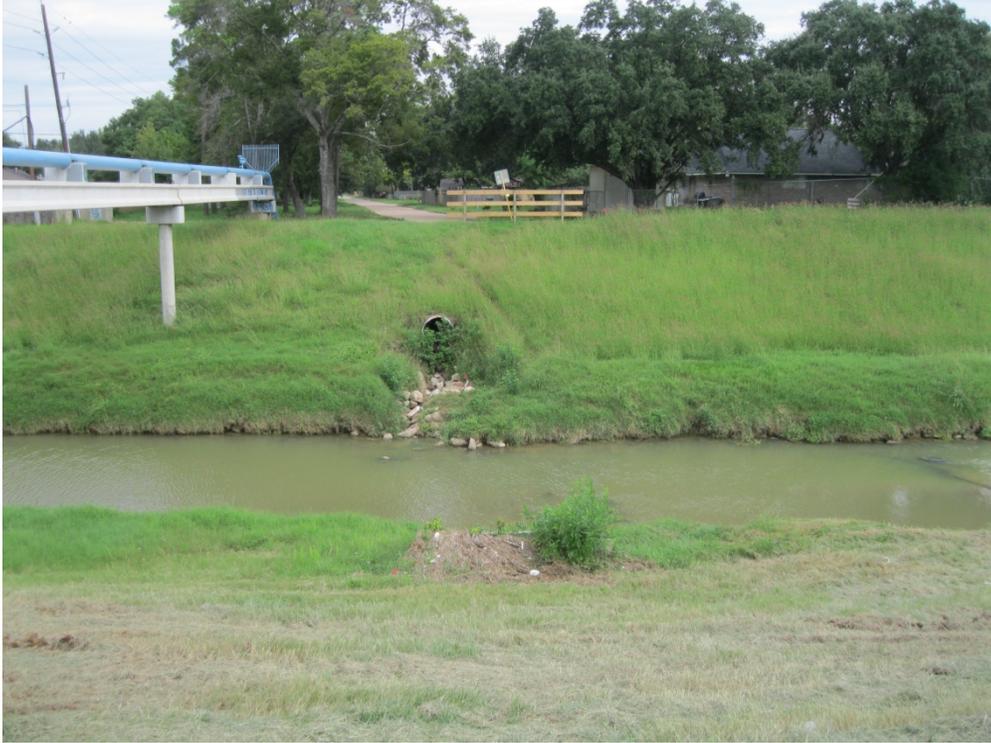
White Oak Bayou Outfall Looking North at Hollister Road

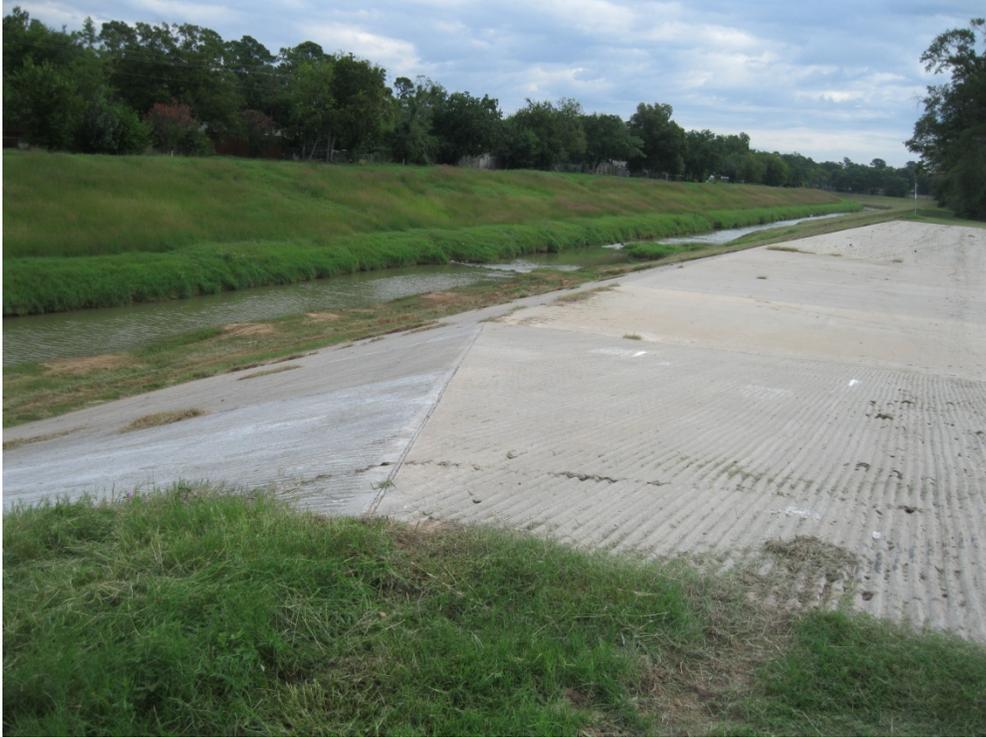
Spillway Southwest of Hollister Road facing East

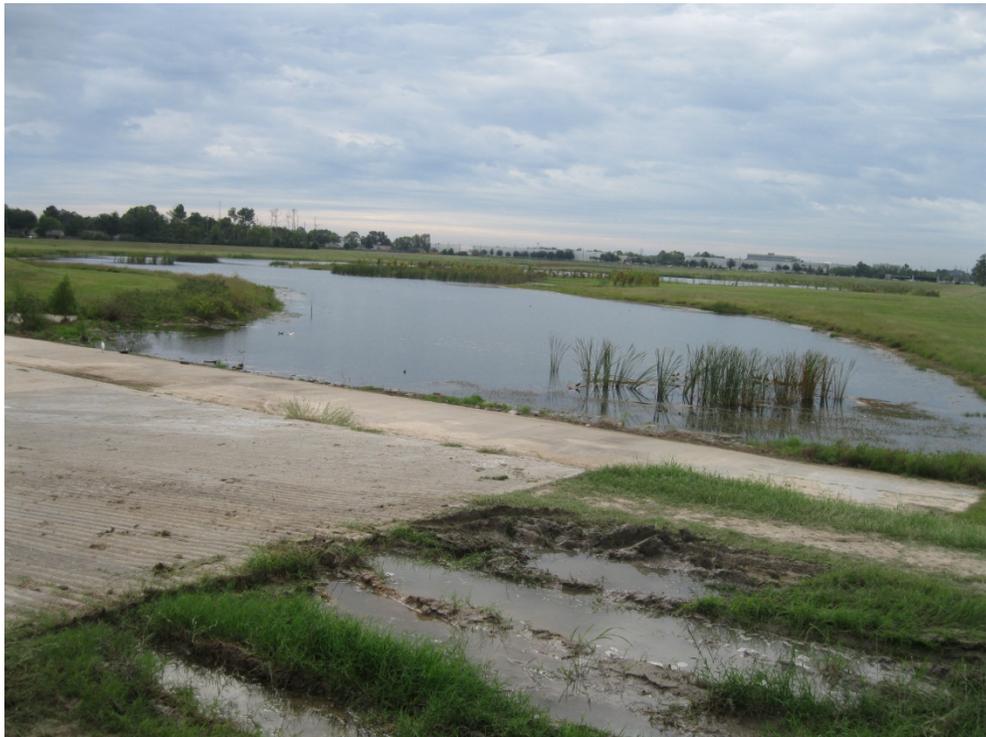
Detention Facility Southeast of Hollister Road Facing Southeast

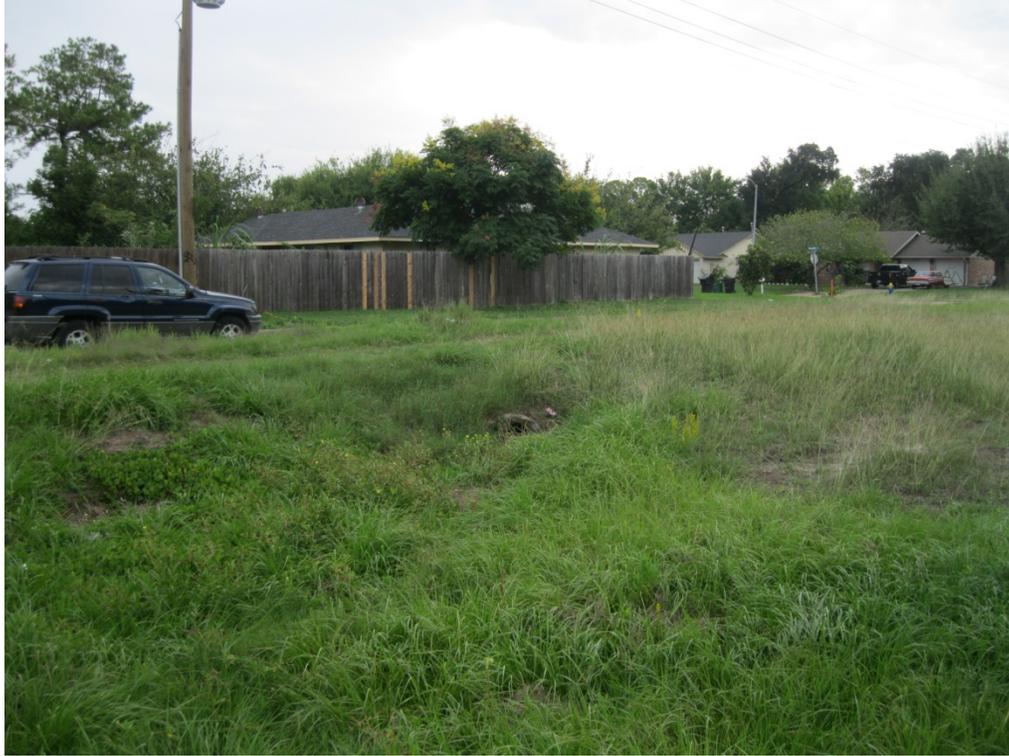
Depressed Area West of Hollister Road with Wetland Vegetation

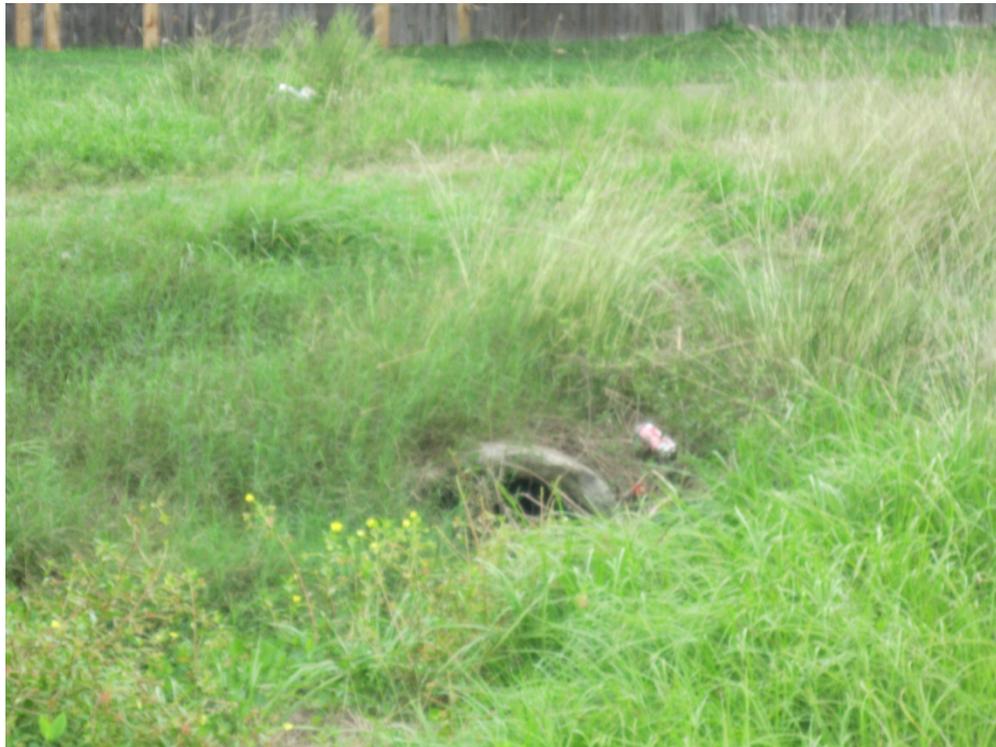
Culvert Draining Depressed Area West of Hollister Road
