WETLAND DELINEATION REPORT

HOLLISTER ROAD PAVING AND DRAINAGE

FROM NORTH OF WHITE OAK BAYOU
TO WEST GULF BANK ROAD

APRIL 2015
(REVISED APRIL 27, 2015)

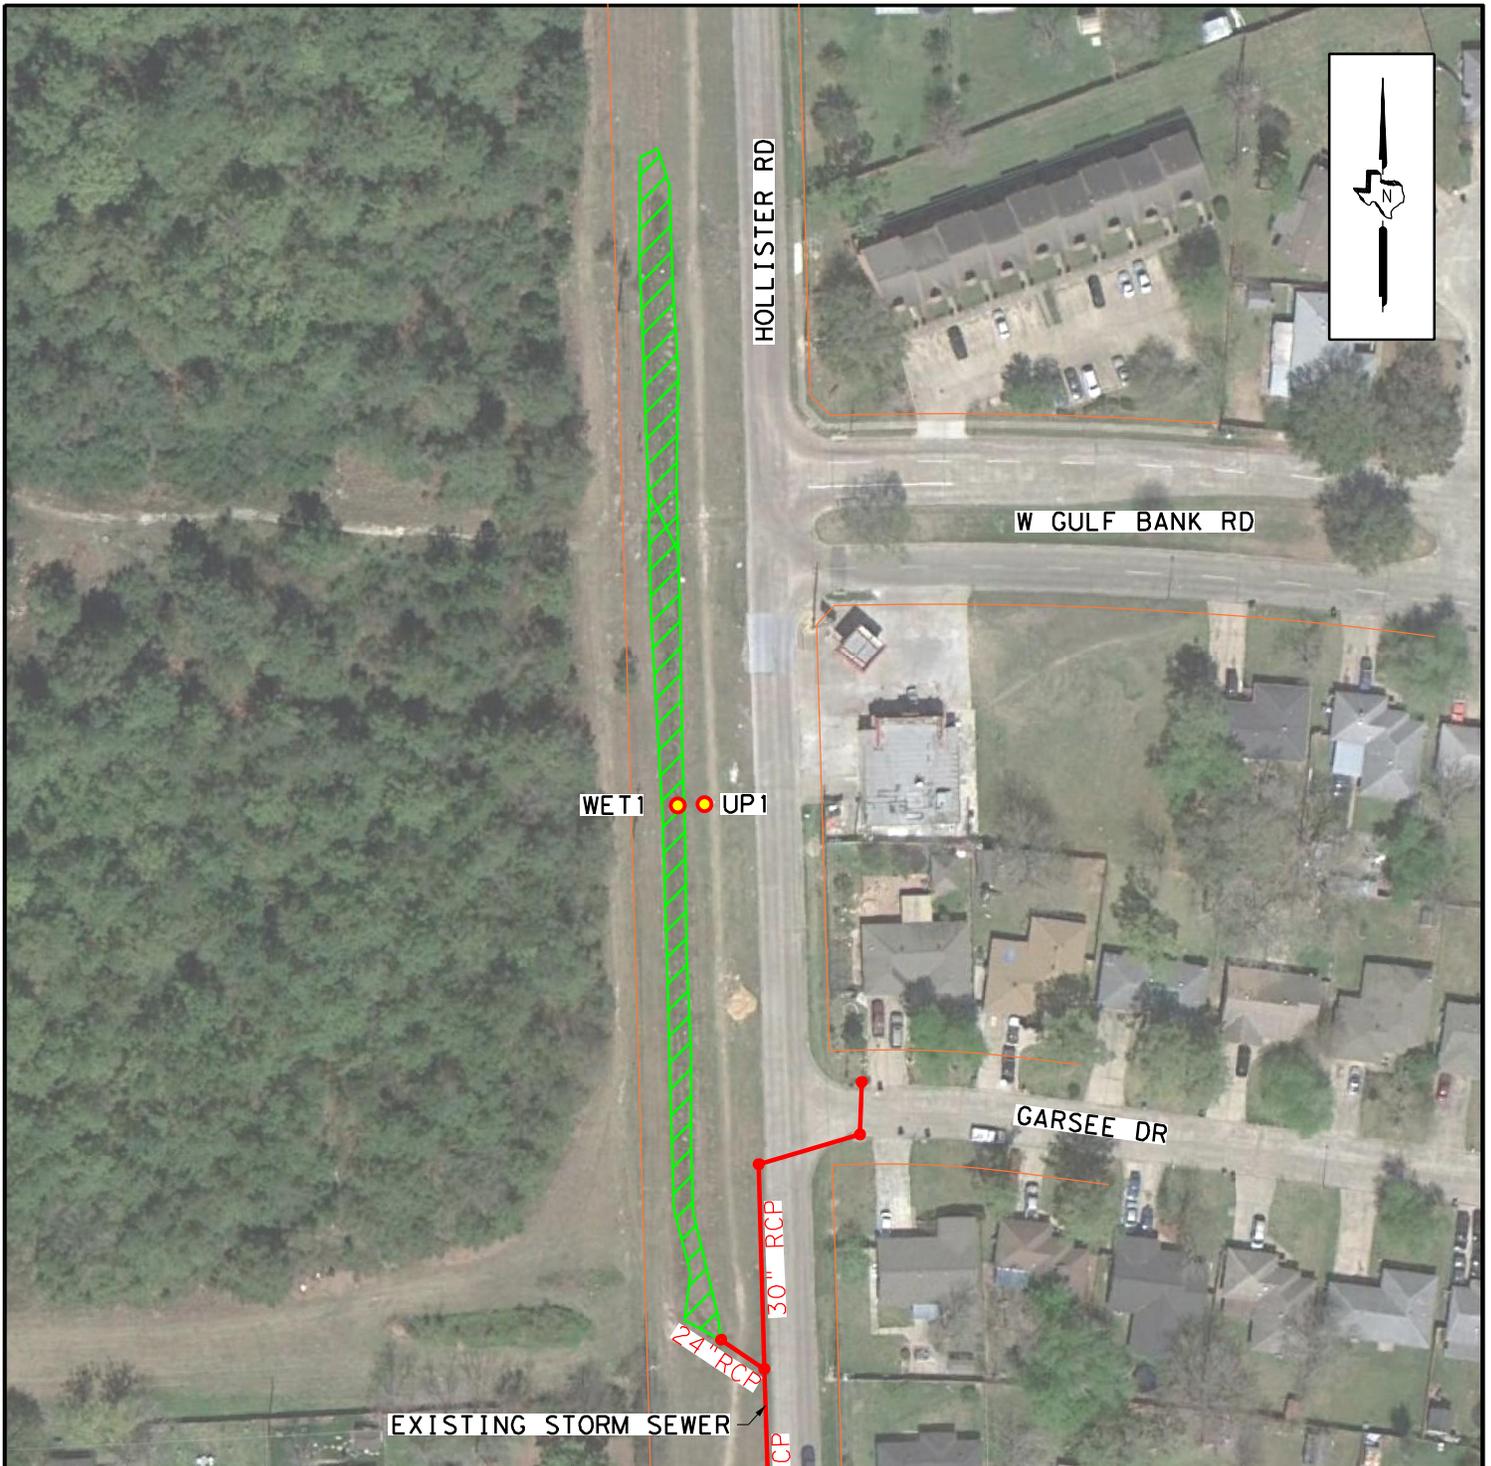
WETLAND LOCATION MAP

Several delineation points were taken along the wetland boundary to define the wetland area (GPS data is shown in Appendix K). Wetland 1 covers an area of approximately 0.1882 acres located inside the ROW limits and within the 100 year floodplain. Wetland 1 is connected to a culvert that flows to a storm sewer along Hollister Road which outfalls into White Oak Bayou.
