Asbestos Survey Report

Water Facility - Park Ten Central #1 & 2 Well
1300 Langum Creek
HOUSTON, TX

WBS No. S-001000-0046-4
Task Number 14-13
ECMS Project Number: 3817D

January 15, 2015

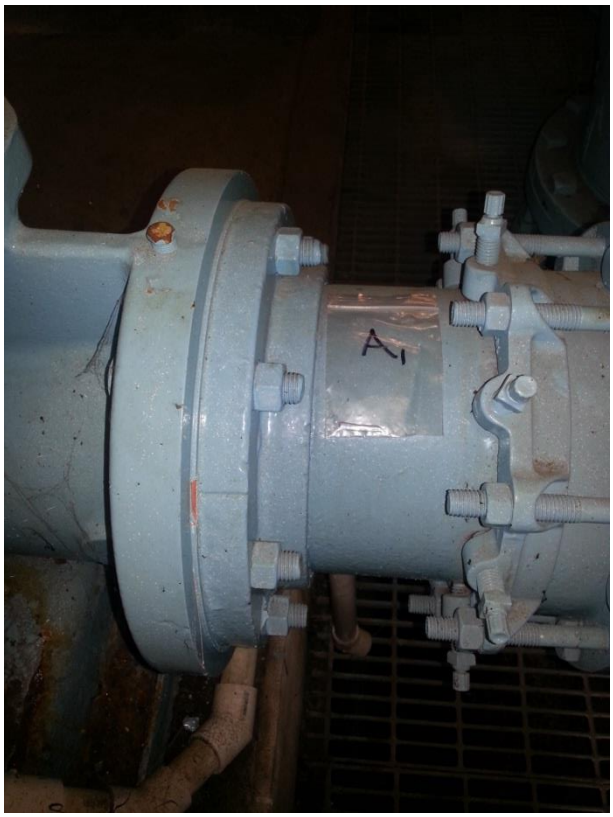
Full view of pumping system.

Medium Flange Gasket

Medium Flange – Valve Gasket

Flange at Centrifuge Base Plate

Seal at Motor Shaft

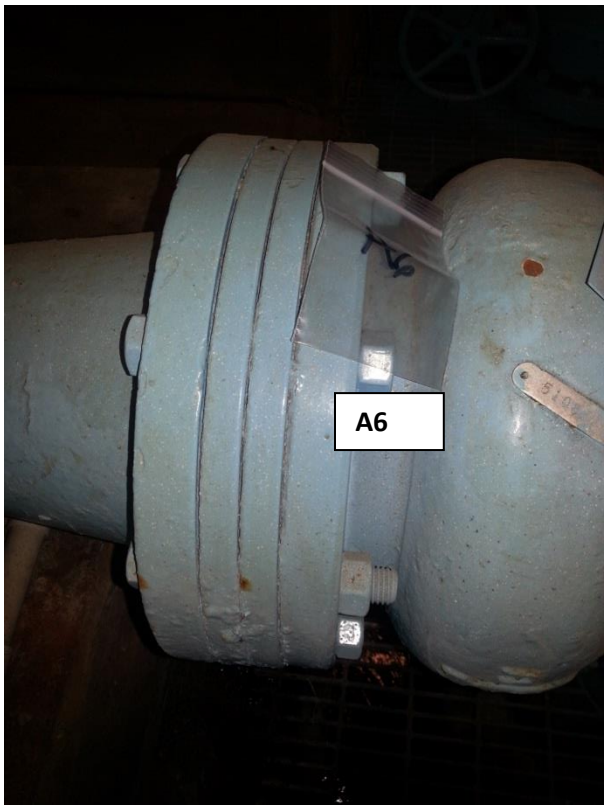
Flange Gasket

Gasket at Centrifuge Base Plate

Medium Flange Gasket

Large Plate Gasket

Small Flange - Valve Gasket

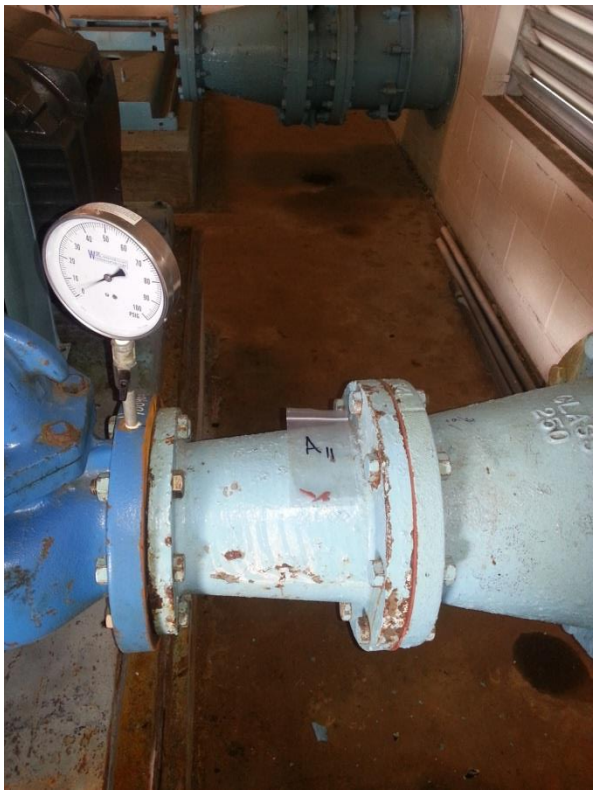
Small Flange Gasket

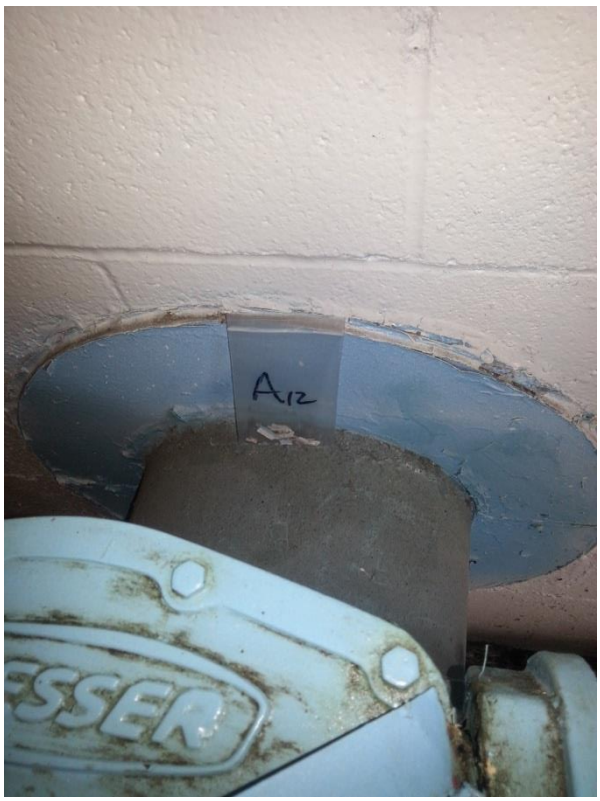
Twelve (12) bulk material samples consisting of one wall caulking, seven flange gaskets and four centrifuge pump gaskets were taken of suspect asbestos-containing materials (ACM). All sample materials were in good condition. One sample collected from centrifuge pump assembly (sample A3) and one sample taken from wall caulking (sample A12) tested positive for asbestos content.

Caulking at cement wall

Based on the analytical findings and site observation; No action necessary unless renovation, remodeling, or demolition is planned. (City of Houston Hazard Category C-3)
