**PHASE I GEOLOGIC FAULT ASSESSMENT
SKYSCRAPER SHADOWS LOCAL DRAINAGE PROJECT
STORM SEWER AND PAVING
WBS NO. M-000126-0070-3
HOUSTON, HARRIS COUNTY, TEXAS**

**PREPARED BY
HVJ ASSOCIATES, INC.
HOUSTON, TEXAS
FEBRUARY 17, 2015**

**REPORT NO. HE1510720
KEY MAP 575 P & Q**

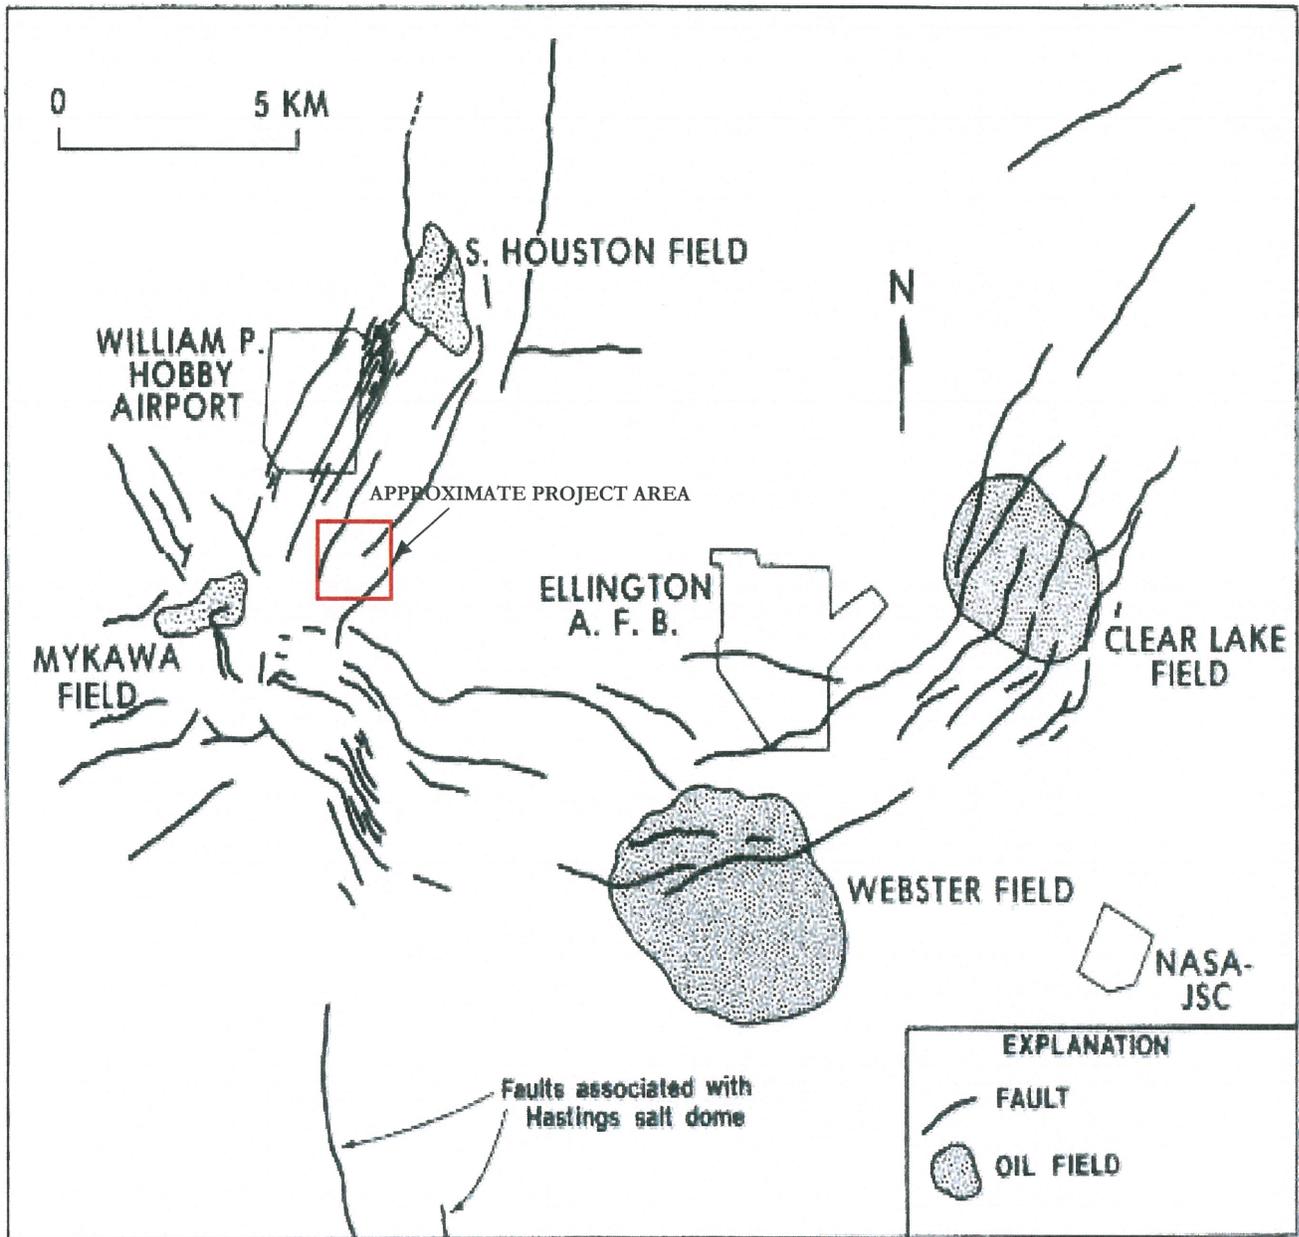
Verbeek and U.S. Clanton label this fault as Fault 25. This fault is part of a series of parallel faults that extend to the southwest off the South Houston Oil Field (see Plate 2 - Project Area Fault Pattern Map and Plate 3 – Project Area Fault Location Map).

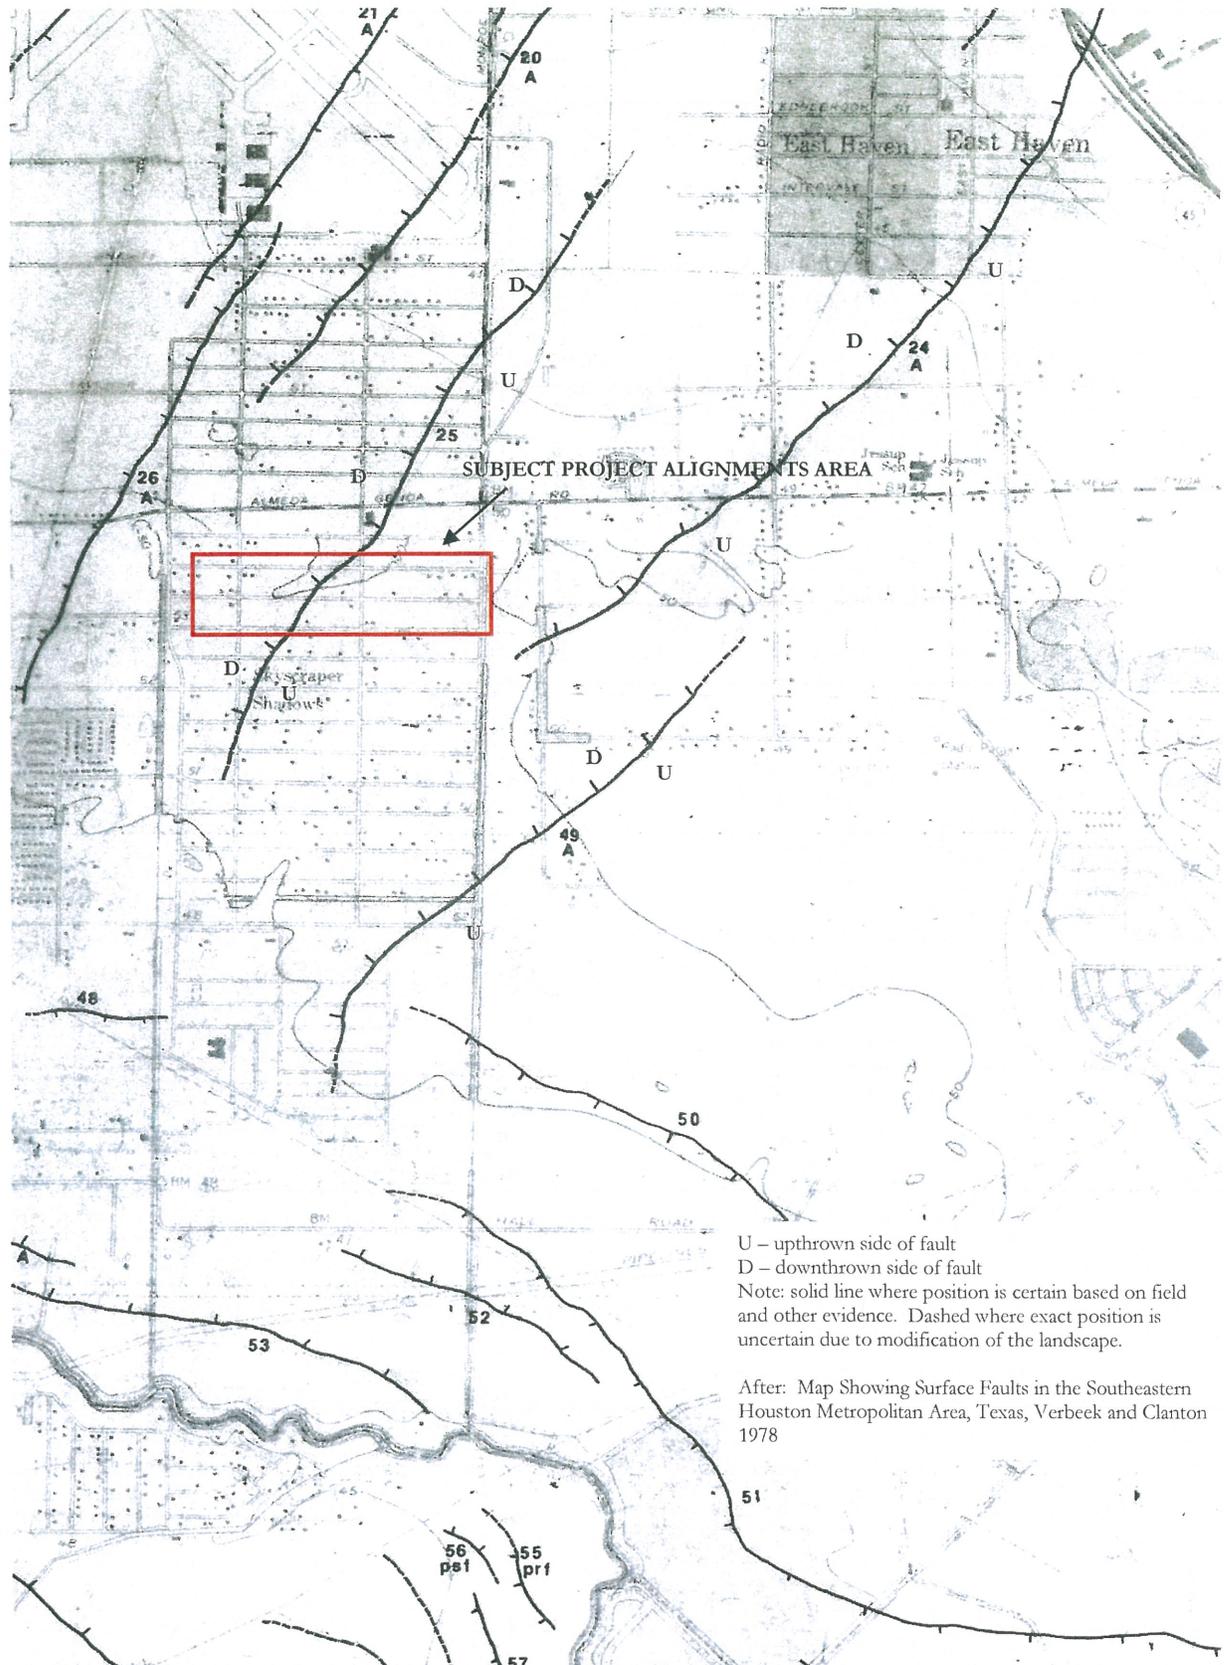
Plate 3
 Project Area Fault Location Map
 Skyscraper Geologic Assessment Project
 Houston, Harris County, Texas

United States Geological Survey Open File Report 78-797 "Map Showing Surface Faults in the Southeast Houston Metropolitan Area, Texas" by E.R. Verbeek and U.S. Clanton (1978) shows southwest to northeast trending down to the northwest geologic Fault 25 crossing the Subject Project Alignments. Geologic Fault 25 crosses Gulick Lane near the intersection of Wingtip, extends to the southwest crossing Lanham and Holiday and ends south of the Subject Project Alignments area south of Fuqua. This fault is radial to the old South Houston Oil Field approximately three mi. northeast of the Subject Project Alignments area. A portion of the U.S.G.S. map which shows several Geologic Faults in the area is provided as Plate 3 - Project Area Fault Location Map.

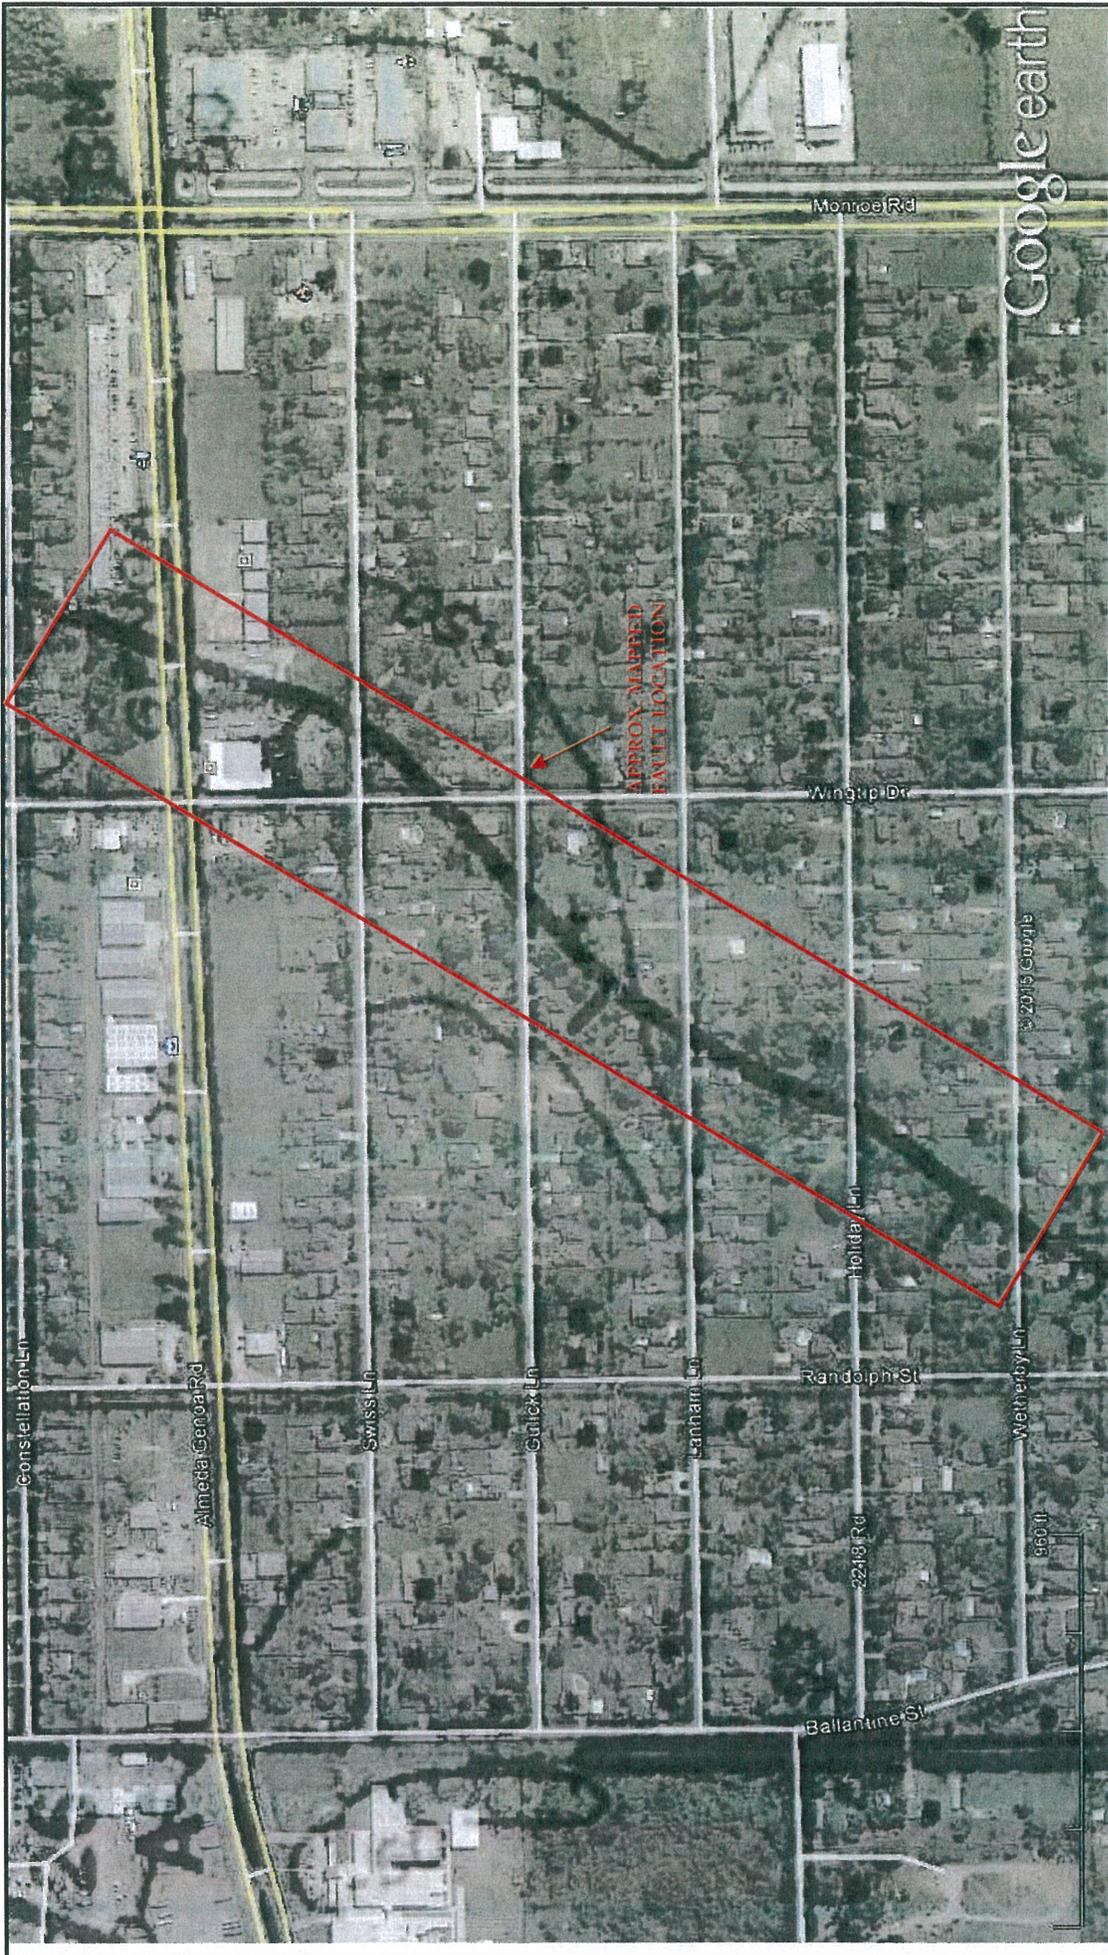
Plate 4A
 Approximate Mapped Fault Location Map
 on Current Aerial Photograph
 Skyscraper Project Area
 Houston, Harris County, Texas

Field reconnaissance was performed to physically observe the fault and to identify features. Geologic Fault 25 may cross Gulick Lane at/near the intersection of Gulick Lane and Wingtip (see Plates 3 and 4A/4B). The upthrown zone of fault influence for this fault is estimated to extend 100 ft. southeast of the approximate mapped fault location. The downthrown zone of influence for this fault is estimated to extend 100 feet northwest of the approximate mapped fault location (see Plate 5A & 5B).
