PHASE I GEOLOGICAL FAULT INVESTIGATION
CITY OF HOUSTON WATER LINE
REPLACEMENT IN
KICKERILLO AREA
WBS NO. S-000035-0185-3
HOUSTON, TEXAS

REPORT NO. 1140194602

GEOTEST ENGINEERING, INC.
Houston, Texas

December 20, 2013

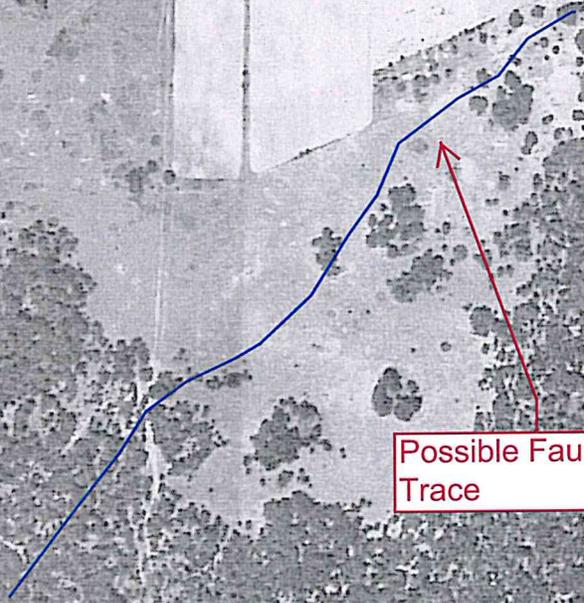
FIGURE 2.7

A series of seven (7) aerial photographs of the project area for the years 1944 to 2009 were reviewed. The review of aerial photographs indicated that the project area was developed to residential area between the years 1953 and 1978. The aerial photographs of 1944 and 1957 indicate some evidence of color shading which may be indicative of Long Point Fault. The aerial photographs are presented on Figures 2.1 through 2.7.

Possible Fault Trace
