Subject: **SOUTHWEST WASTEWATER TREATMENT
PLANT
4211 BEECHNUT
WBS No. R-000265-0103-4**

Asbestos Survey Report

Southwest Waste water Treatment Plant
4211 Beechnut
HOUSTON, TX

WBS No. R-000265-0103-4
Task Number 15-04
ECMS Project Number: 3830

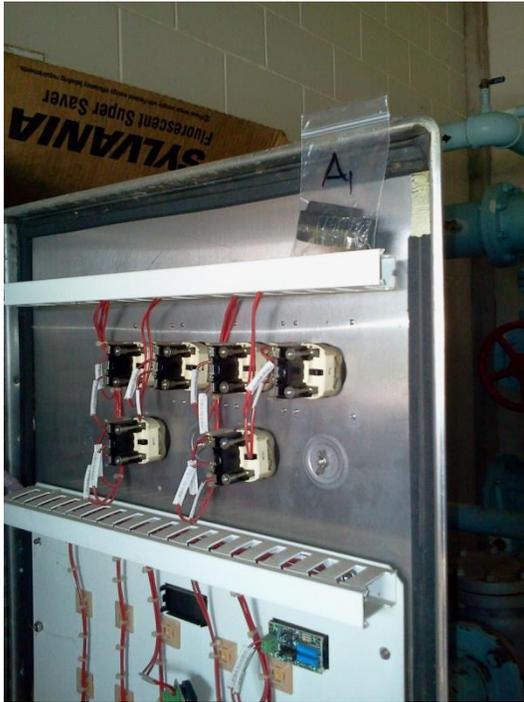
Door Seal Gasket – Door Control Panel Portable Water Building

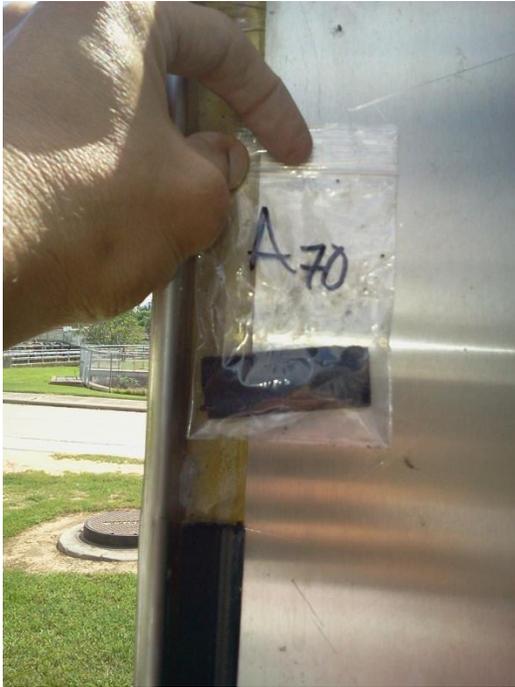
Seal and Door at LPC 0760 Right Panel

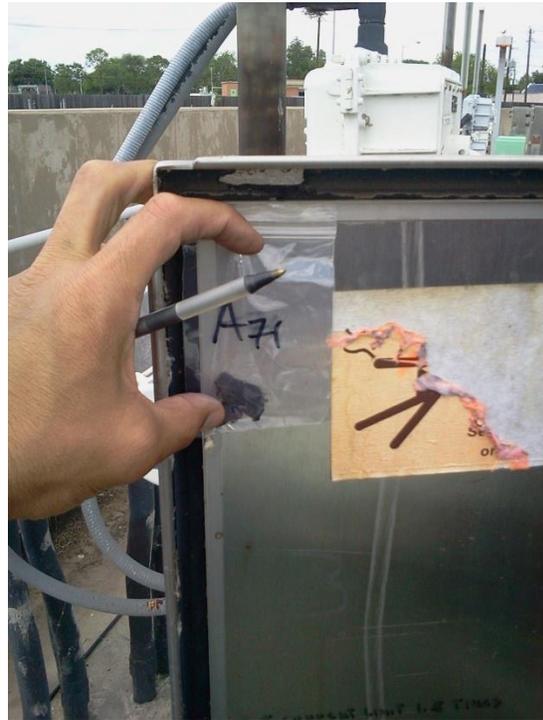
Seal and Door at Control Panel LP5A2A CKT. 6

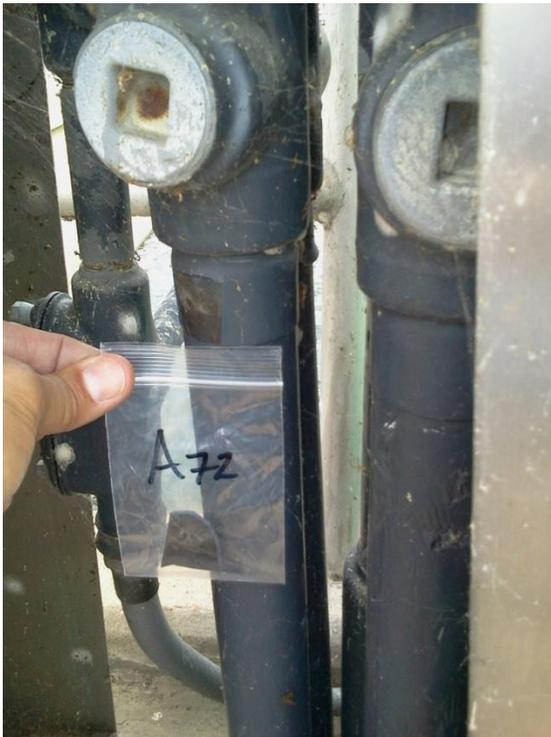
Pipe Coat Resin at base of Panel LP5A2A CKT. 6

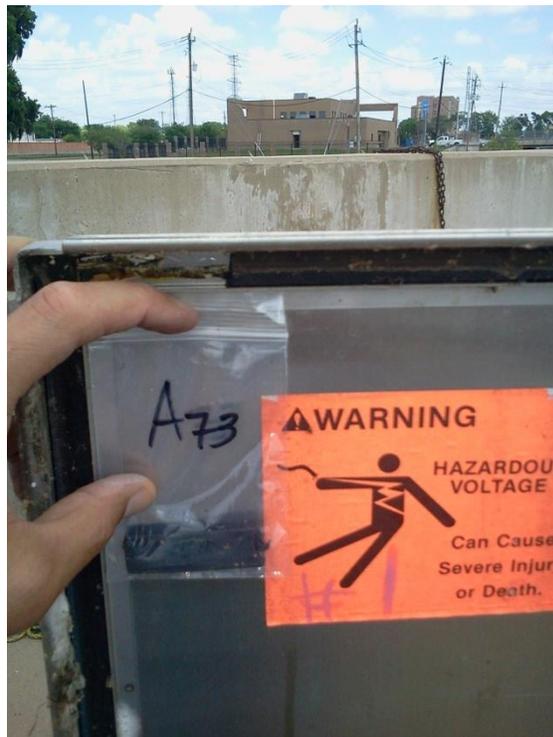
Seal and Door at Control Panel LP5A2A CKT. 8

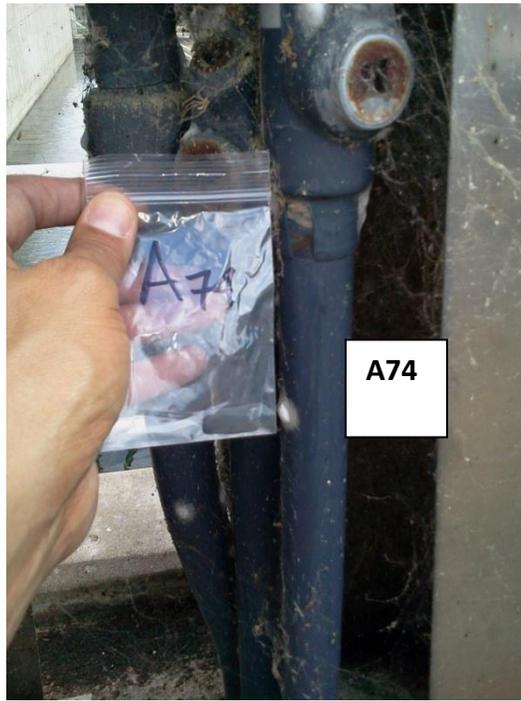
Pipe Coat Resin at base of panel LP5A2A CKT. 8

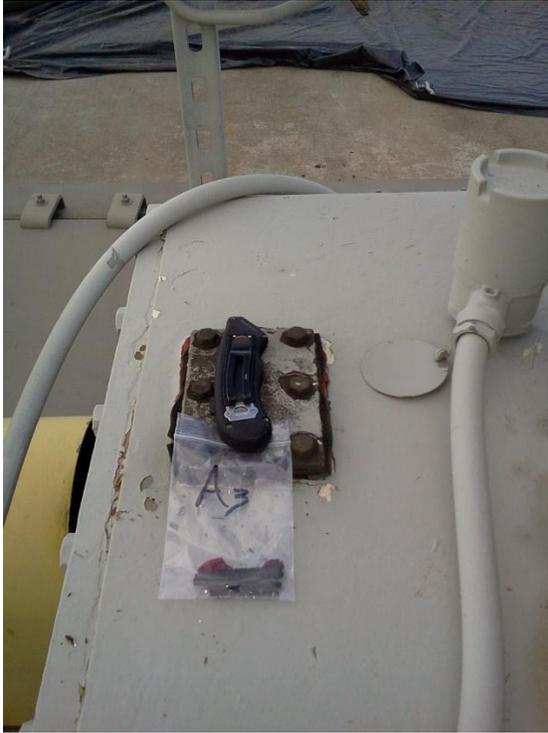
Gasket top Plate of Mixer #030253 NW

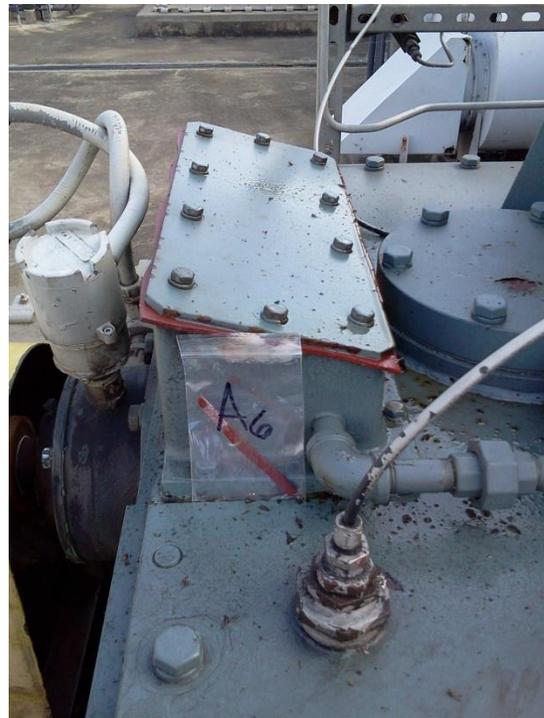
Gasket top Plate of Mixer #118615 S Corner

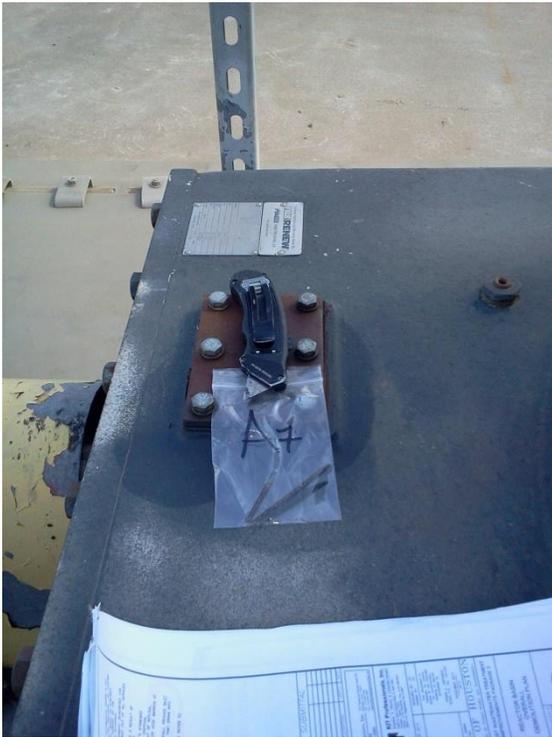
Gasket top Plate of Mixer #117800 Extreme SW Corner

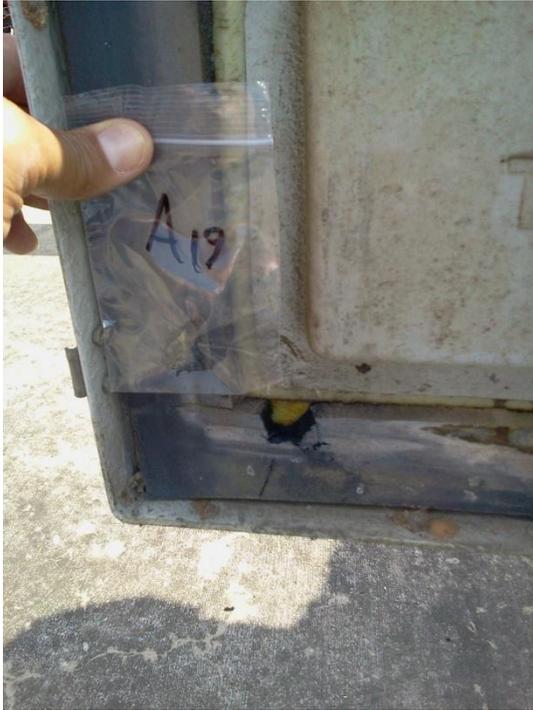
Gasket Door Seal at Junction Box
Electrical #AIT-0233

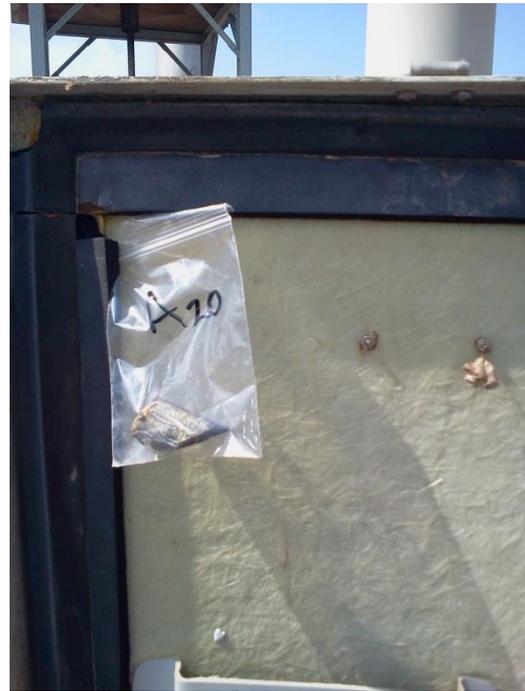
Gasket Door Seal Junction Box
Electrical #AIT-0244

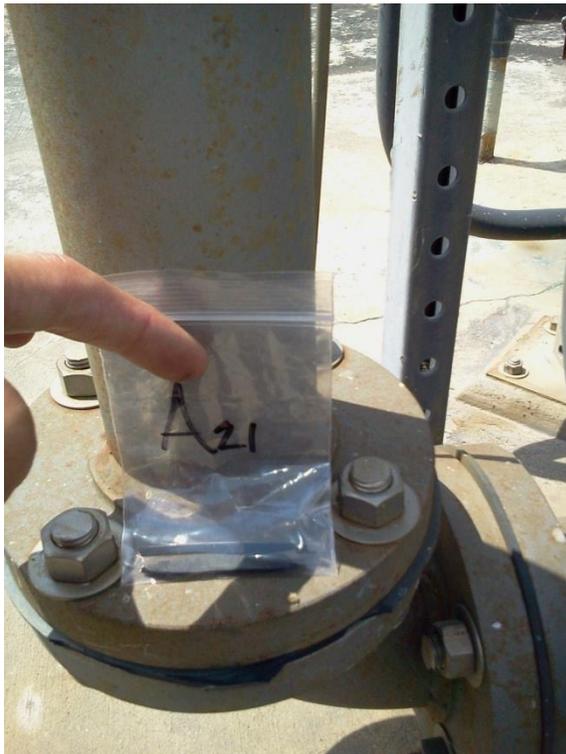
Small Flange Gasket
system 5 of Gas Sampling Station North

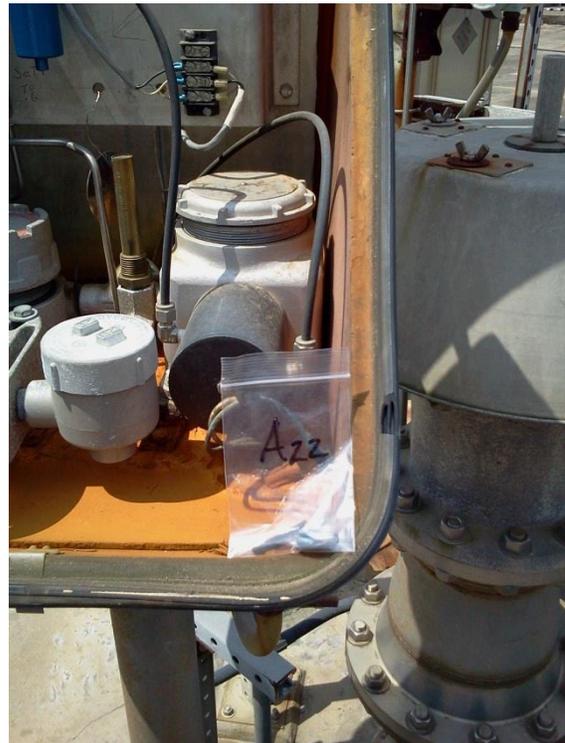
Door Seal at Upright Control Box
system 5 of Gas Sampling Station North

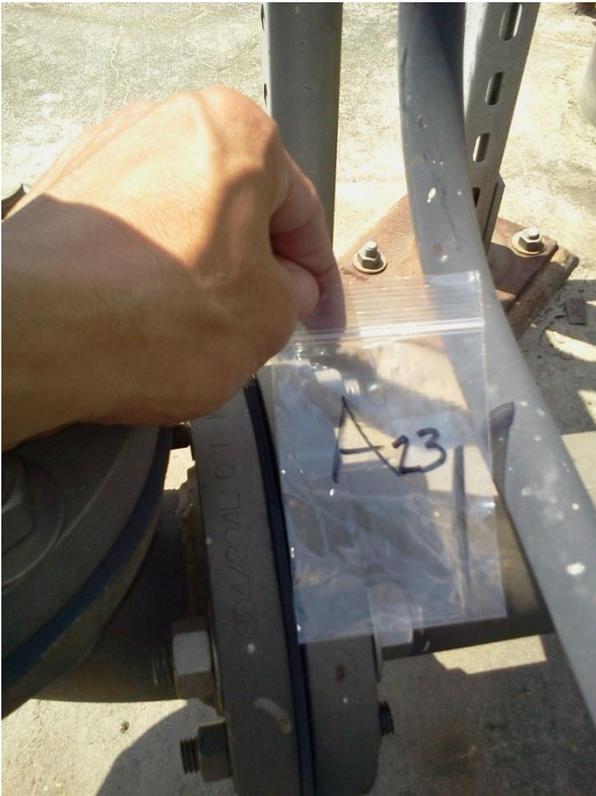
Small Flange Gasket
System 4 of Gas Sampling Station

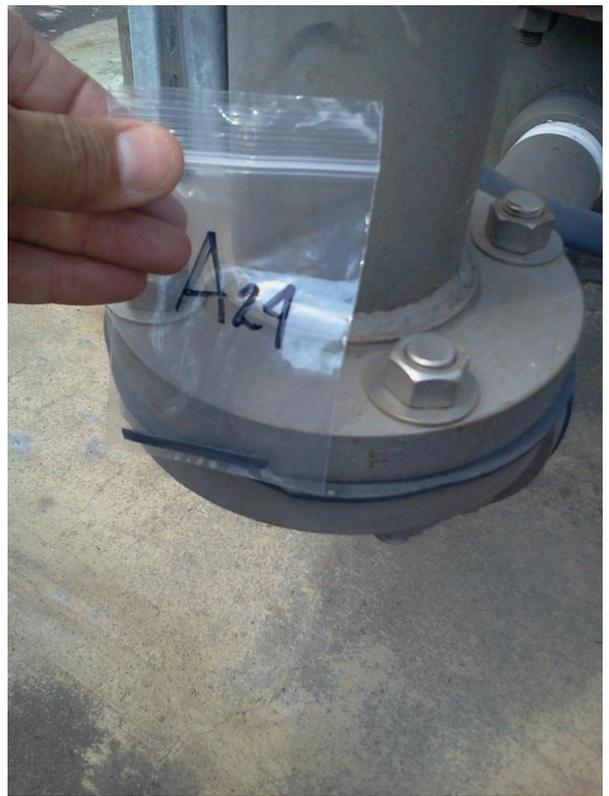
Small Flange Gasket
System 3 of Gas Sampling Station

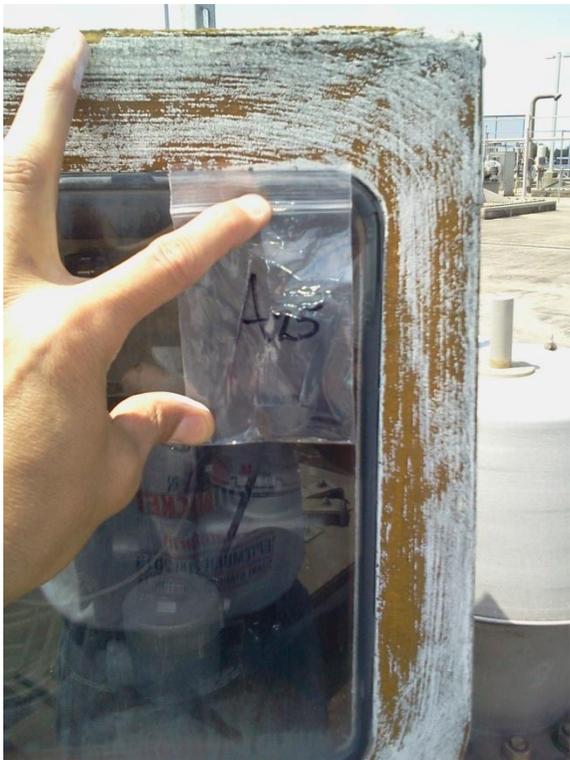
Door Seal at Upright Control Box

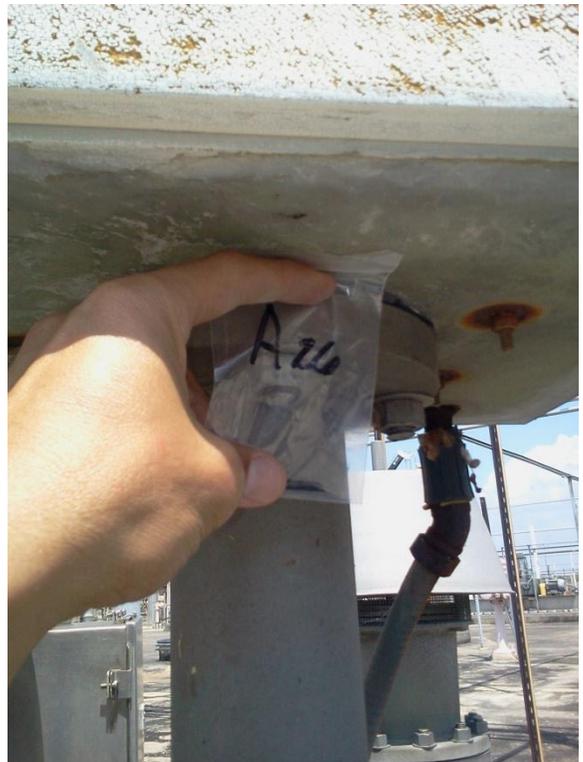
Small Flange Gasket at base of box
System 1 Gas Sampling Station

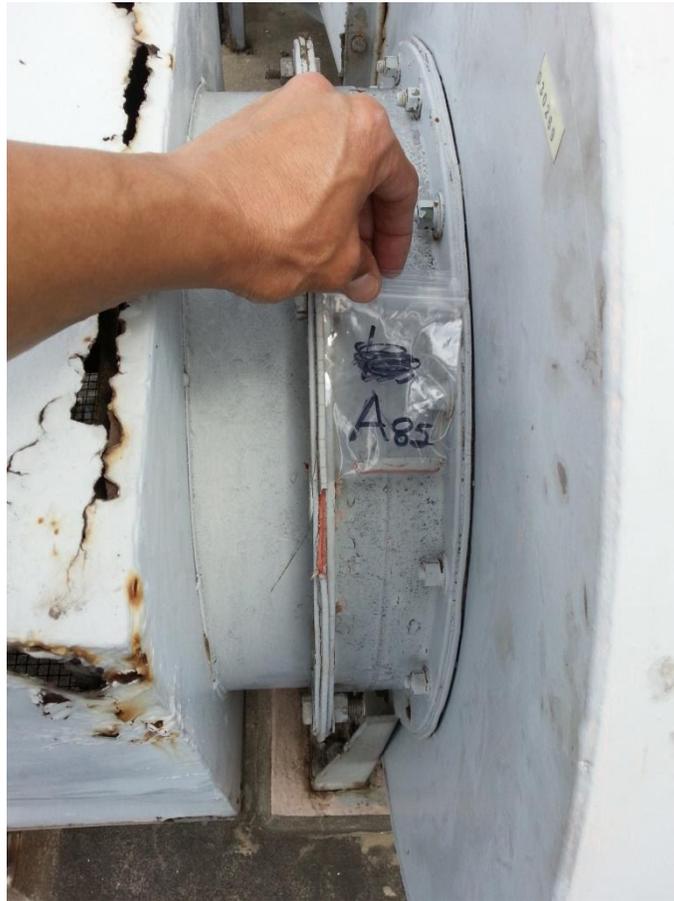
Large Circular Flange Gasket at Vent Intake
Blower #030269 Extreme E/SE Corner

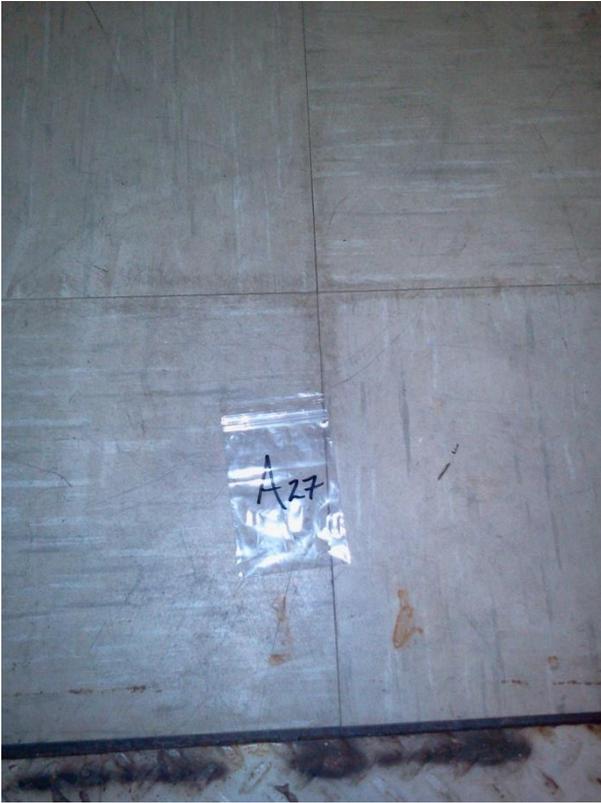
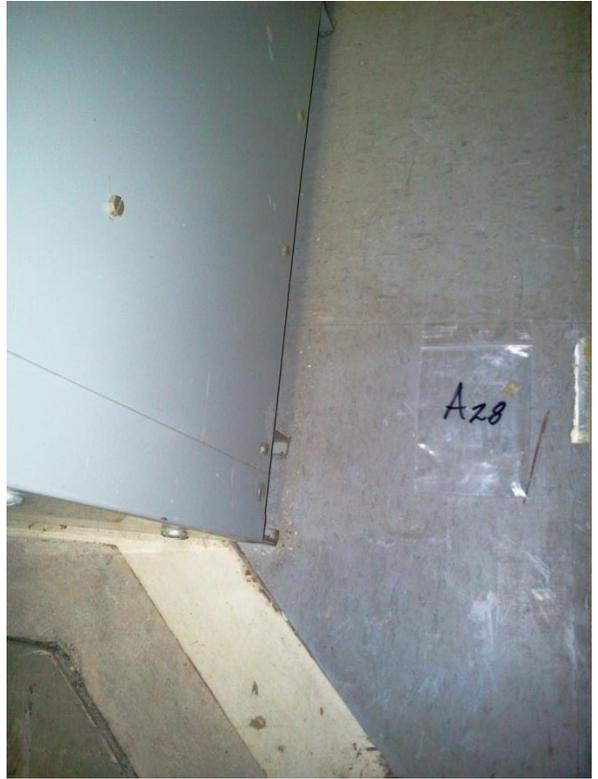
12x12 floor tile SW Corner adjacent to exit door

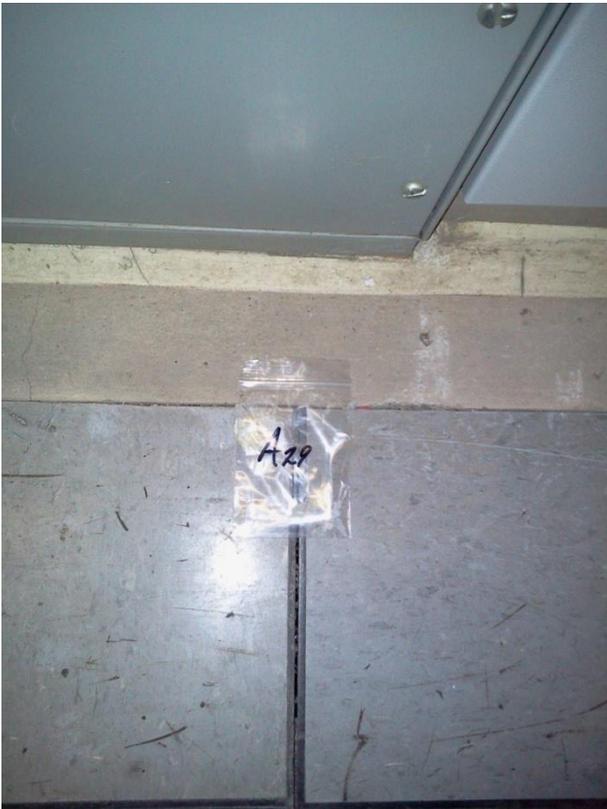
12x12 floor tile NW Area adjacent to I/0270 Cabinet

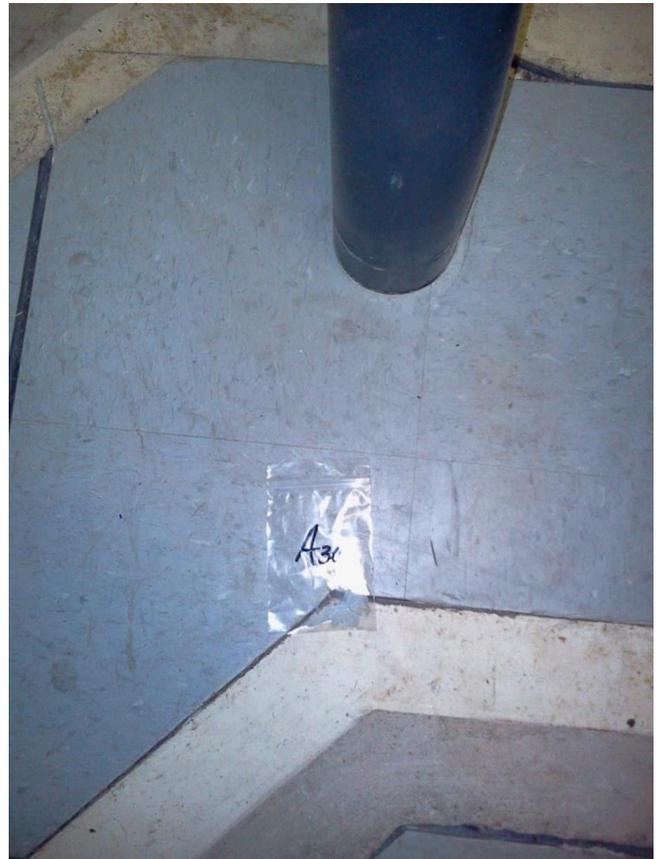
12x12 floor tile NE Corner area adjacent to MCC-7B2 Cabinet

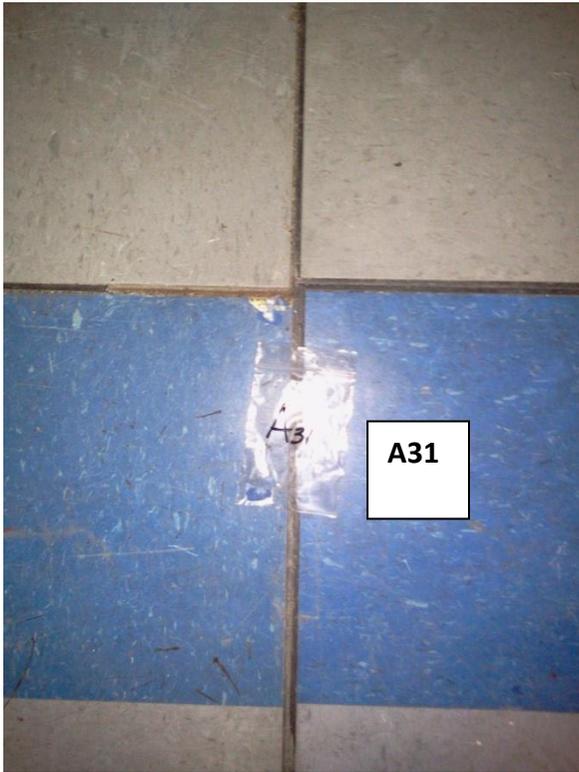
12x12 floor tile NW Corner area adjacent to PC 270 Cabinet

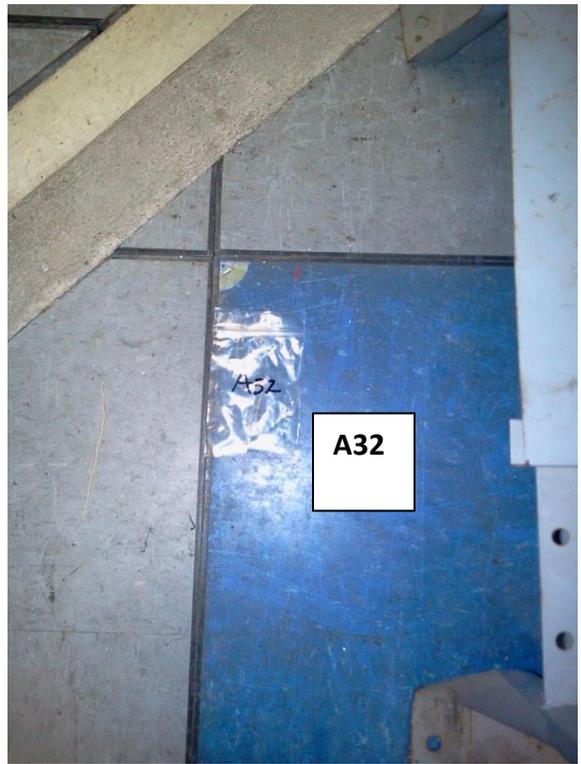
12x12 floor tile SE Corner area adjacent to MCC-7A1 Cabinet

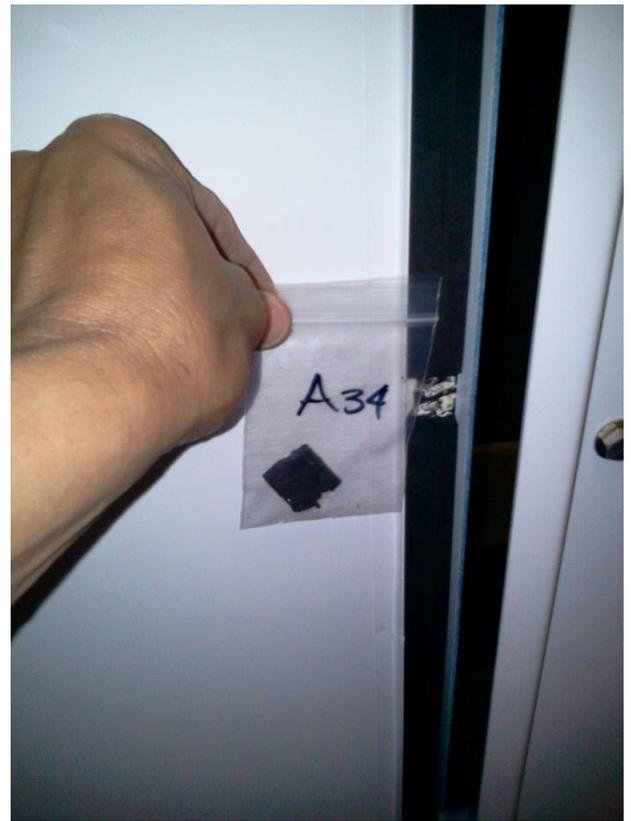
Seal and door of cabinet – Cabinet PC 270 Door

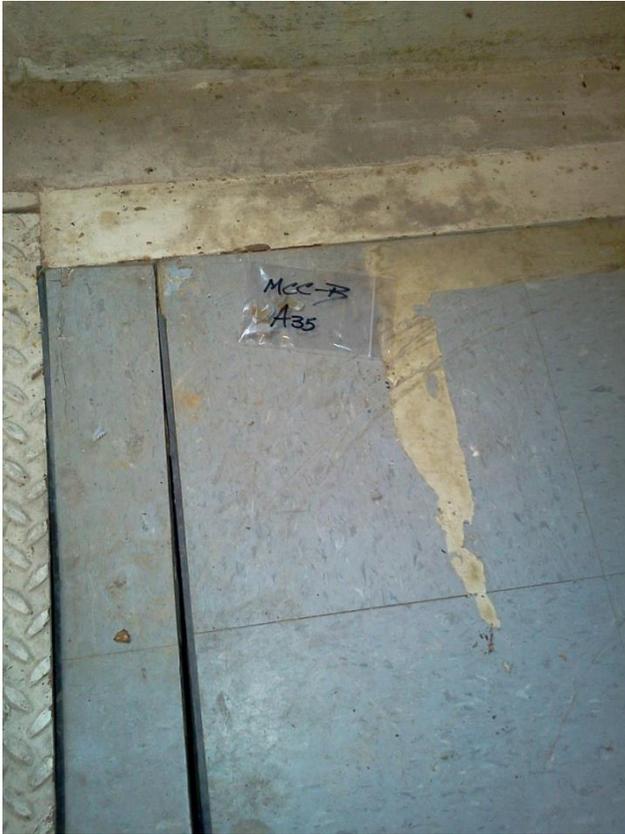
12x12 floor tile W/NW corner of building

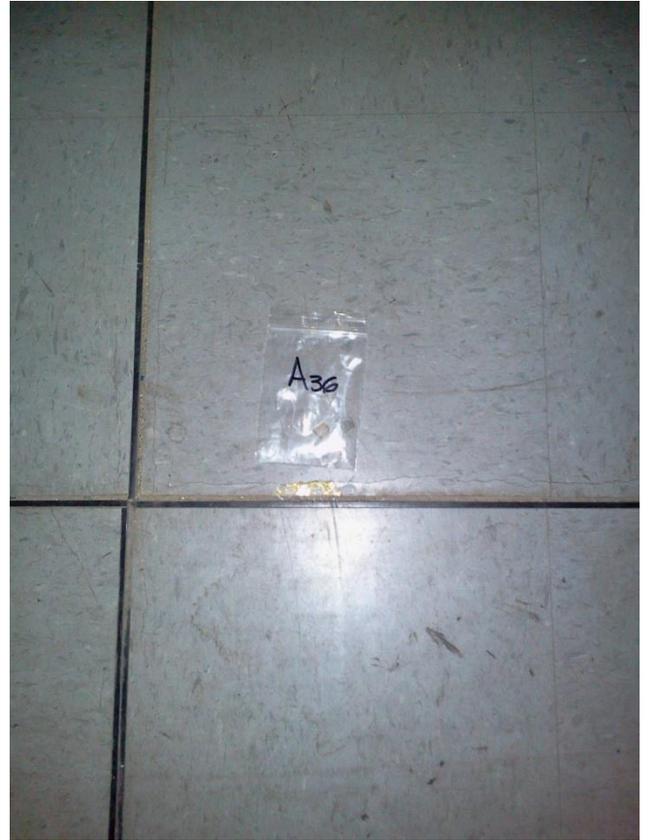
12x12 floor tile North of floor adjacent to LPC-150 Cabinet

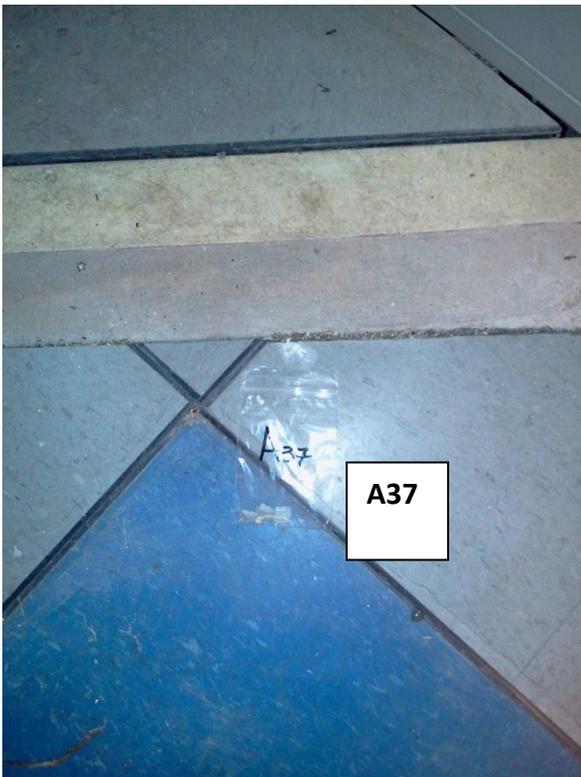
12x12 floor tile E/SE of building area

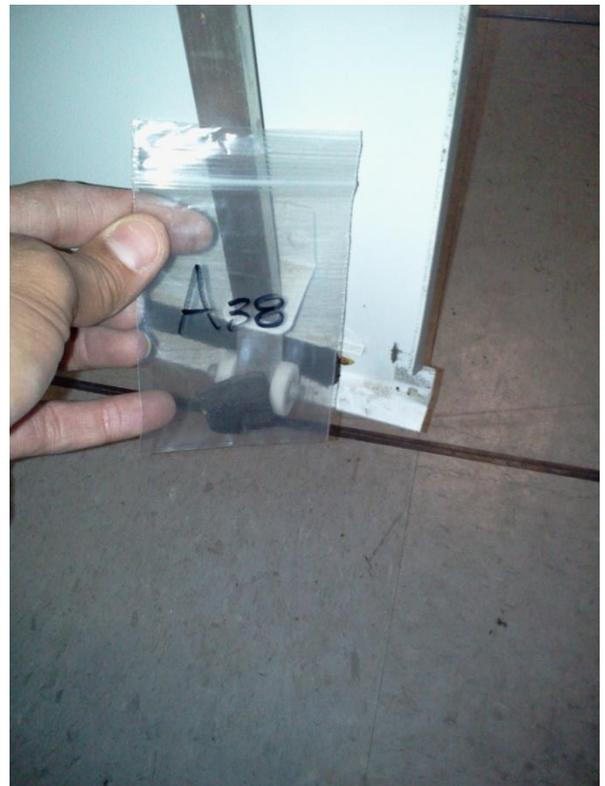
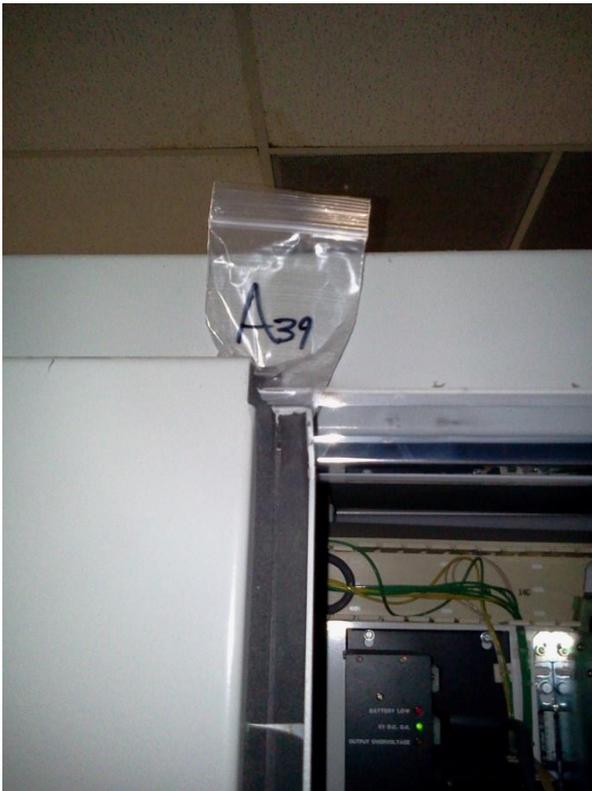
Door Seal Cabinet LPC-150

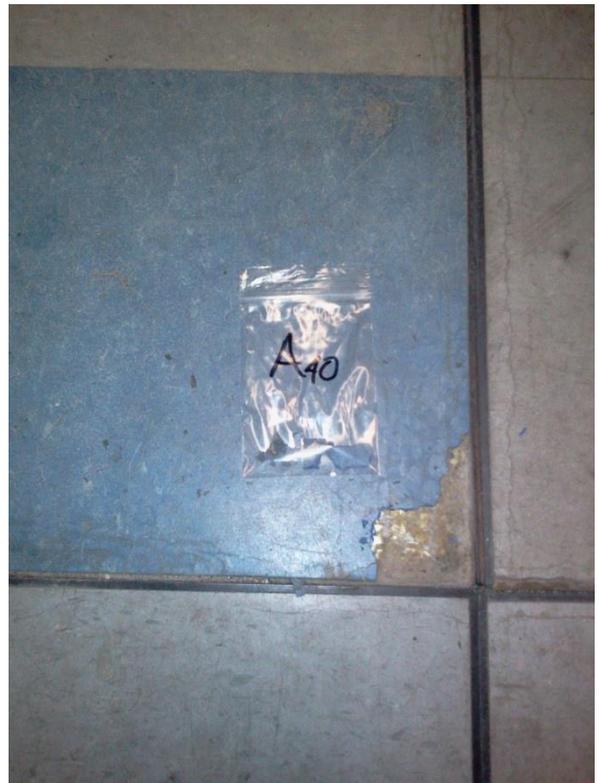
12x12 floor tile West area of building

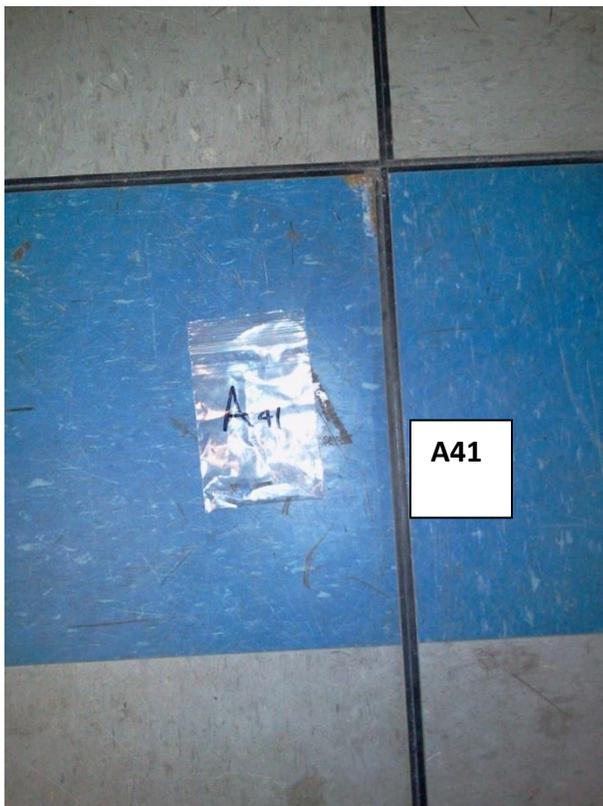
12x12 floor tile South area of building

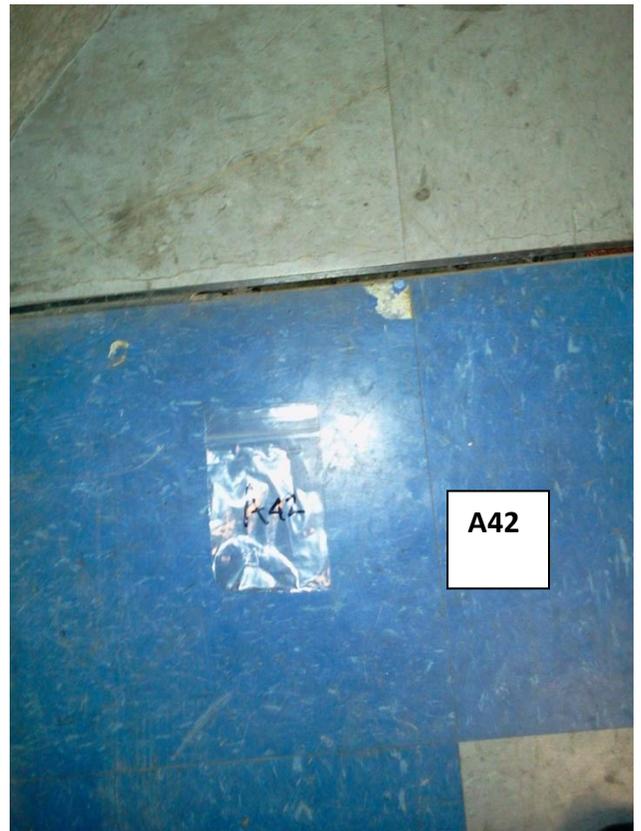
12x12 floor tile NE area adjacent to exit door

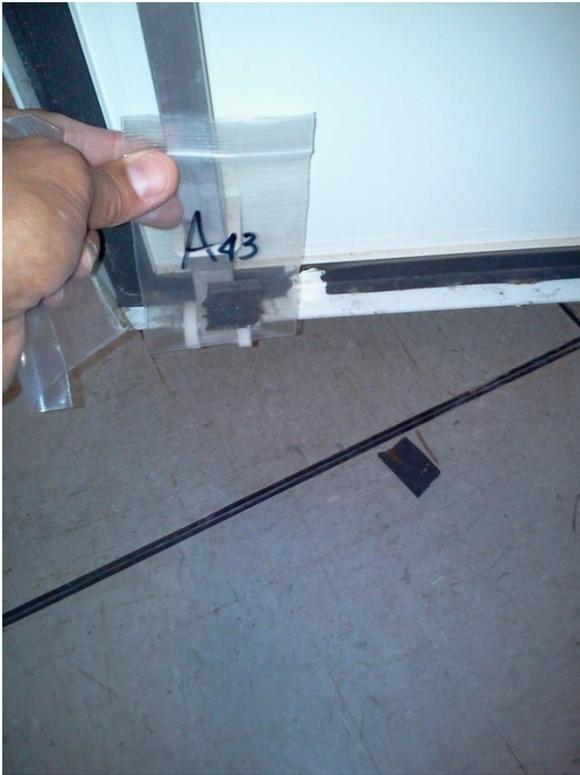
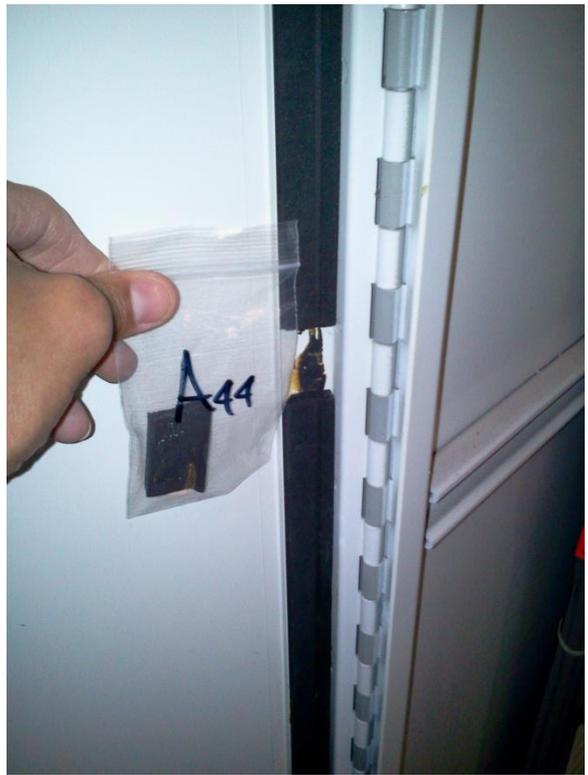
Door Seal Gaskets Electrical Panel I/O 290

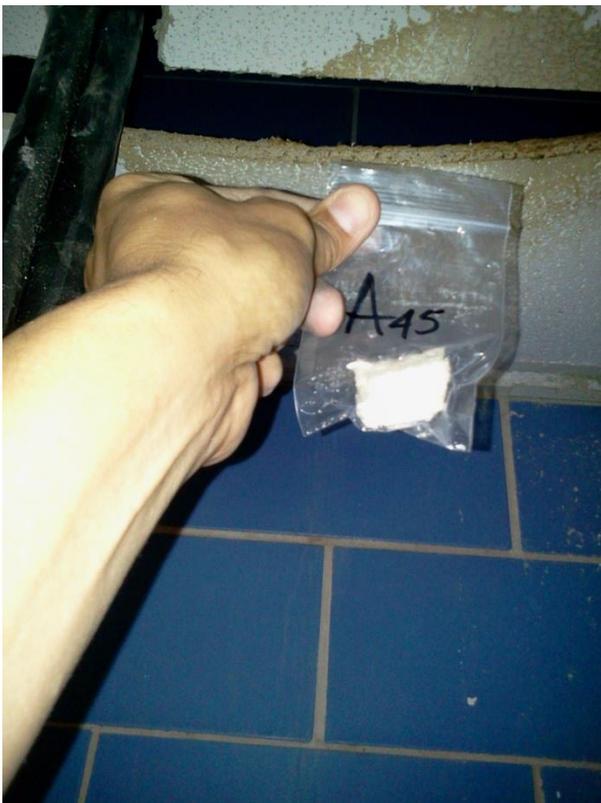
2x4 ceiling panels North/NW area of ceiling

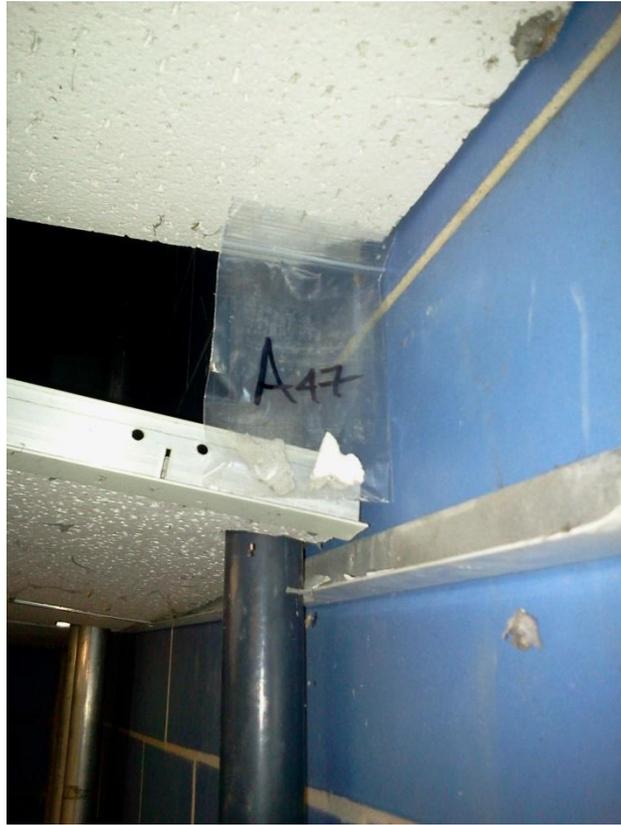
2x2 ceiling panels West/NW Area of ceiling

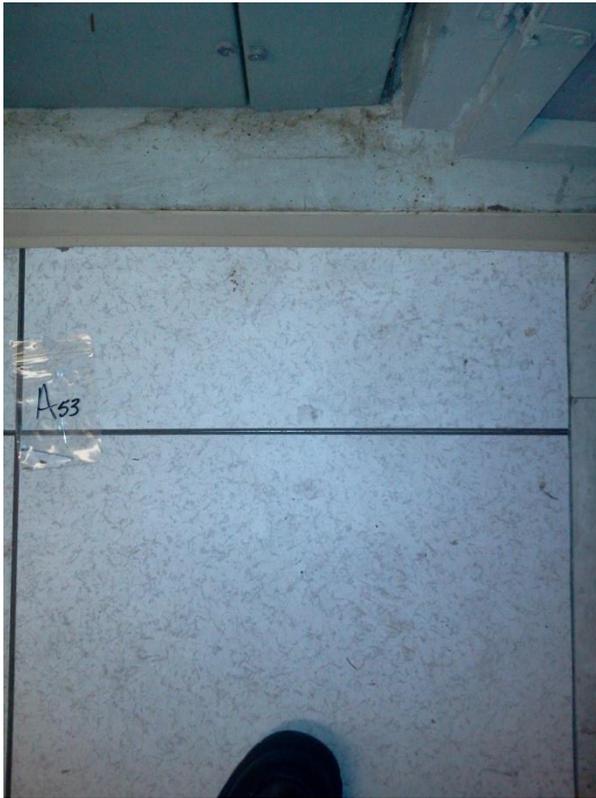
2x2 floor tile E/NE area back door

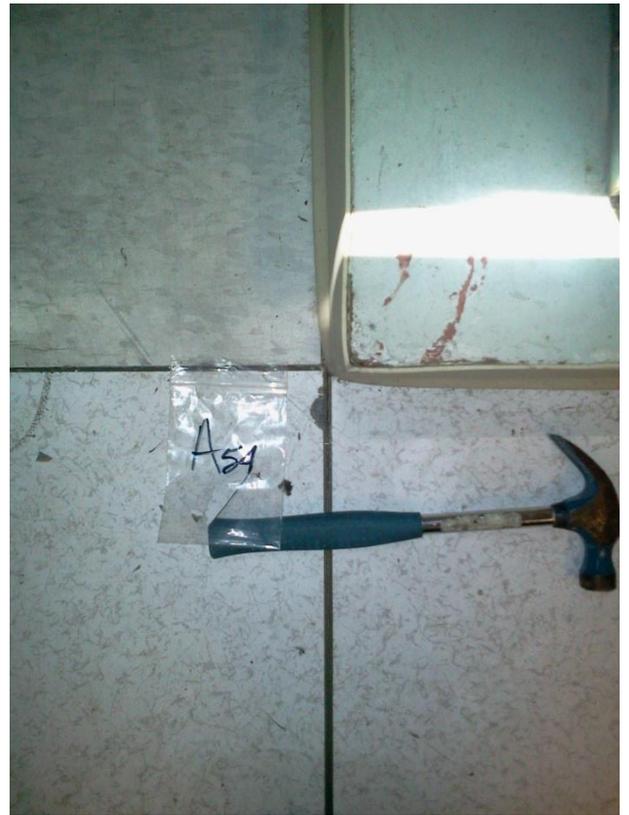
2x2 floor tile S/SW area front door

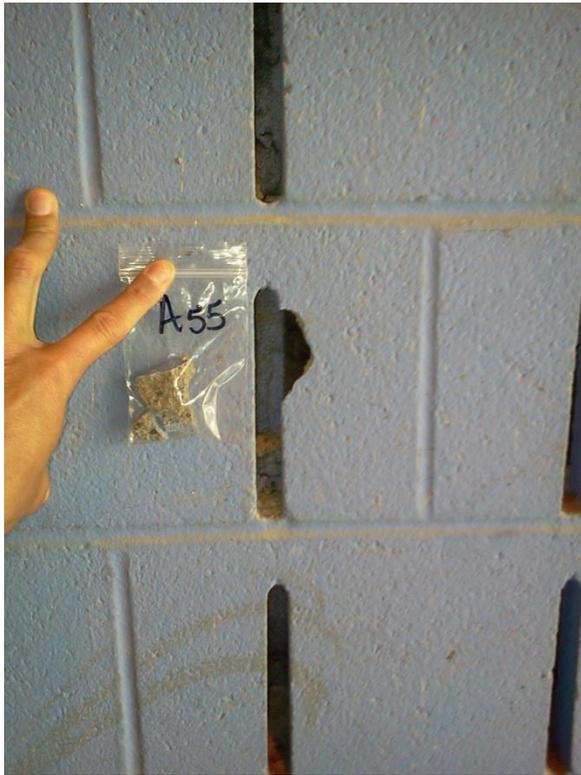
Wall Texture W/NW wall area

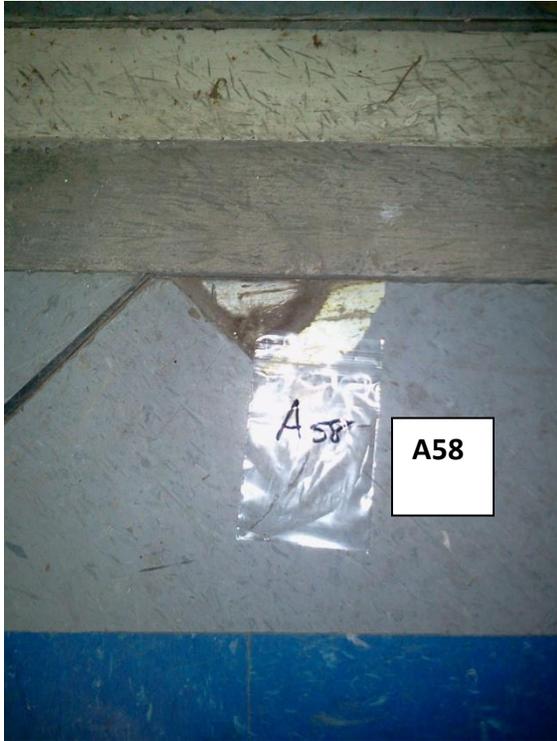
12x12 flooring SW corner of building interior

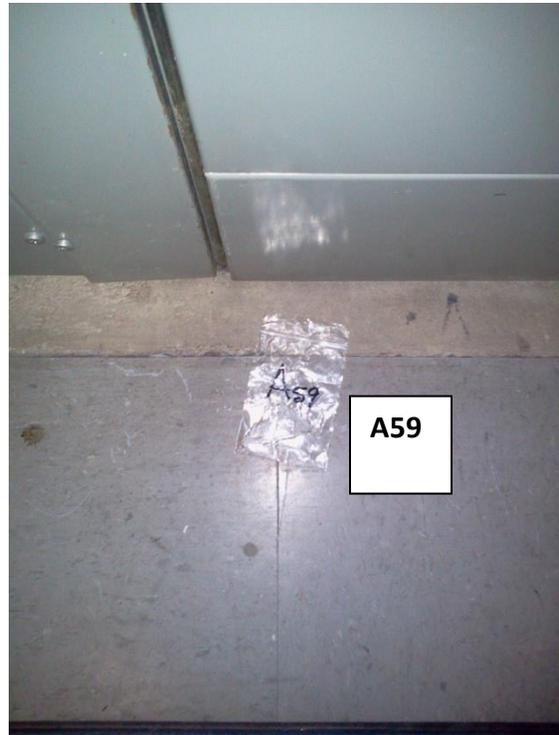
12x12 flooring East side of building interior

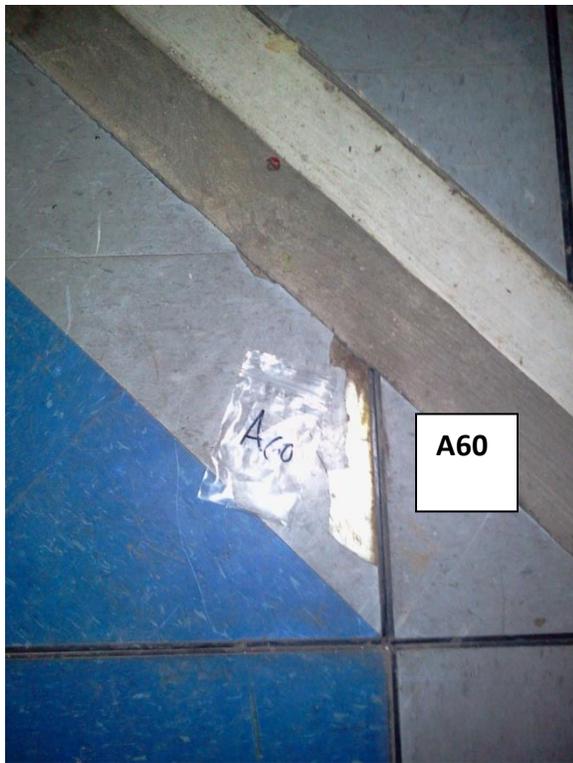
12x12 flooring NW corner of building interior

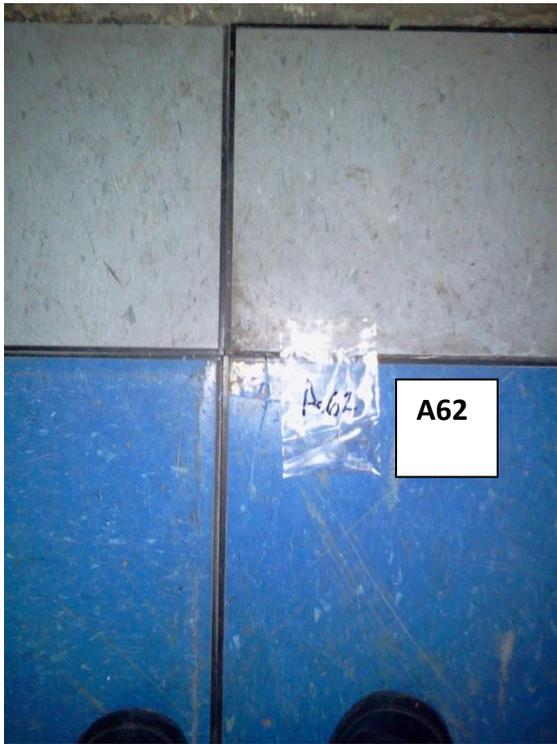
12x12 flooring East area of building & door entrance

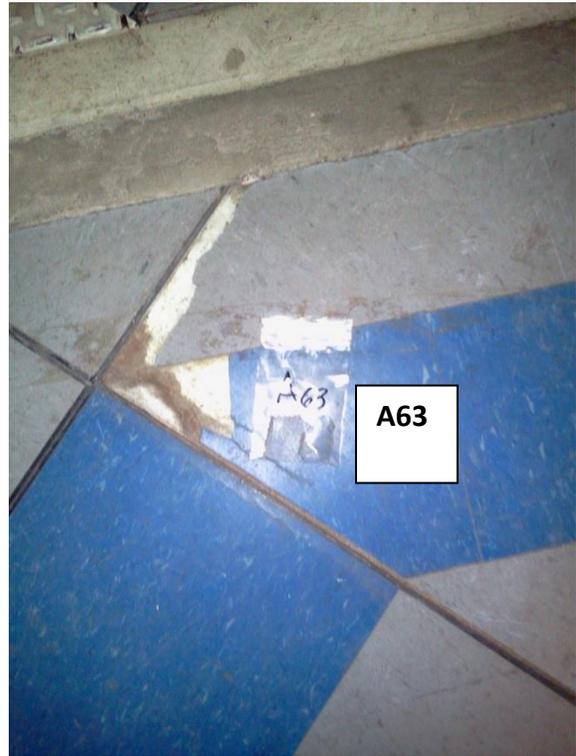
12x12 flooring NW corner of building interior

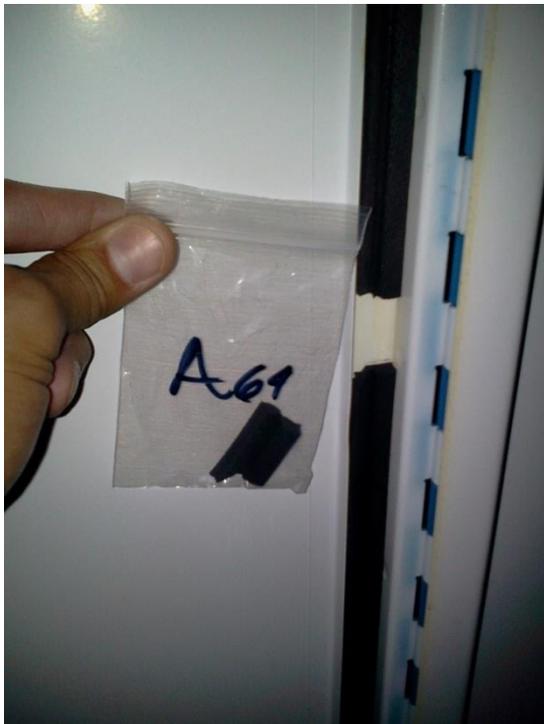
Door Seal short blue cabinet LPC-0800

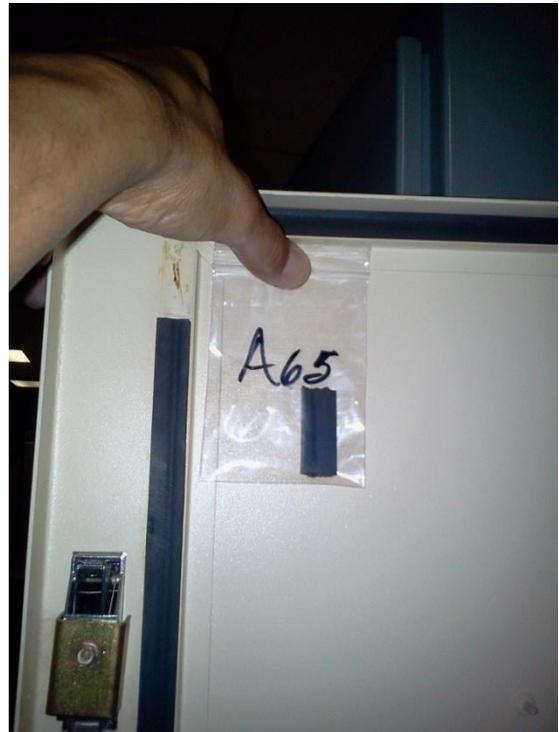
Door Seal Slim beige/brown cabinet E/C 0430

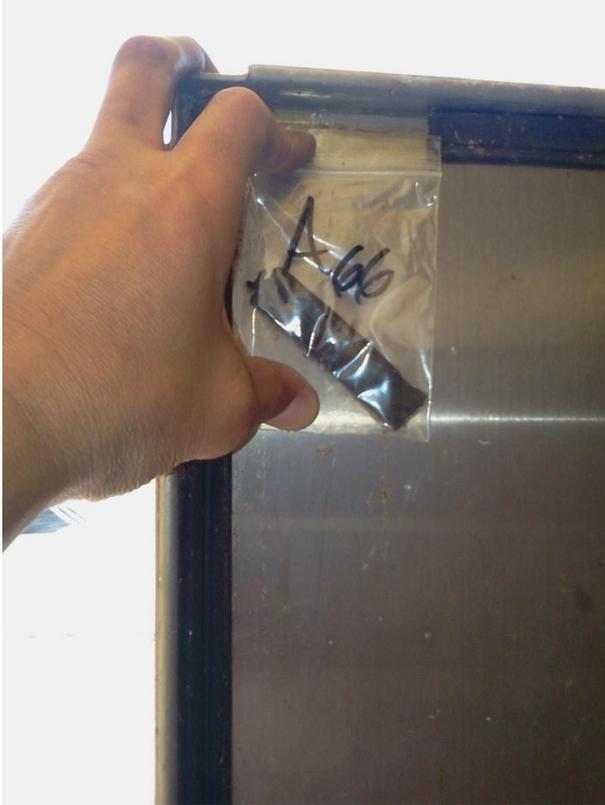
Seal & Door at FIP-0820

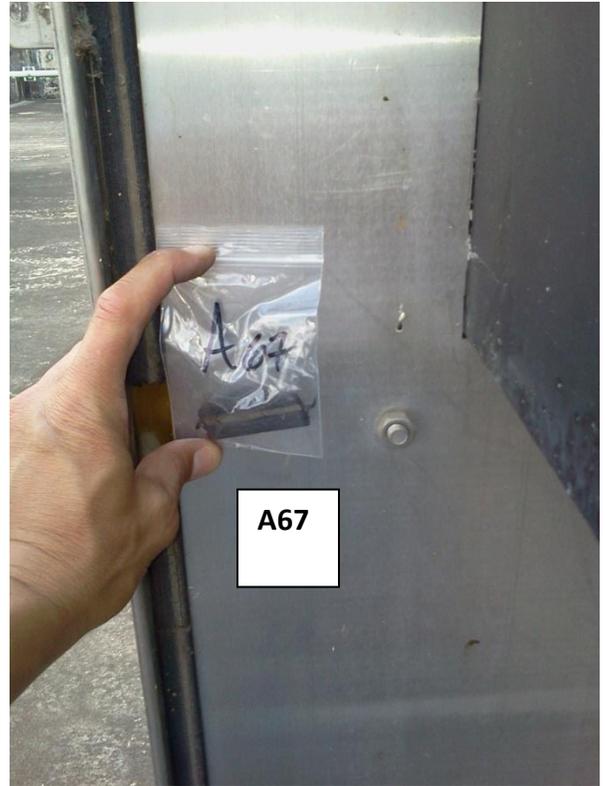
Seal & Door at FIP-0870
