Subject: **SOUTHWEST WASTEWATER TREATMENT
PLANT
4211 BEECHNUT
WBS No. R-000265-0103-4**

Asbestos Survey Report

Southwest Waste water Treatment Plant
4211 Beechnut
HOUSTON, TX

WBS No. R-000265-0103-4
Task Number 15-04
ECMS Project Number: 3830

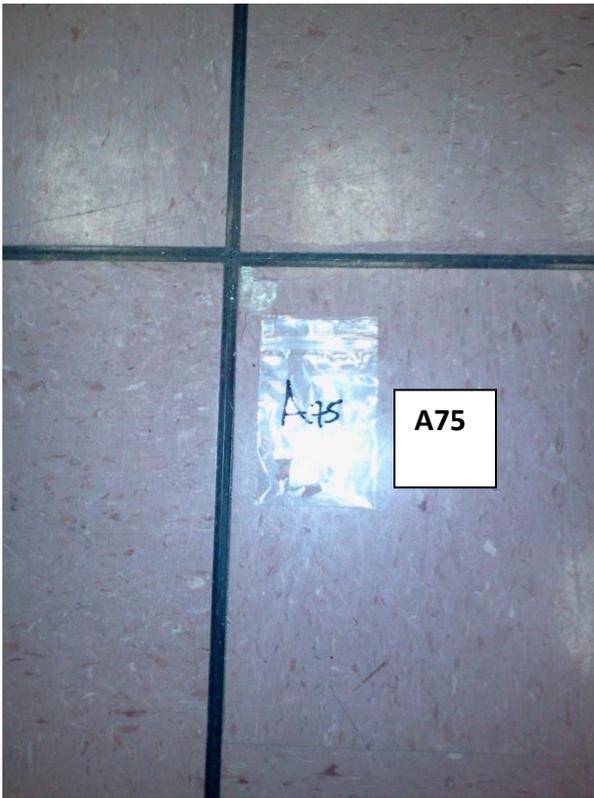
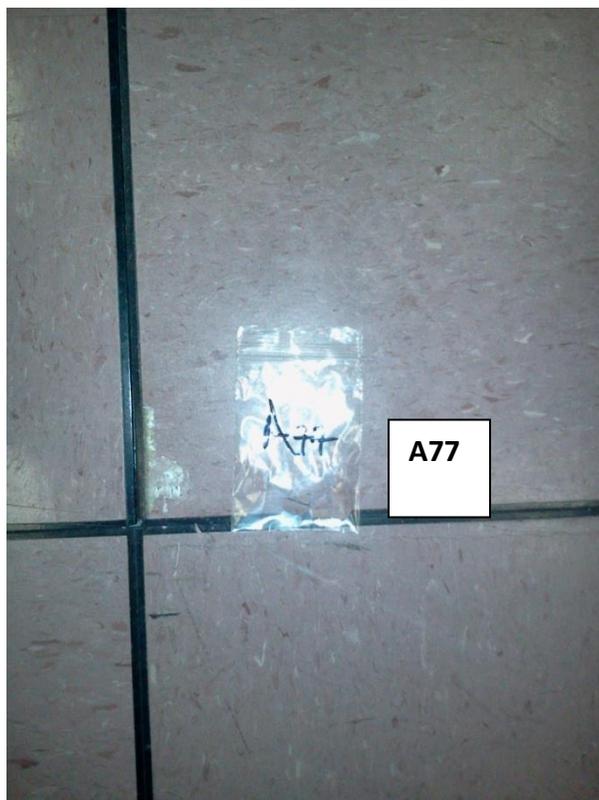
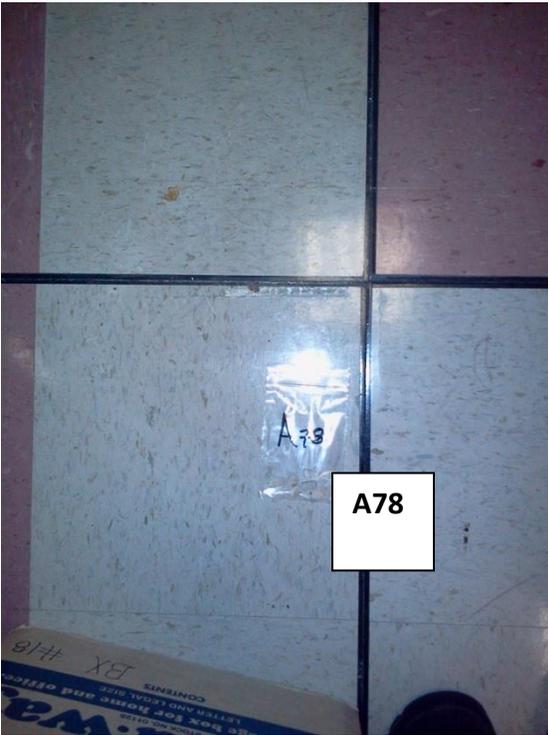
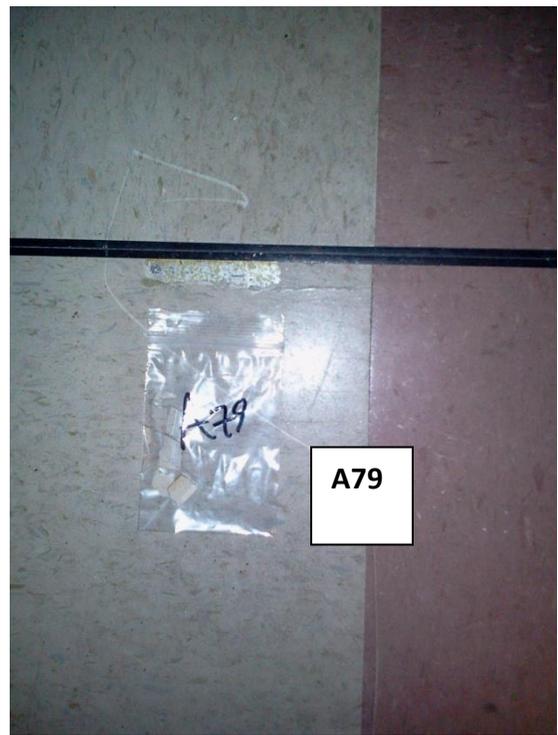
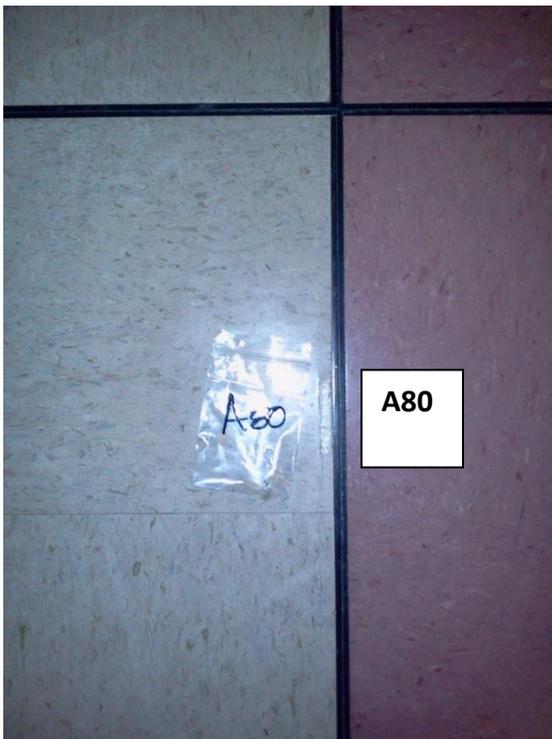
2x2 floor tile Control Room 2nd Level

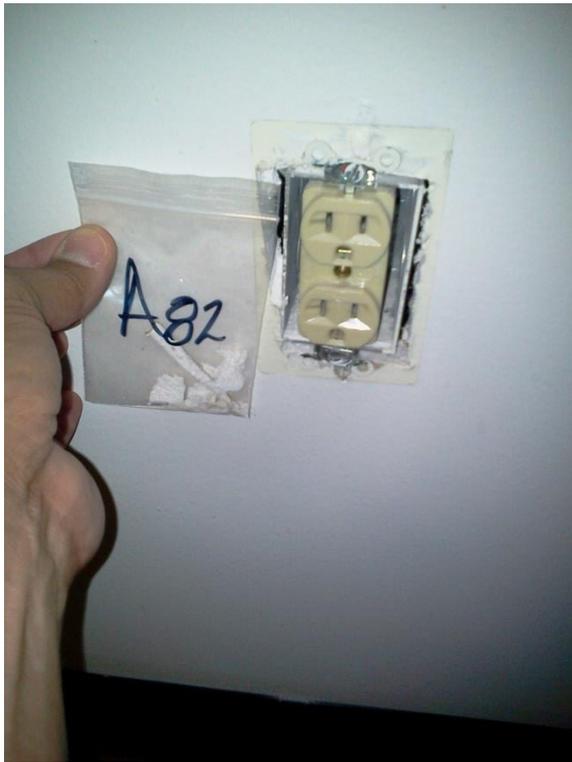
Wall Texture Control Room 2nd level North Wall

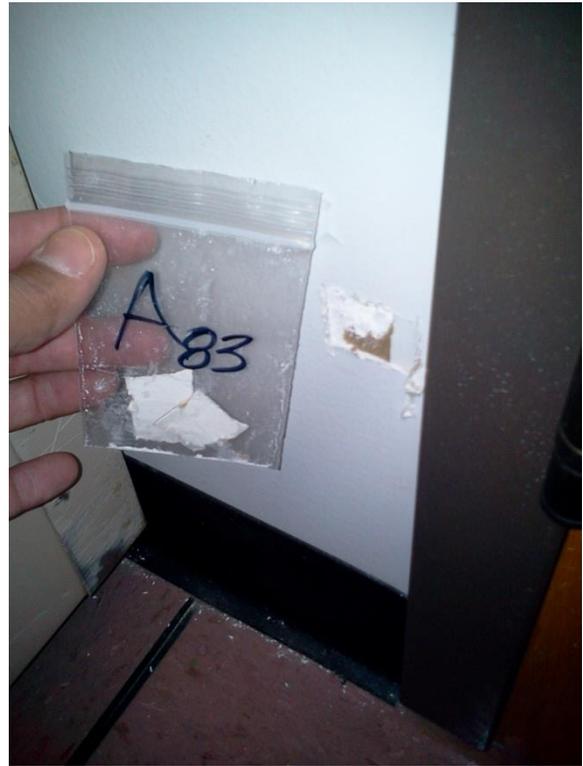
Wall Texture Control Room 2nd level East Wall

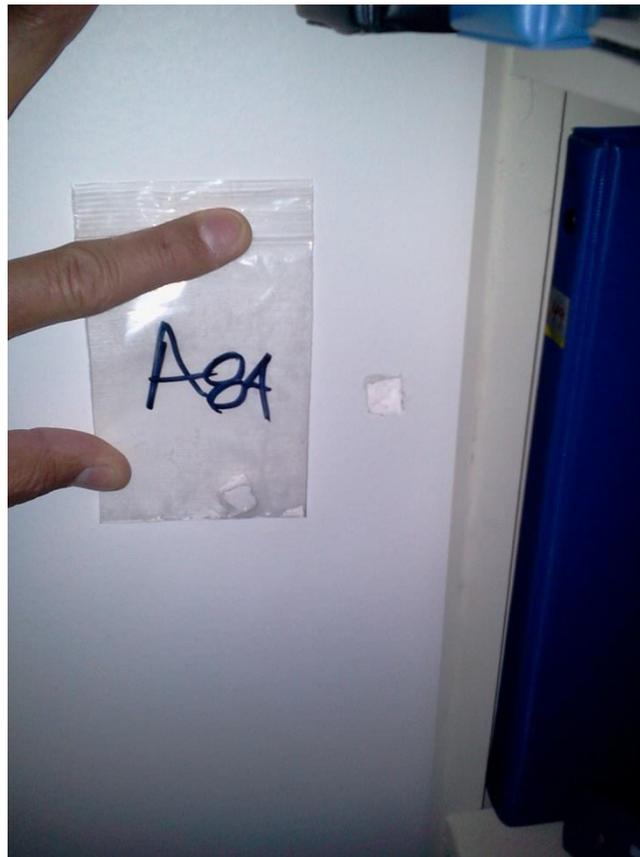
Wall Texture Control Room 2nd level NW Wall
